PROPERTY CONDITION ASSESSMENT

765 Fremont Avenue
Los Altos, Santa Clara County, California 94022

RSB Project No. 2403055

Report Date: May 3, 2024

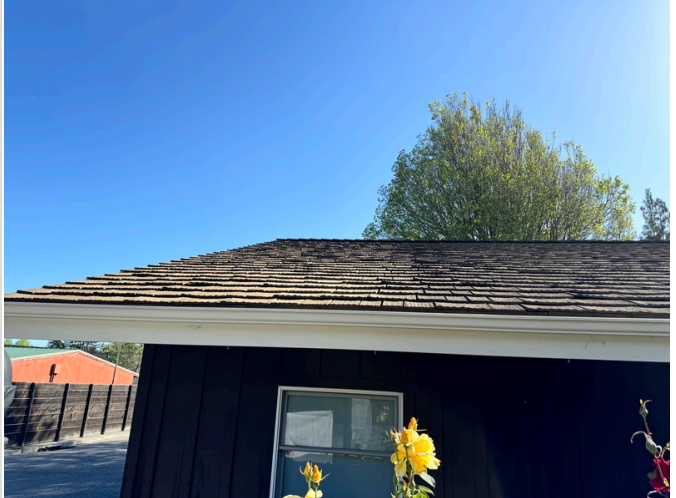
The wood shake roof appears to be in satisfactory condition. Roofs of this type typically have an average, effective useful life of approximately 30 years, depending on the property's location, material type and quality, quality of installation, roof maintenance and exposure, amount of roof traffic, and regional climatic conditions. Based on its current condition, and expected useful life, the roof is expected to reach its life expectancy during the evaluation period covered by this report. Accordingly, Replacement Reserves are recommended for roof replacement during the analysis term.

14. Roof

Cost Recommendation	EUL	EFF AGE	RUL	Year	Cost
Wood shake roof replacement	30	30	0	1	\$93,100
Total					\$93,100

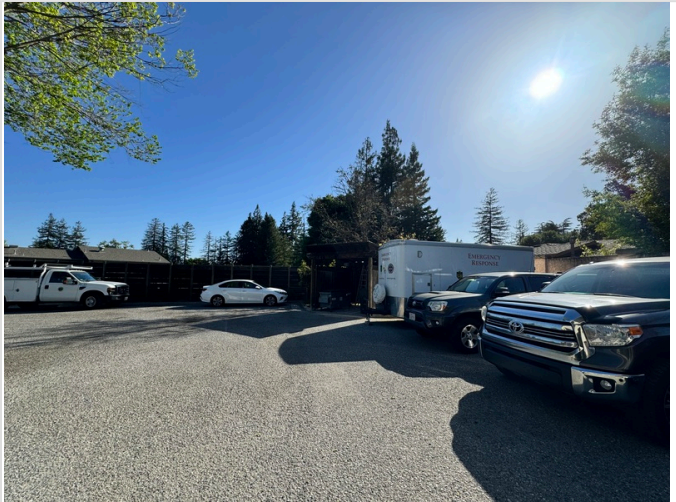
The parking area sealant and striping is in poor condition, with indications of heavy wear. Based on the observed condition of the parking and drive areas, and the average effective useful life of pavement and pavement sealants, seal coating, and striping, repairs to the asphalt, the application of sealants, seal coating, and striping of the parking and/or lane markings are recommended as an Immediate Repair. Additional Replacement Reserves are recommended for repeated applications during the analysis term.

16. Parking pavement

Cost Recommendation	EUL	EFF AGE	RUL	Year	Cost
Patching, crack sealing, seal coating and striping	5	5	0	Immediate	\$211
				5	\$211
				10	\$211
Total					\$633

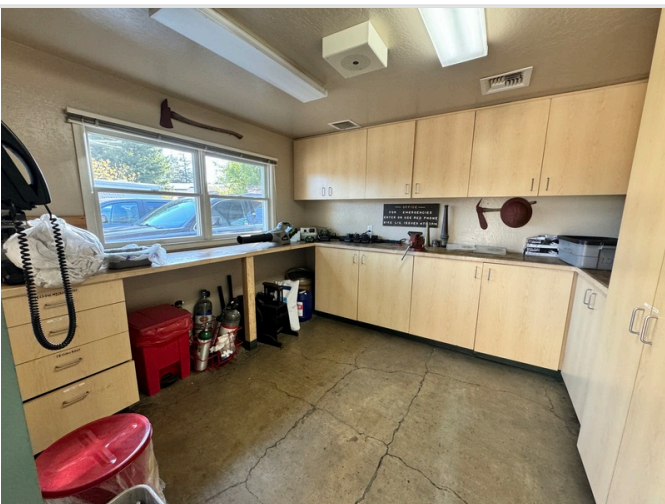
Condition: Foundation and footing construction could not be verified at the time of the assessment due to hidden conditions. The substructure appears to be sound and in fair condition. However, severe cracks were observed in foundation components and appear to be the result of possible substructure degradation. Completion of a foundation investigation and report, with recommendations for repairs, if any, and their associated costs, by a foundation engineer is recommended as an Immediate Repair. An allowance is included in the Immediate Repairs table. This *Report* can be updated with the cost of the repairs once they have been determined by the consultant.

41. Cracks observed on the flooring

Cost Recommendation	EUL	EFF AGE	RUL	Year	Cost
Inspection and report by foundation engineer	-	-	-	Immediate	\$6,000
Total					\$6,000

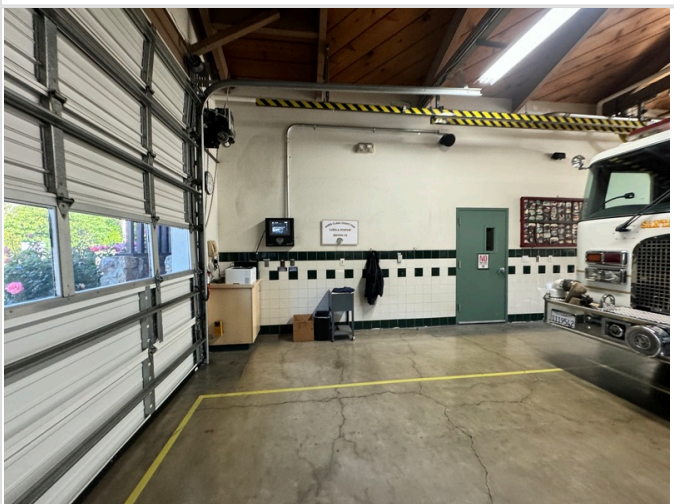
42. Garage interior, cracks observed on the flooring
