PROPERTY CONDITION ASSESSMENT

10 Almond Avenue
Los Altos, Santa Clara County, California 94022

RSB Project No. 2403055

Executive Summary	
Project Name:	Los Altos Fire Station
Property Address:	10 Almond Avenue, Los Altos, Santa Clara County, California 94022
Property ID (APN):	170-43-005
Property Owner (per tax records):	City of Los Altos
Property Type:	General Public Use (Los Altos Fire Station)
Site Acreage:	Approximately 0.90 - acres
Number of Buildings:	One (1)
Total Building Square Footage:	Approximately 9,442 (Calculated) - SF
Year Built:	1968 (Historic Aerials)
Number of Floors:	One (1)
Number of Units:	One (1)
Substructure (Foundation):	Slabs-on-grade
Superstructure (Building Frame):	Concrete and steel
Facades (Exterior Walls):	Stucco, brick veneer and wood siding
Roof:	Pitched, asphalt shingle roof and low-slope, modified, bituminous asphalt membrane roof
HVAC:	Grade-mounted HVAC units, PTAC units and gas furnace
Elevators:	Not applicable
Fire and Life Safety:	Fire extinguishers
Seismic Zone:	4
Flood Zone:	Flood zone X Unshaded

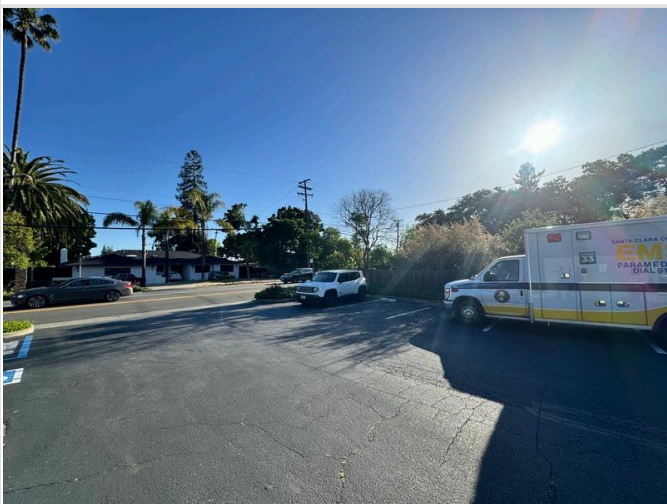
Condition: Overall the paving, curbing, and parking appeared to be in fair to poor condition. Cracks and alligating were observed in the pavement at number of locations. Immediate Repairs are recommended for partial, full-depth repairs and asphalt overlay.

59. Cracks and alligating observed on the pavement

Cost Recommendation	EUL	EFF AGE	RUL	Year	Cost
Partial full depth asphalt repairs and overlay	25	25	0	Immediate	\$13,192
Patching, crack sealing, seal coating and striping	5	3	2	2	\$4,253
				7	\$4,253
				12	\$4,253
Total					\$25,951

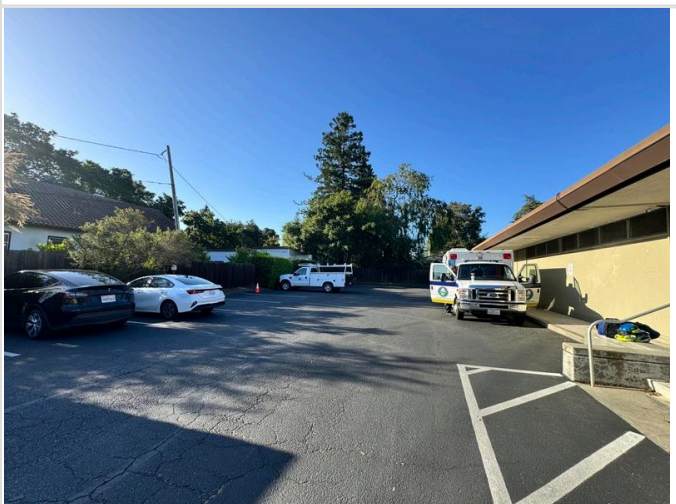
60. Cracks and alligating observed on the pavement

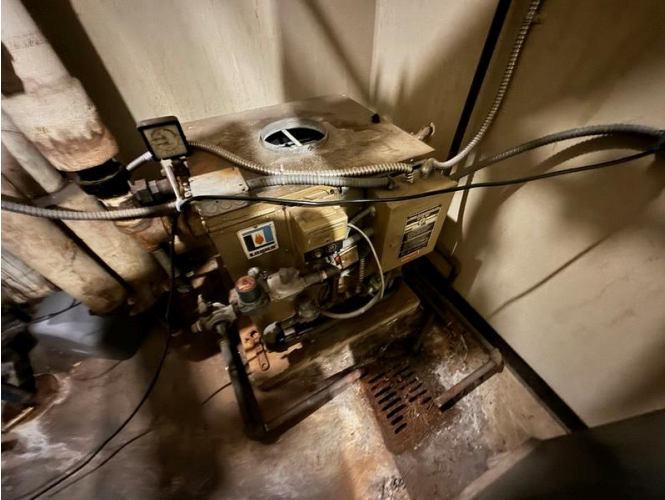
61. Decommissioned water boiler

Item	Quantity	Unit	Unit Cost	Immediate Cost
Partial full depth asphalt repairs and overlay	6,596	SF	\$2.00	\$13,192.00
Gas-fired water boiler replacement	1	Allow	\$23,000.00	\$23,000.00
Total Cost: \$36,192
