ARBORIST REPORT

TREE PROTECTION PLAN

REV. OCTOBER 6, 2022

PROJECT: 905 LEONELLO AVE, LOS ALTOS, CA 94022

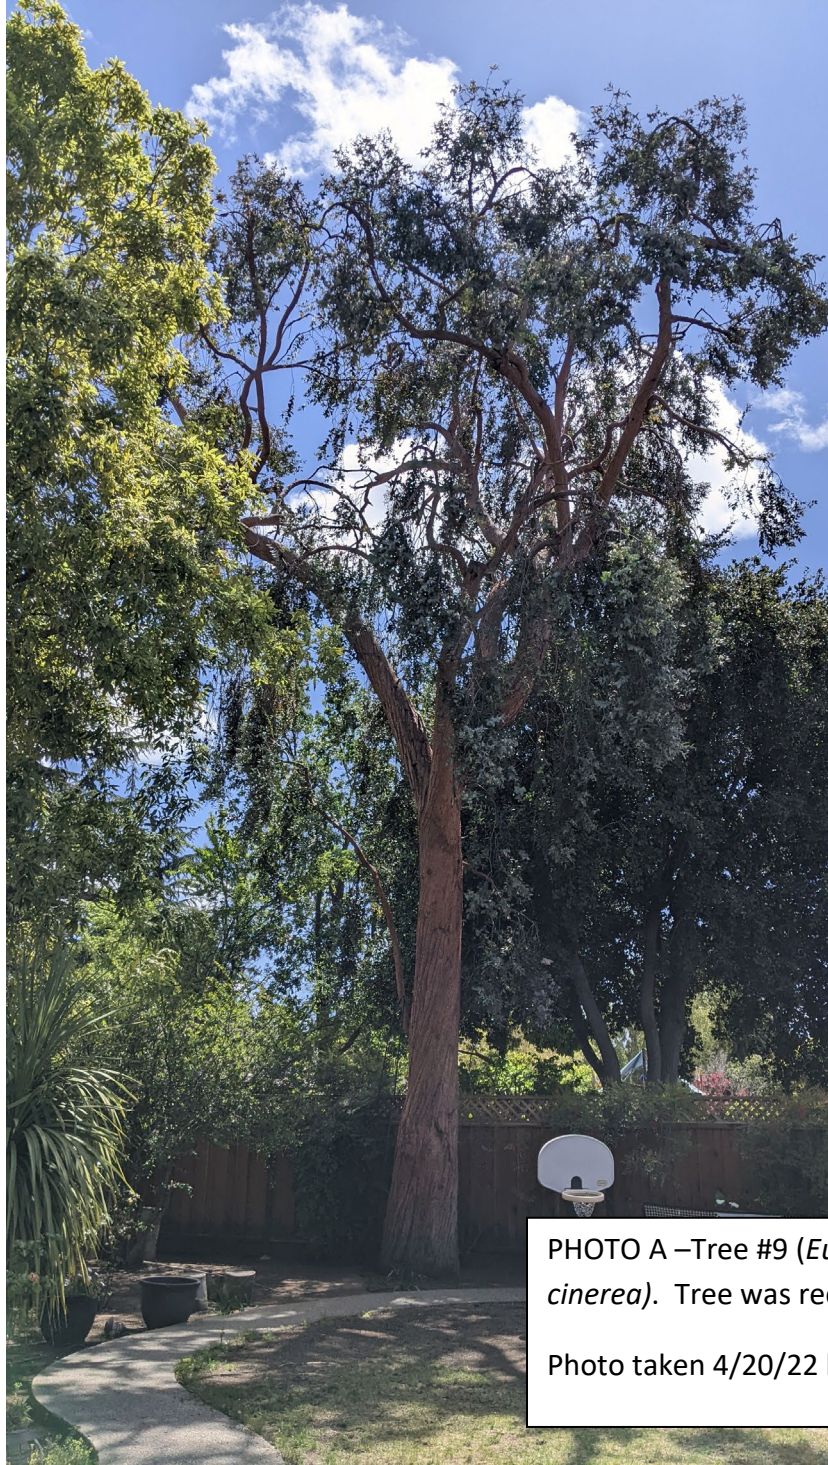
- **Tree #9 (Argyle apple, *Eucalyptus cinerea*):** Although the client valued this tree and wished to preserve it, they are requesting removal at my recommendation. I observed that the lower trunk had a sunken look, and upon investigation, found that more than 50% of its circumference was rotten, with the outer wood coming apart easily in my hands. Ann had reported that another *Eucalyptus* had failed at trunk in years prior and it was my assessment that whole-tree failure of this one was probable within the next two years. Recent reduction pruning of its canopy has reduced the loading on the defect and will buy some time. However, with the house located within the fall zone, I recommended removal as soon as the City provides approval and before the next storm season if possible. Based on its very poor and potentially dangerous condition, removal of Tree #9 may be justified by City code chapter 11.08.090 Clause A.1 “the condition of the tree with respect to disease.” **Please see photos at the end of this report.**

PHOTO A –Tree #9 (*Eucalyptus cinerea*). Tree was recently pruned.
Photo taken 4/20/22 by B. Firestone

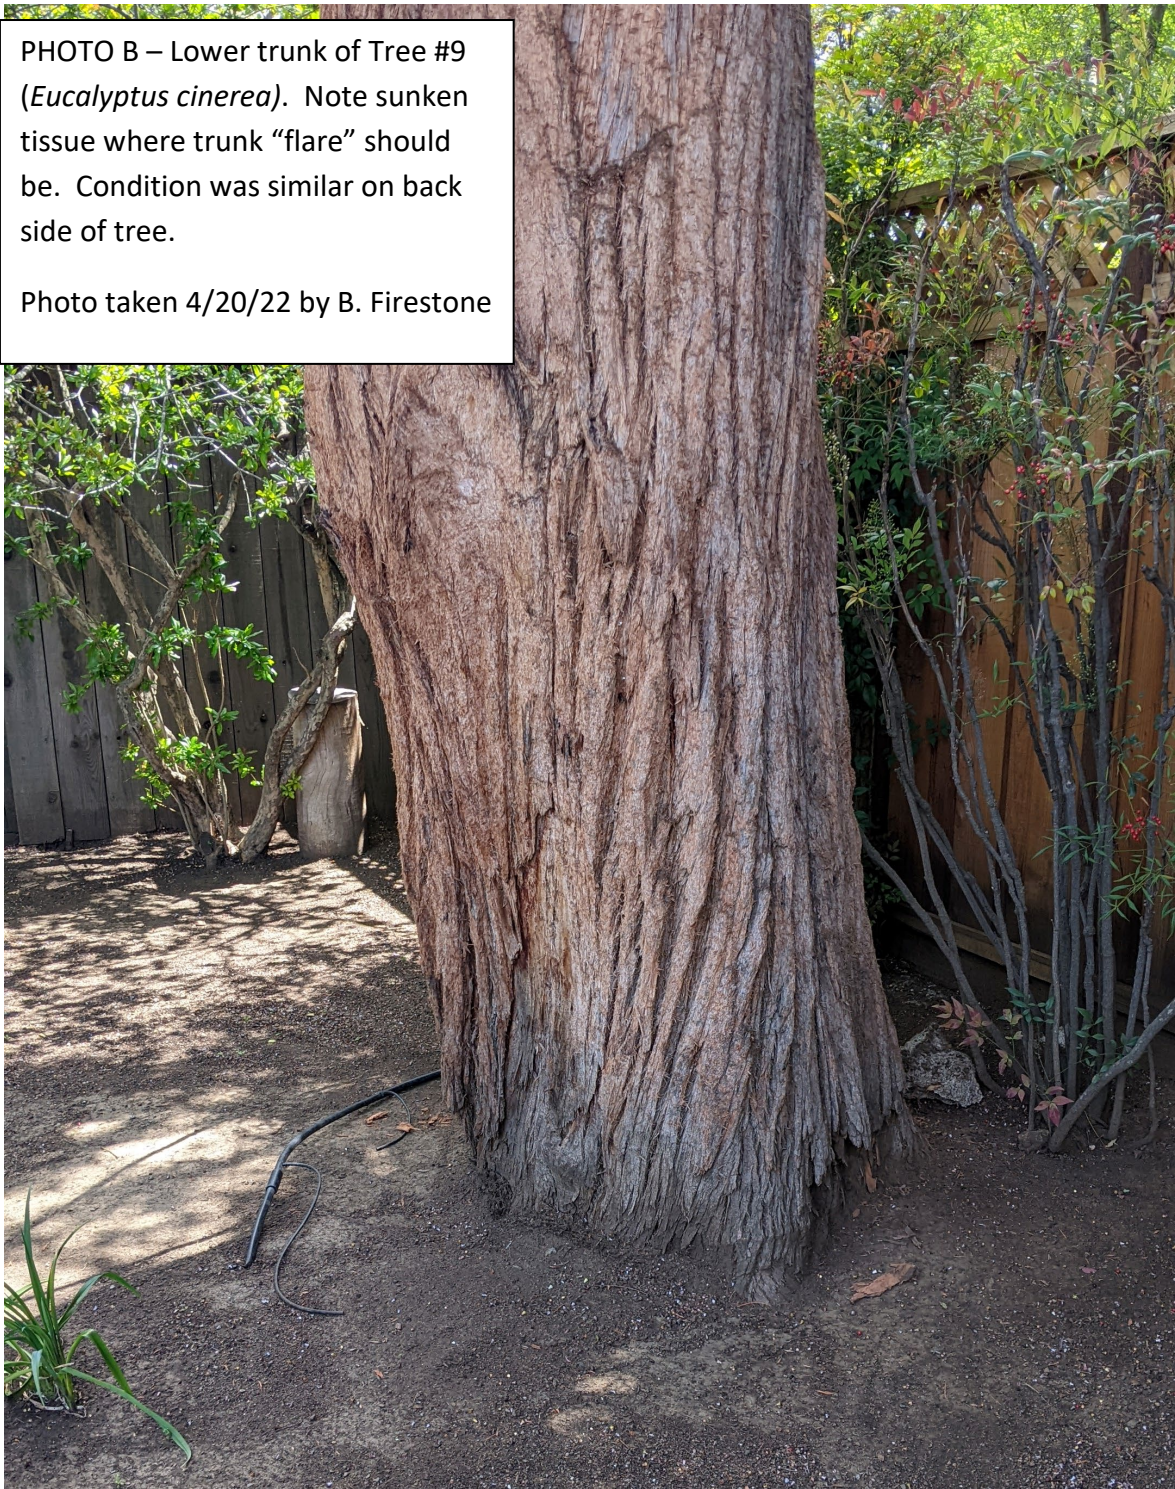
PHOTO B – Lower trunk of Tree #9 (*Eucalyptus cinerea*). Note sunken tissue where trunk “flare” should be. Condition was similar on back side of tree.
