December 19, 2022

RE: Evaluation of Root Exploration at 749 University Ave, Los Altos, California Project Site

FINAL ARBORIST REPORT, TREE INVENTORY, CONSTRUCTION IMPACT ASSESSMENT AND TREE PROTECTION PLAN

RE: 749 University Avenue, City of Los Altos, California [APN 175-18-042]

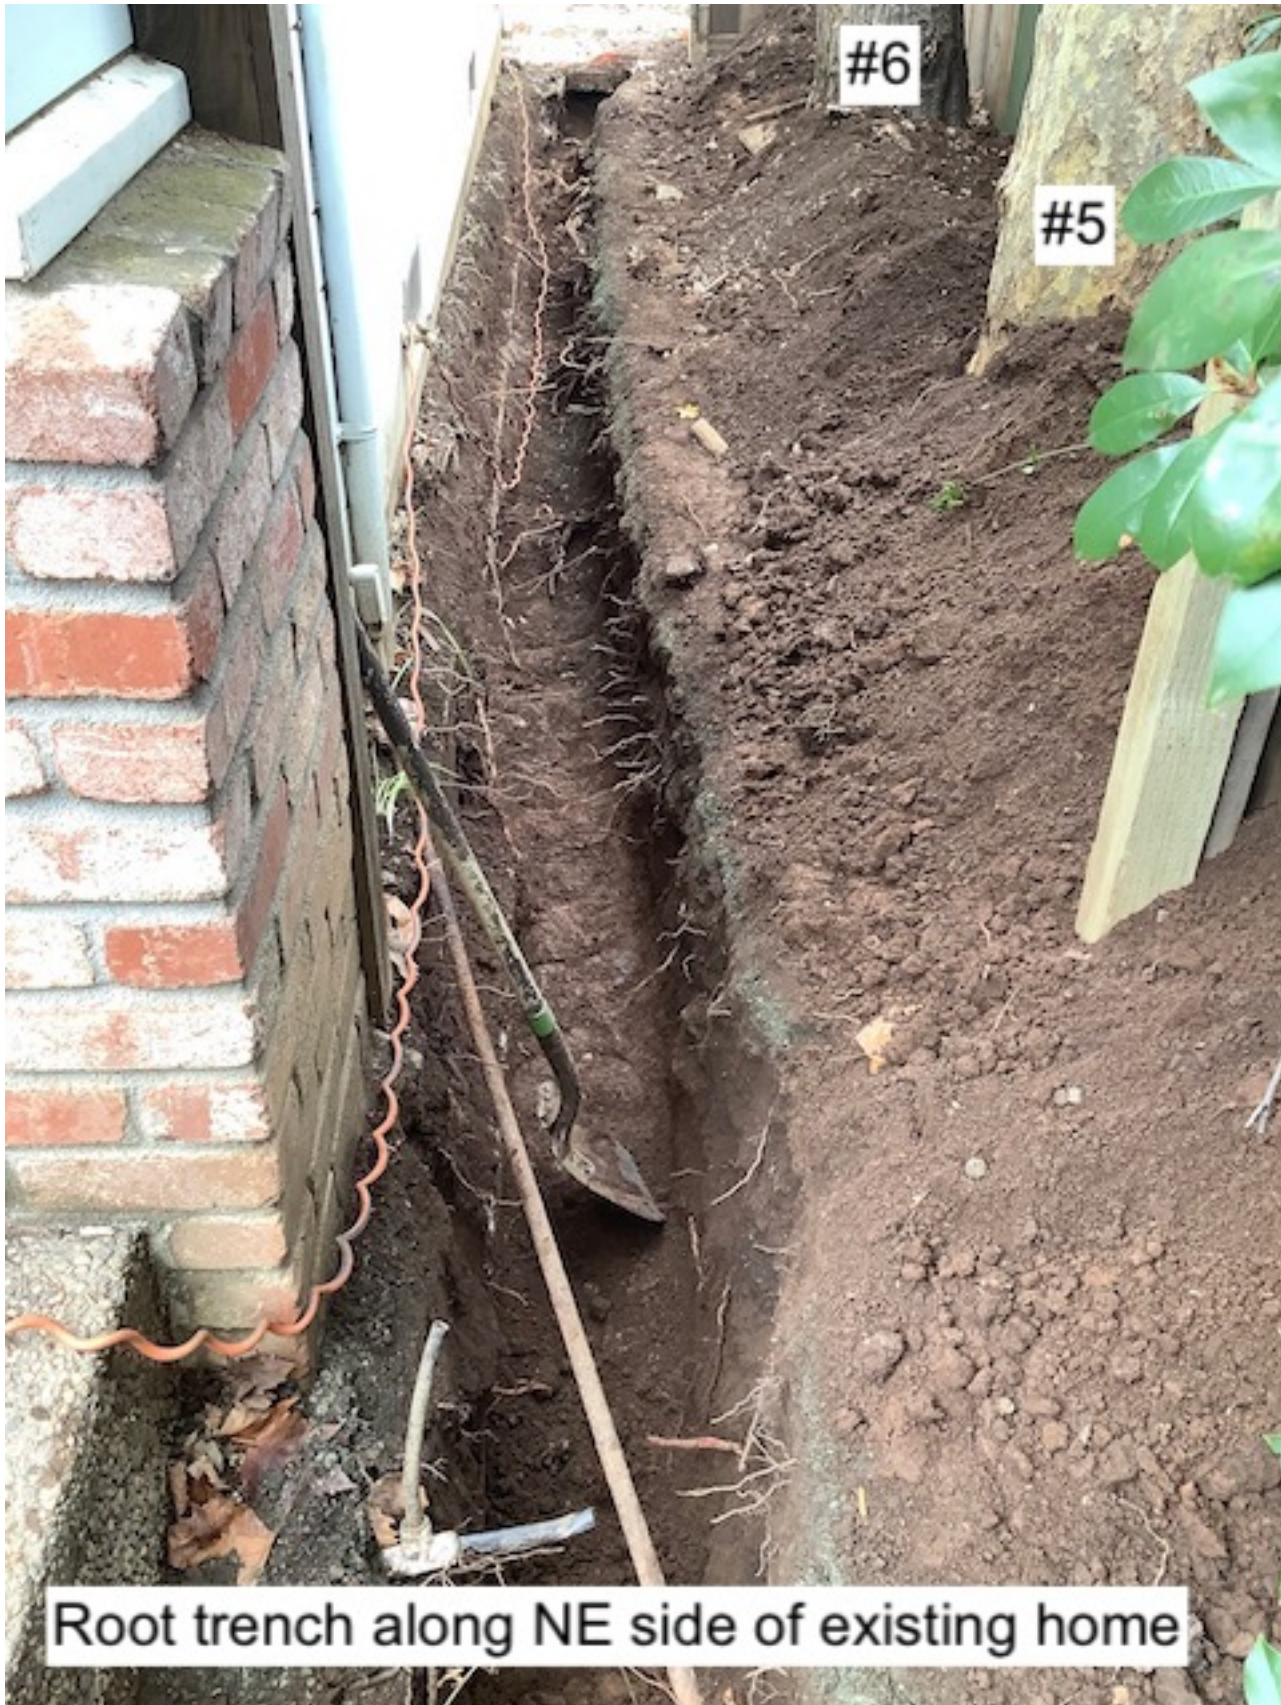
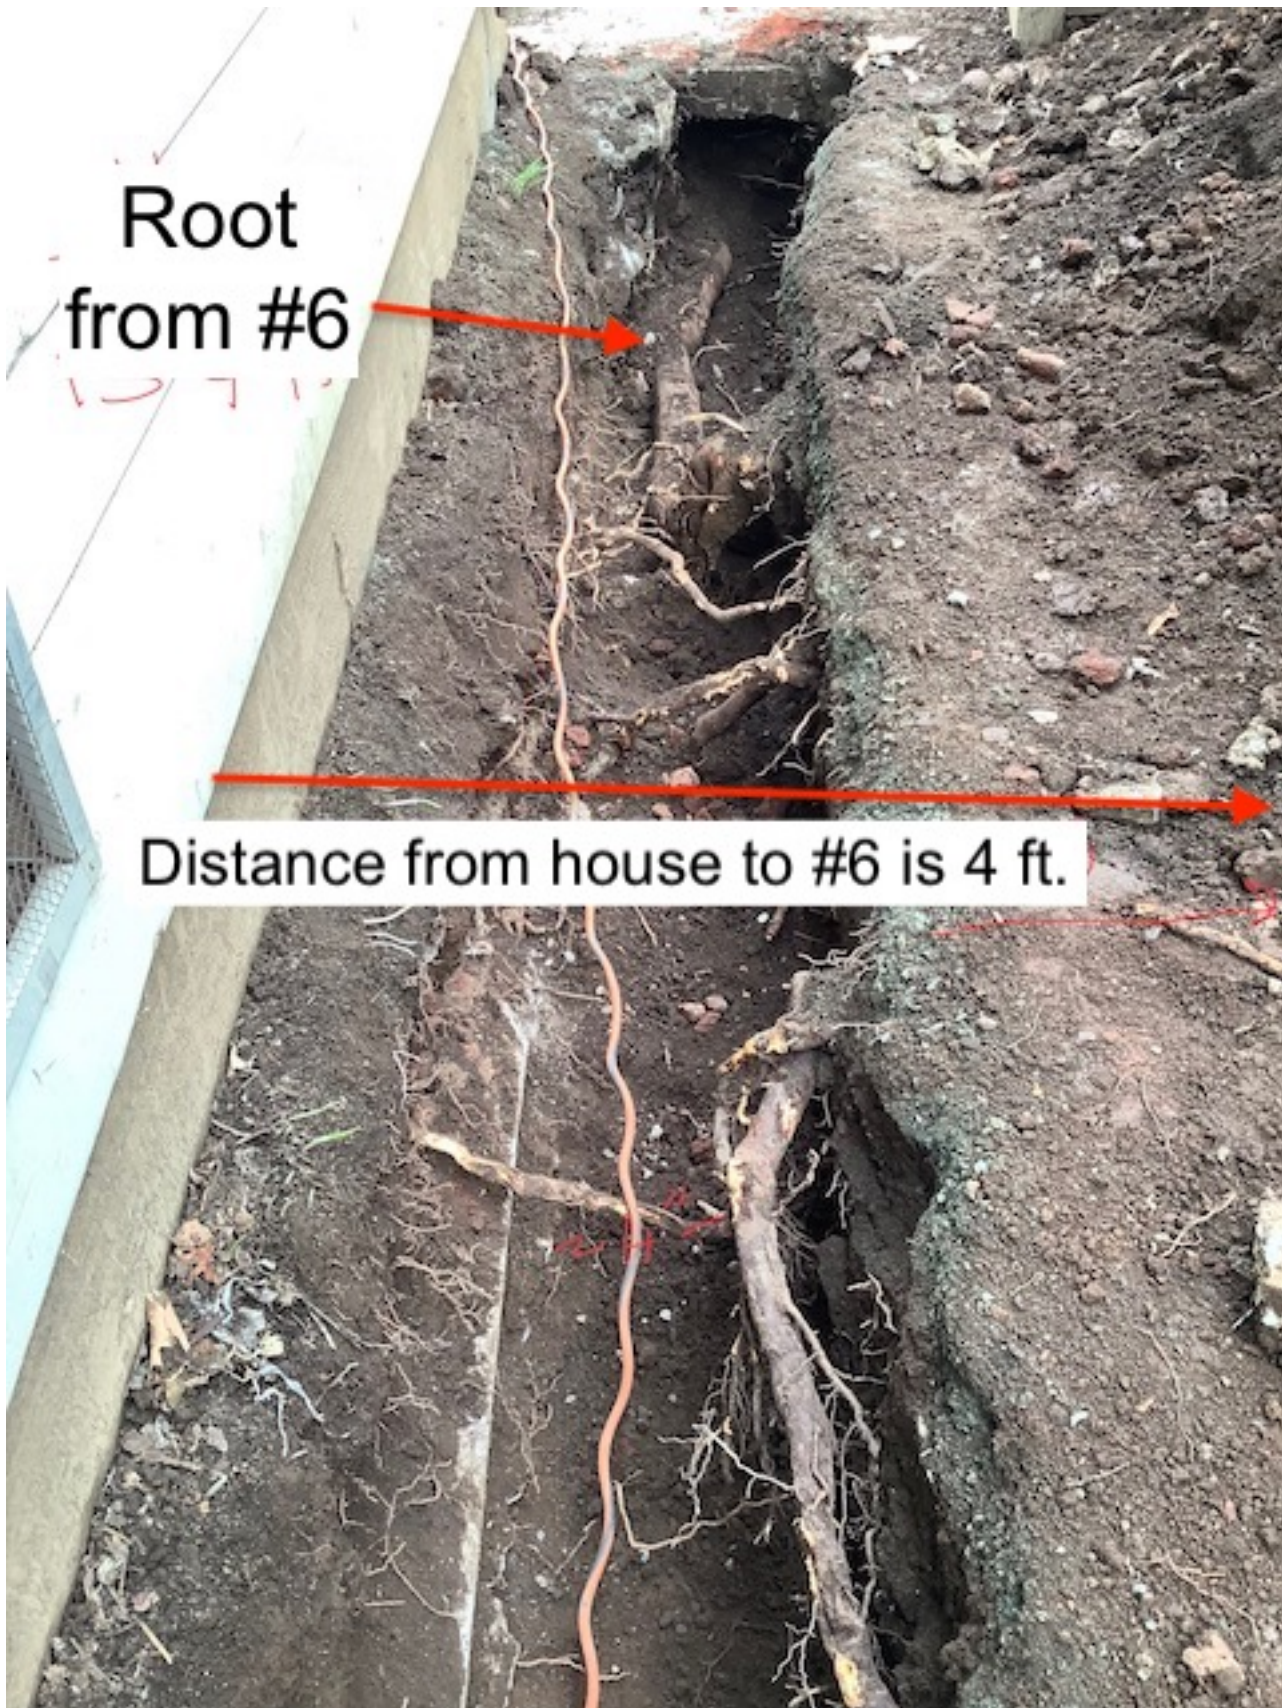
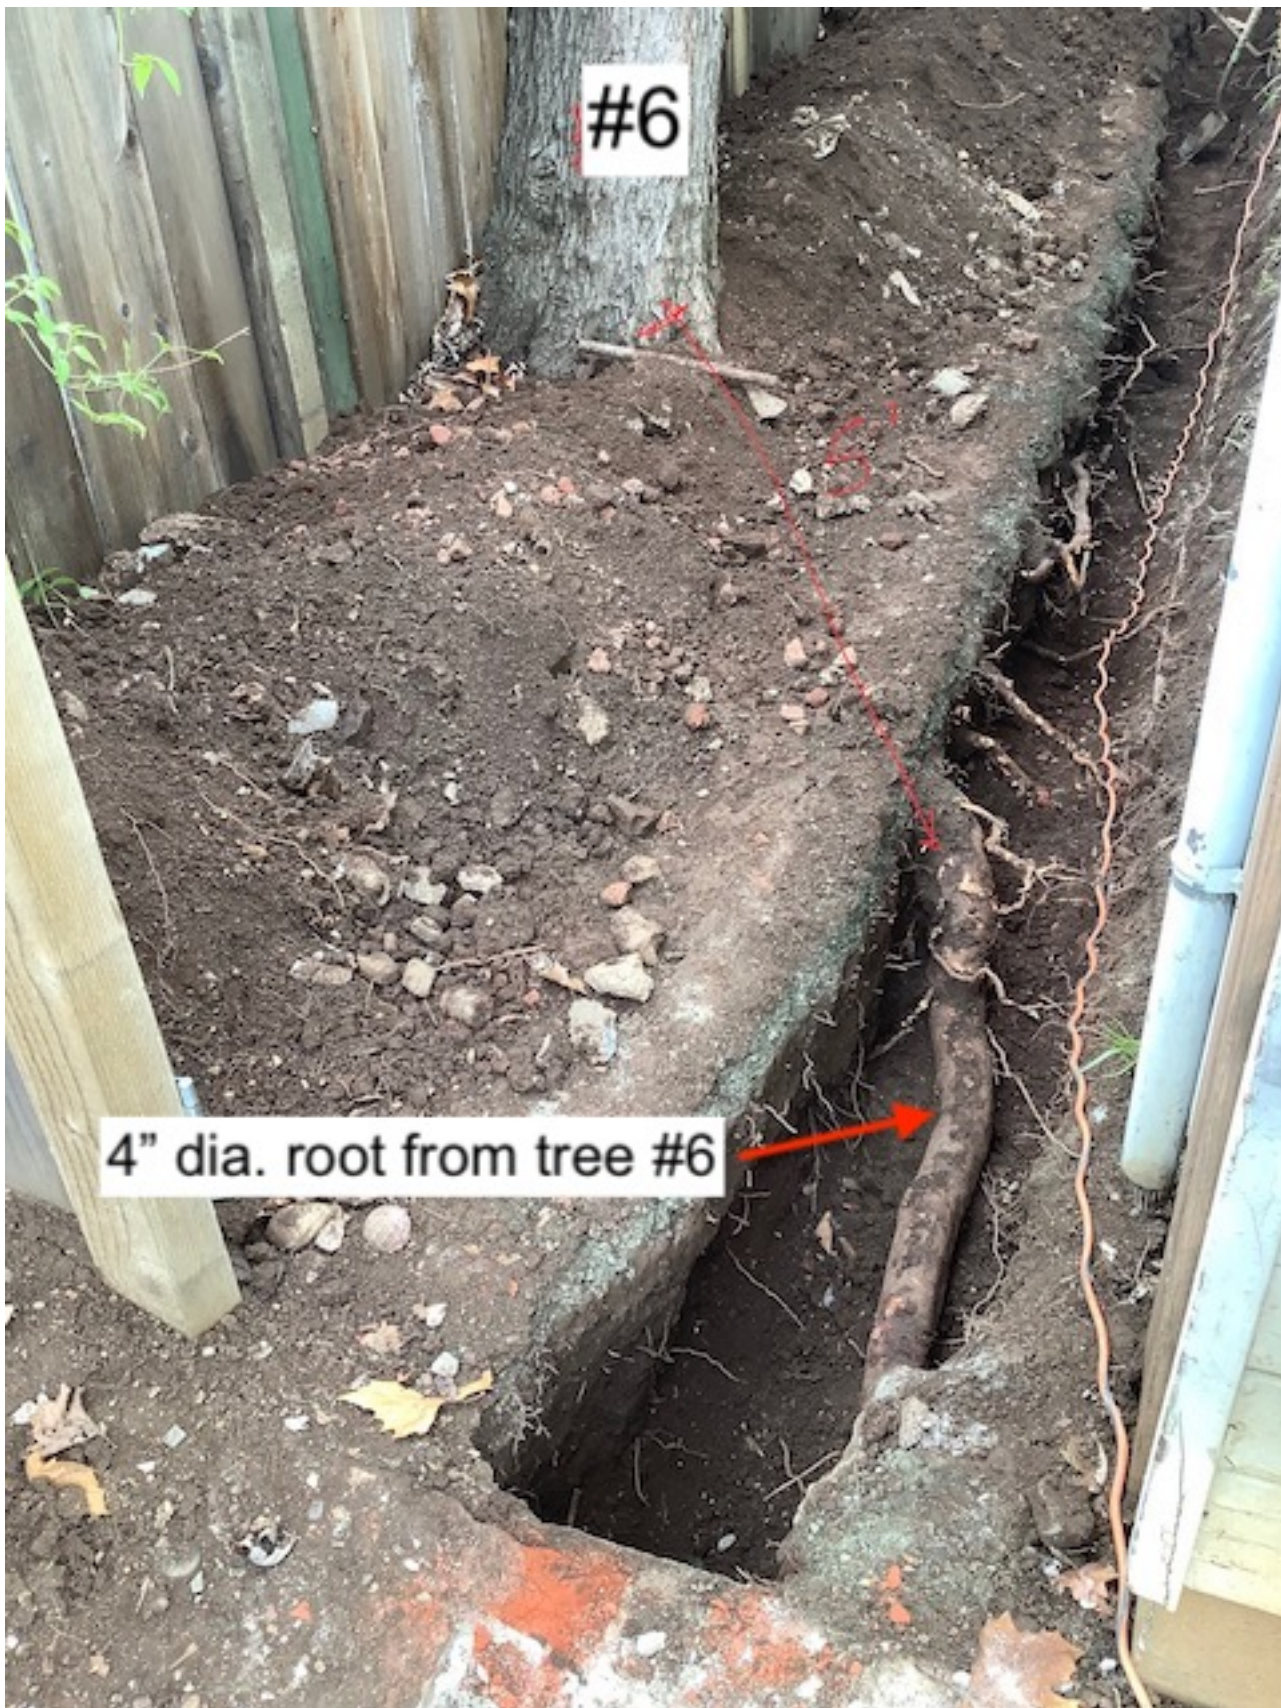
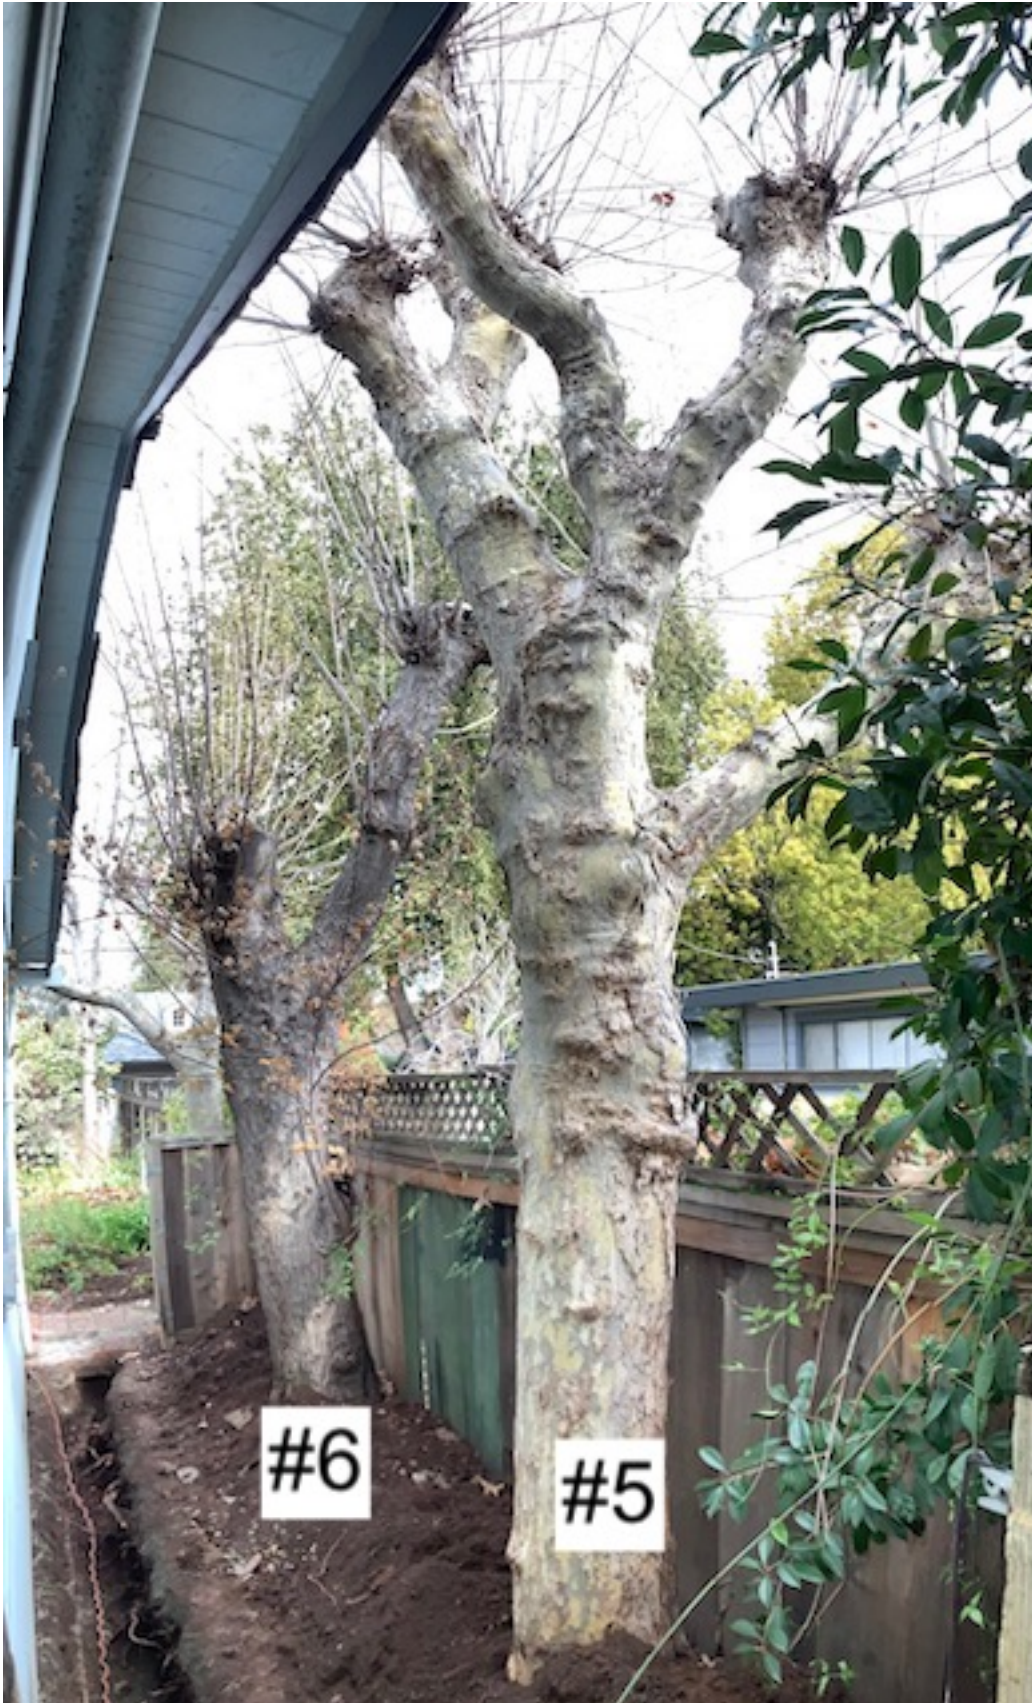
A root trench was hand dug by two crew members of Golden State Co. along the north east side of the existing home. Refer to the attached exhibit for the approximate location of the trench relative to tree #'s 4, 5, 6 and 7 (Tag #'s 1242, 1243, 1244, 1245). This trench was dug to expose roots which may be growing in the top 2 feet of soil to the west of these trees. The trench was approximately 12" wide by 24" deep. The only significant root (2" diameter or greater) observed was one 4" diameter root from tree #6. This root grew west at a depth of about 1 foot until it reached the raised floor foundation, then it grew northeast adjacent to foundation past the point of excavation. Refer to the attached photographs.

direction of the project arborist, following current ISA best practices. It was noted in the evaluation that the area to the northeast of all four trees, on the adjacent parcel, is primarily lawn, which is a favorable environment for root growth.

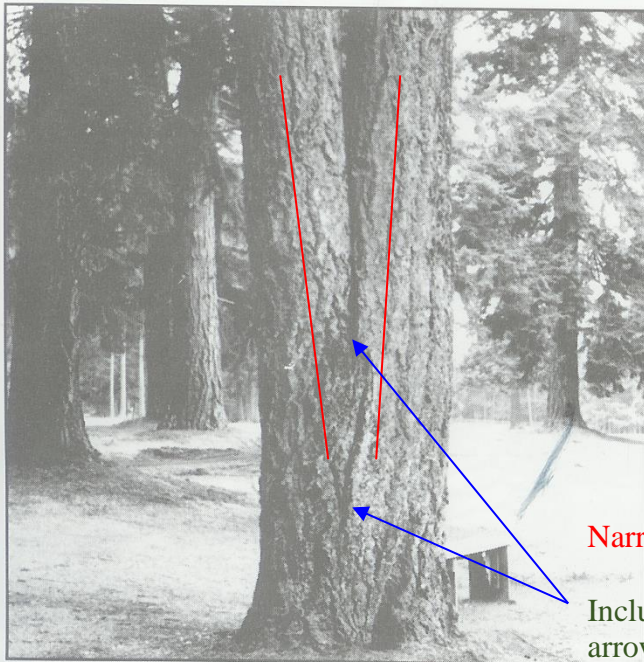
The tree in this picture has a co-dominant leader at about 3' and included bark up to 7 or 8'. Included bark occurs when two or more limbs have a narrow angle of attachment resulting in bark between the stems – instead of cell to cell structure. This is considered a critical defect in trees and is the cause of many failures.

Narrow Angle
Included Bark between the arrows
