**ARBORIST REPORT
AND
TREE PRESERVATION PLAN
5633 ARBORETUM DRIVE
LOS ALTOS, CALIFORNIA**

**SITE OBSERVATIONS:
MAY 21, 2018**

**Arborist Report
5633 Arboretum Drive
Los Altos, California**

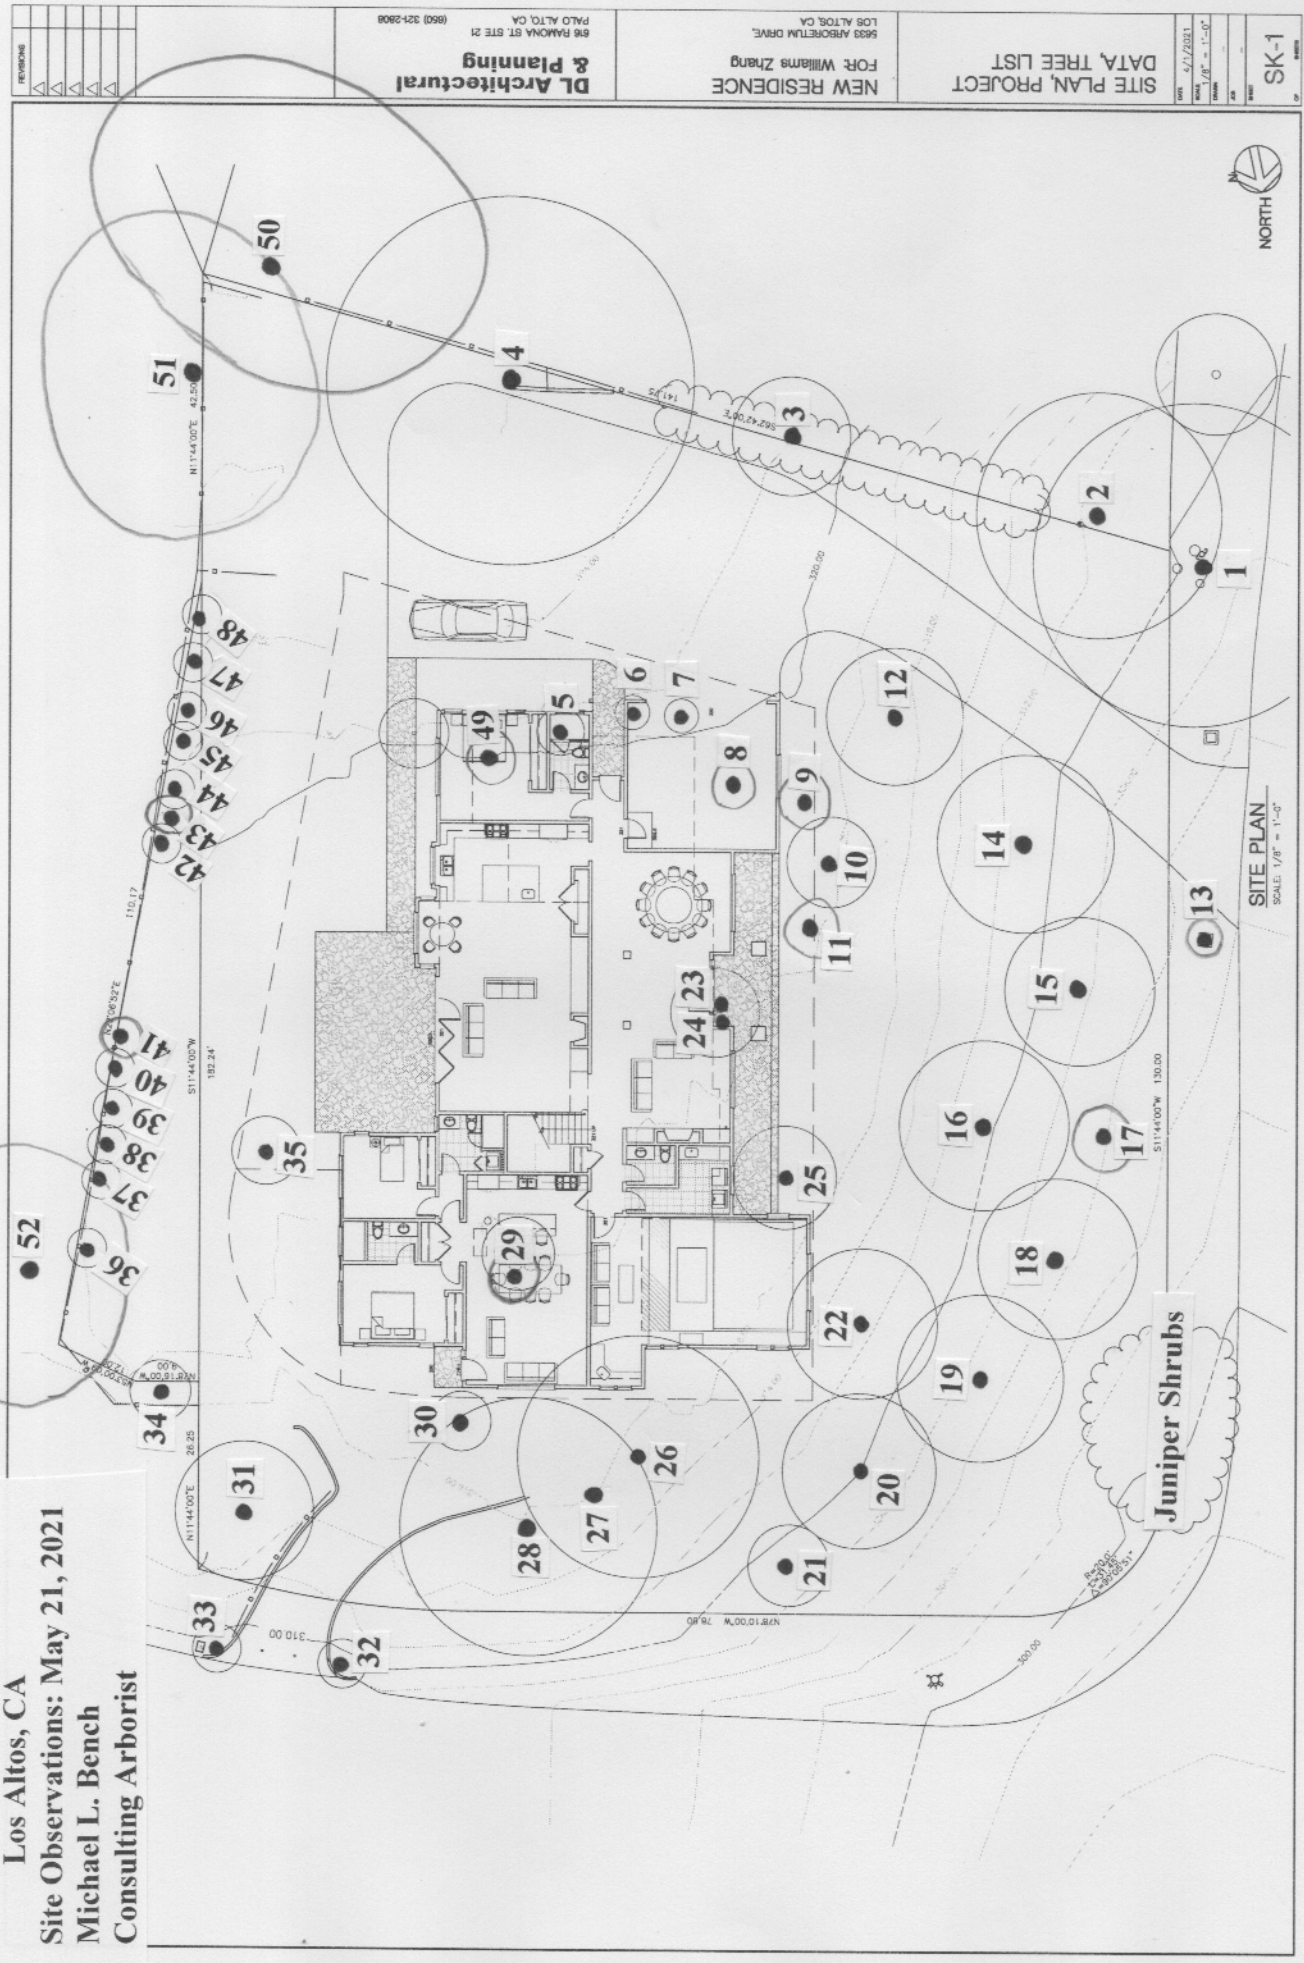
Tree Map
A Mark-Up of the Site Plan
Site: 5633 Arboretum Drive
Los Altos, CA
Site Observations: May 21, 2021
Michael L. Bench
Consulting Arborist

I have marked up the Site Plan to show the locations of the 52 trees. I call this mark-up the Tree Map, which is included in the attachments.
