Arborist Report

240 Alta Vista Ave
Los Altos, CA 94022

Inspection Date: March 24, 2021
Revision Date: April 21, 2022

Prepared by: Chris Stewart
Project Arborist: Michael Young
contractors license # 755989
certified arborist WC ISA #623

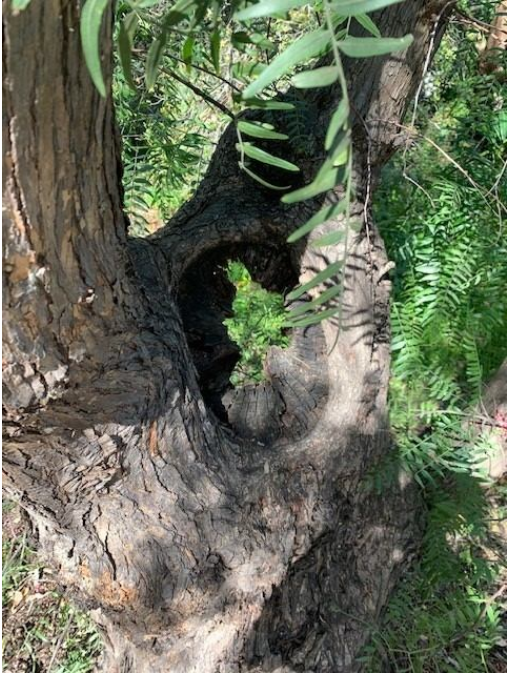
Tree #106 is a Pepper (*Schinus mole*), Recommend removal, hole in trunk, codominant leaders, thin canopy

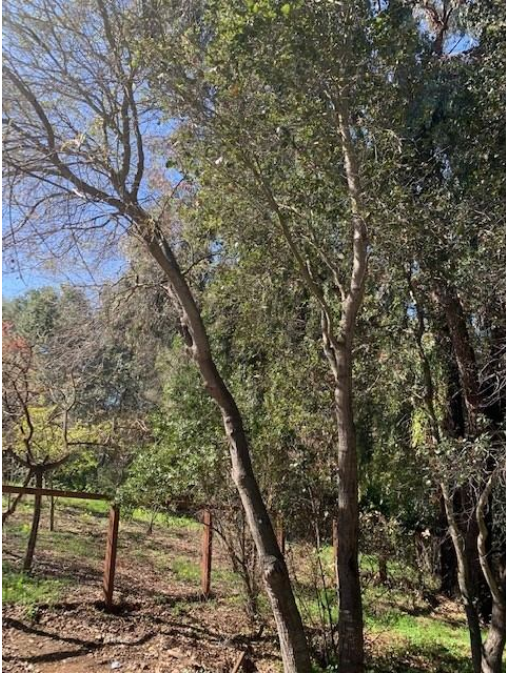
Tree #119 is a Coast live oak (*Quercus agrifolia*), Recommend removal, codominant leaders at base, thin canopy

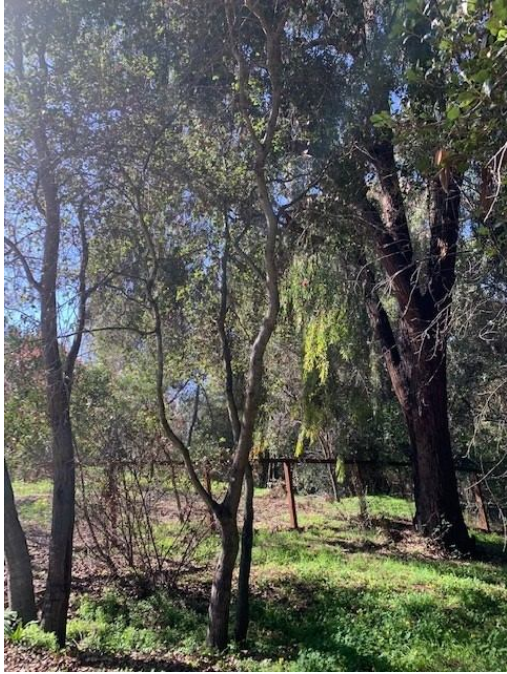
Tree #120 is a Coast live oak (*Quercus agrifolia*), Recommend removal, codominant leaders at base, thin canopy

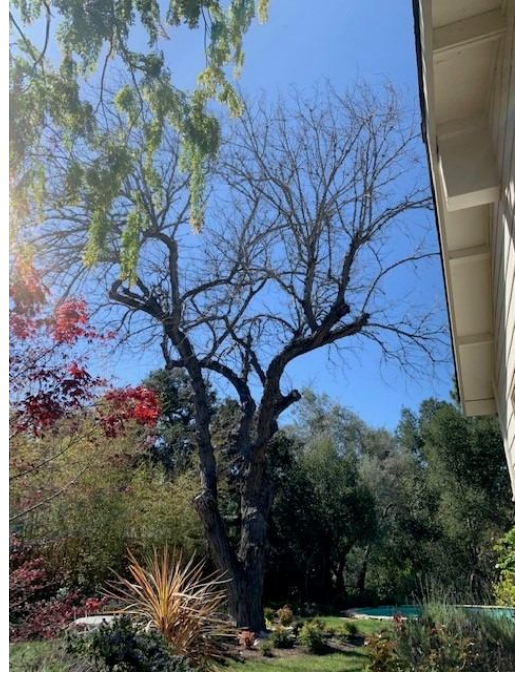
Tree #136 is a Siberian elm (*Ulmus pulmila*), Recommend removal, codominant leaders at 5.5' that are prone to failure, declining health, hazard

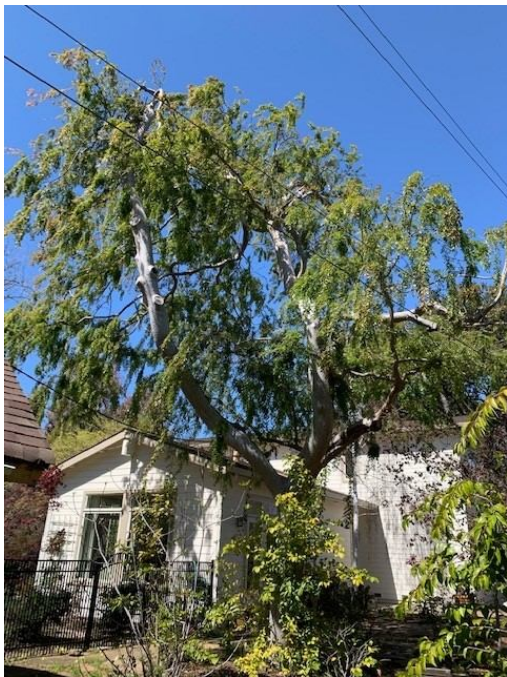
Tree #138 is a Chinese elm (*Ulmus parvifolia*), Recommend removal, codominant leaders at 6' that are prone to failure, declining health, hazard

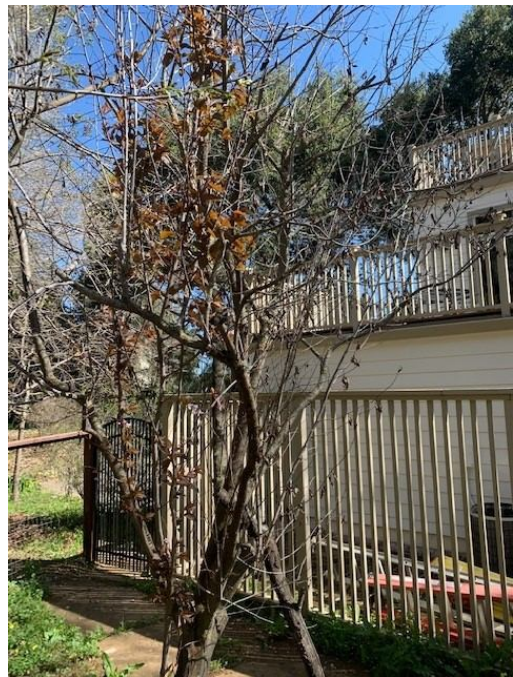
Tree #125 is a Plum (*Prunus domestica*), recommend removal, tree is dead
