Kielty Arborist Services LLC

March 25th, 2022

Site: 265 Mt. Hamilton Avenue

As requested on Thursday, March 10th, 2022, Kielty Arborist Services LLC visited the above site for the purpose of providing a Tree Inventory Report/Tree Protection Plan for the proposed construction. A home addition and remodel is proposed for this site, and as needed an Arborist Report is required when submitting plans to the city of Los Altos. Site plan A-1 dated 12/21/21 was reviewed for writing this report. This Tree Inventory Report is not a Tree Risk Assessment. As such, no trees were assessed for risk in accordance with industry standards, nor are there any tree risk ratings or risk mitigation recommendations provided within this preservation plan.

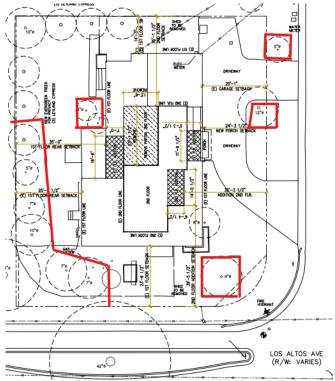
Showing the recommended tree protection fencing

Tree protection zones should be installed and maintained throughout the entire length of the project. Prior to the commencement of any Development Project, a chain link fence shall be installed at the drip line (canopy spread) of any protected tree which will or will not be affected by the construction. Non-protected trees to be retained shall also be protected by fencing material. Non-protected trees can be protected by orange plastic snow fencing. Due to the location of the Valley Oak tree #5, no tree protection fencing is recommended. Therefore, the only protected tree that will require metal chain link fencing is Redwood tree #12. The drip line shall not be altered in any way so as to increase the encroachment of the construction. When work is to take place underneath a trees dripline, fencing must be placed as close as possible to the tree proposed work. If an area of access is needed underneath a trees canopy, the area shall be protected by a landscape barrier. Fencing for the protected trees shall consist of 6-foot-tall metal chain link type supported my 2 inch metal poles pounded into the ground by no less than 2 feet. The support poles should be spaced no more than 10 feet apart on center. Signs should be placed on fencing signifying "Tree Protection Zone - Keep Out". No materials or equipment should be stored or cleaned inside the tree protection zones. Excavation, grading, soil deposits, drainage and leveling is prohibited within the tree protection zones without the project arborist consent. No wires, signs or ropes shall be attached to the protected trees on site. Utility services and irrigation lines shall all be place outside of the tree protection zones when possible. When access is needed and tree protection fencing restricts access a landscape barrier shall be installed to protect the non-protected root zone.
