FINE ART CONSERVATION

CONDITION REPORT, TREATMENT PROPOSALS AND ESTIMATES

DATE: June 15, 2022
CLIENT: City of Los Altos Hills
PROJECT #: 2022/216
OBJECT: Outdoor Sculpture Collection-5 Sculptures
LOCATION: Los Altos Hills

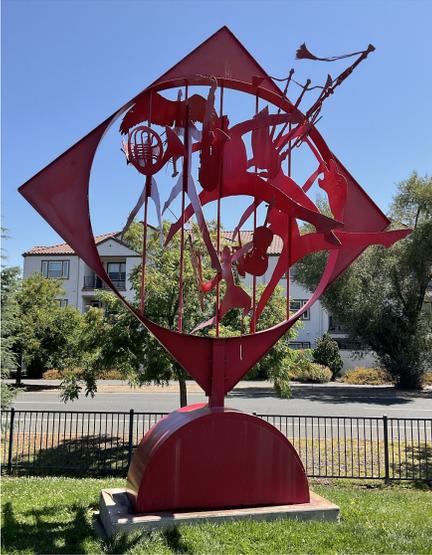
TITLE: Musical Gambon

- The sculpture is structurally stable.
- There is possible corrosion under the paint, supported by the presence of blistering paint and some visible corrosion along bottom edge and along undersides of horizontal elements.
- There are several bent and misaligned elements: both legs are bent on the bottom figure; the proper left figure has a warped front leg; there is slight warping in the legs of the bagpipe and trumpet figures; the bagpipes are bent, the trumpet and bagpipes are intertwined.
- The paint is chalked and blanched.
- There is paint loss on vertical bars exposing a tan primer and a possible intermediate maroon colored primer.
- There are bird droppings, biogrowth, organic debris across the surface.
- There are mineral deposits across the front of the base.

- The deteriorated red paint will be sanded back to provide a key for repainting, both by hand and with palm sanders.
- Corrosion will be converted and reduced.
- The bent and misaligned elements will be realigned as far as possible.
- A painting tent will be installed to cover the artwork during the painting process.
- The chosen industrial paint system will be spray applied including primer, two coats of paint, and a clear top coat.

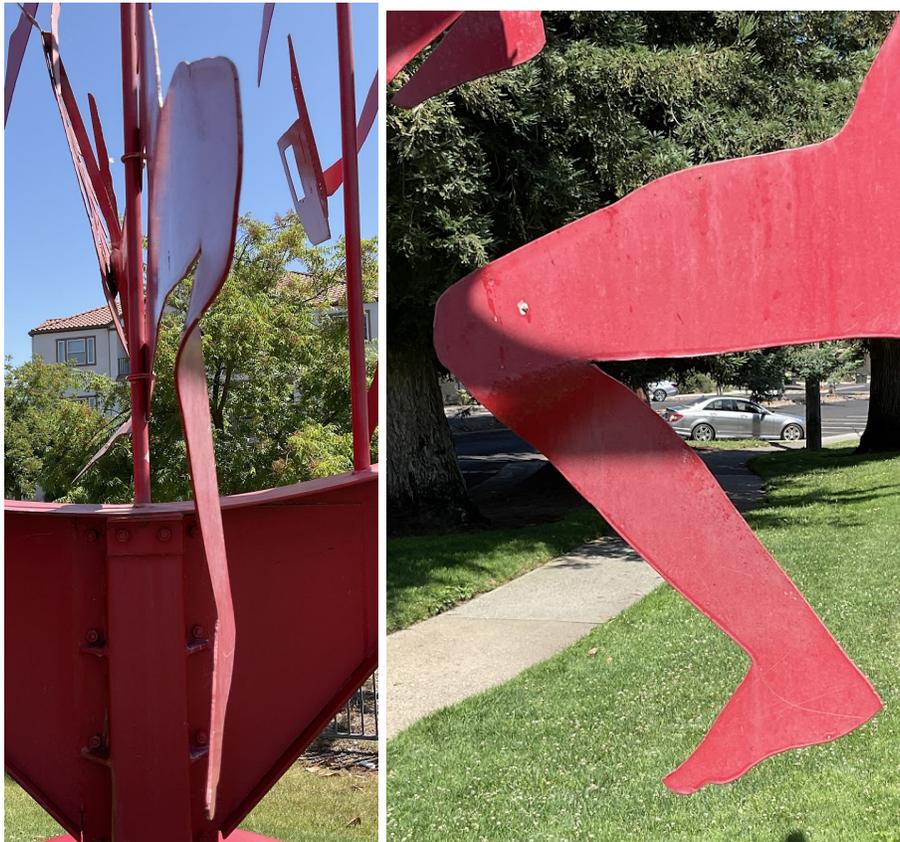
Details Showing Two Views of the Bend in Lower Figure's Leg

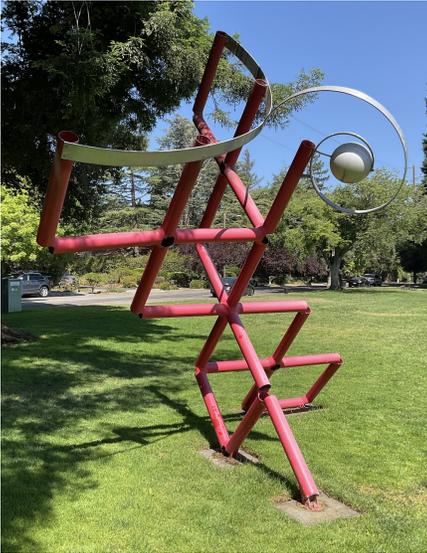
TITLE: Imagine That

- The sculpture is structurally stable.
- There are gouges, dents and abrasions in lower pipes and attachment points to the concrete pads
- There is a crack in the weld on the unpainted aluminum loop.
- There is a slight downward bend in the longest red painted horizontal element at the top of the sculpture
- Two layers of red paint are visible. The top layer is chalking and blanching with losses exposing a lower paint layer. The lower layer is more saturated in color but cracked in all exposed areas;
- There are chips, nicks and losses in both layers of red paint
- The clear coat on the unpainted aluminum elements is failing with aluminum oxide forming in areas of coating loss.
- There are tags on the painted surface.
- There is trash and debris within the tubes.
- There is overall surface dirt and grime, organic debris, and biogrowth,

- The unpainted aluminum elements will be polished by hand and with orbital buffers.
- The crack in the loop will be filled and reinforced.
- An attempt will be made to rebend the dented elements to align them.
- The chosen paint system will be applied to the painted area including primer, and two coats of paint.

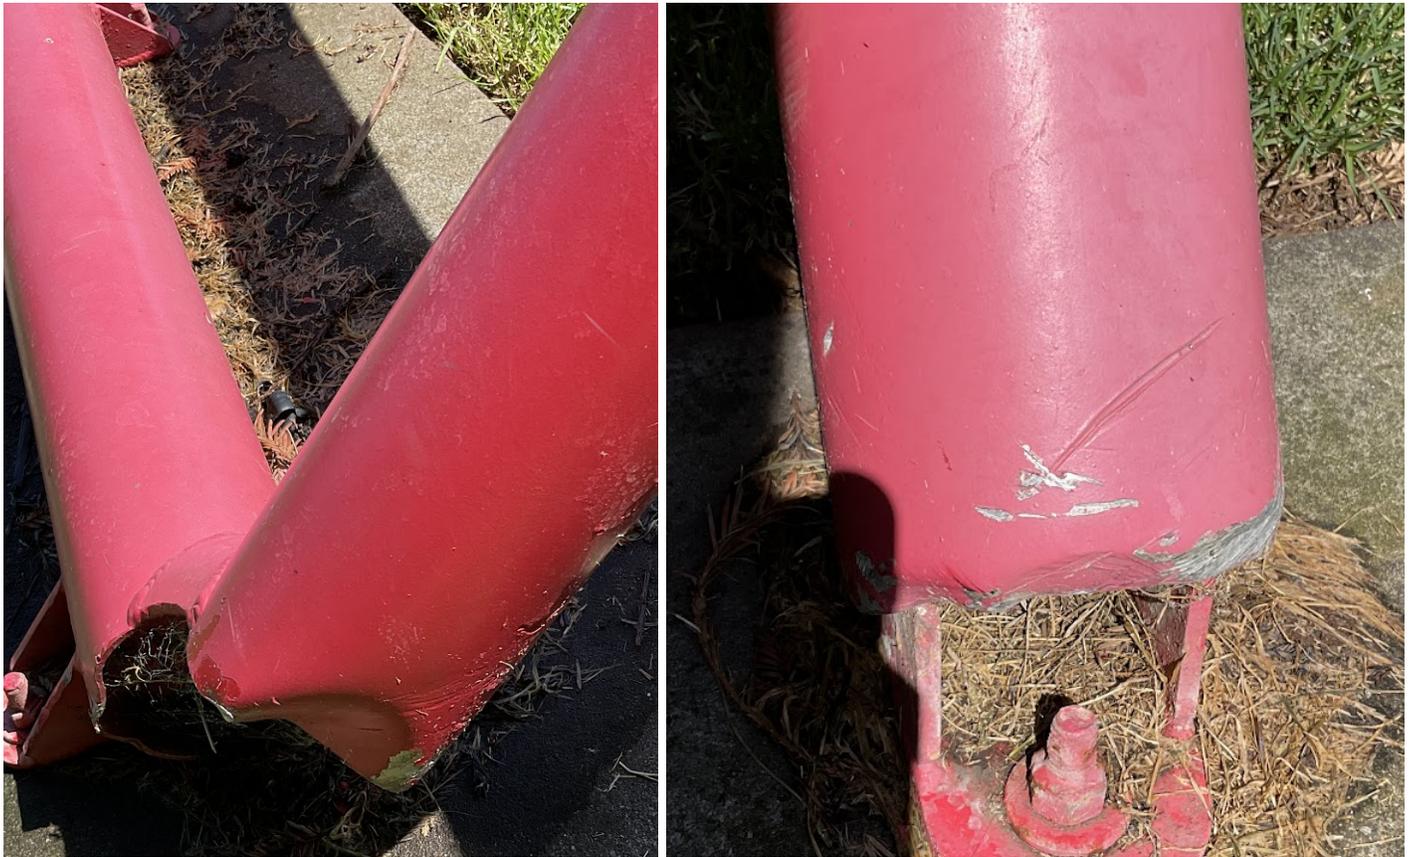
Details Showing Dents and Abrasions on the Bottom of the Lower Tubes

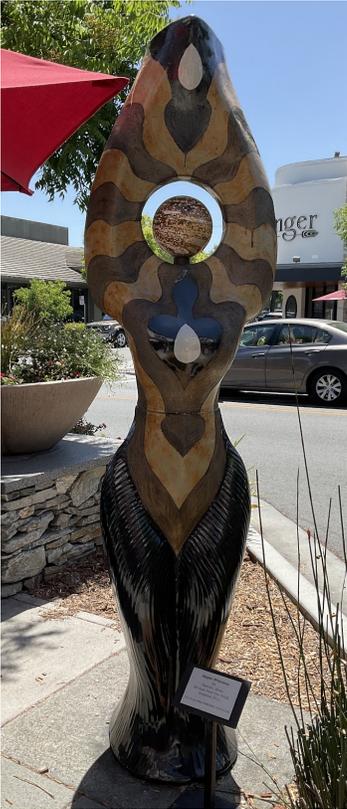
TITLE: Jasper Priestess

- The sculpture is structurally stable.
- There are several losses along the central join.
- There are two vertical firing cracks at bottom, one is about a foot long and the other is about an inch in length.
- There is flaking glaze between the legs accompanied by minor losses.
- There are minor abrasions in the glaze
- There is soiling, bird droppings and organic debris across the surface.

- The flaking glaze will be consolidated and losses will be toned to visually integrate them with the surrounding surface. Minor abrasions will be toned in the same way.
- Losses will be filled and toned with an appropriate inpainting material.

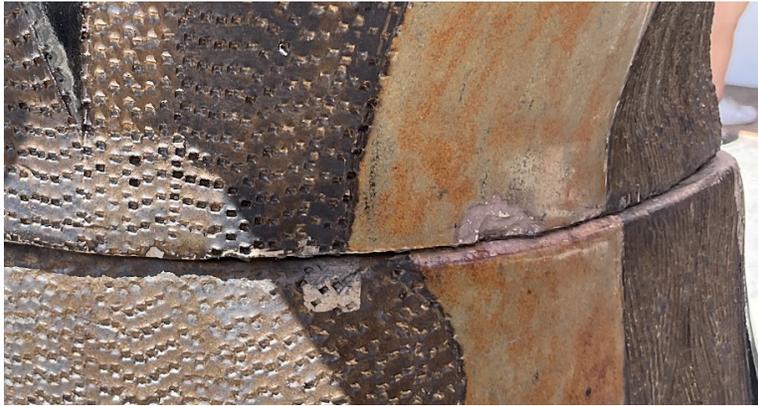
Detail Showing Losses Along Join

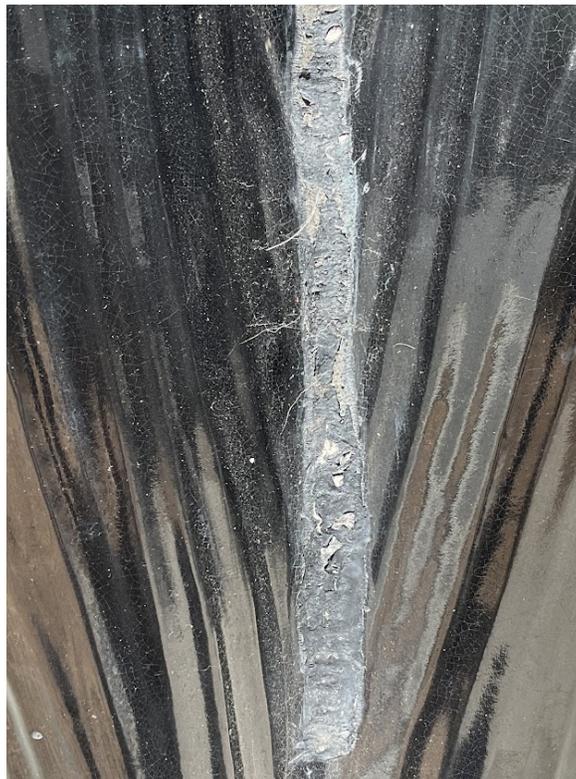
Detail Showing Flaking and Loss in Glaze

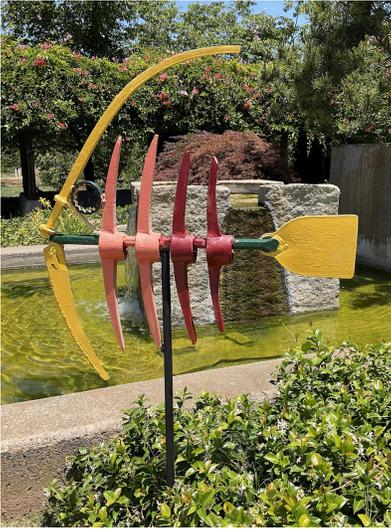
TITLE: Magic Fish

- The sculpture is structurally stable.
- There is some corrosion under the paint.
- The paint is thickly applied with drips and bubbles.
- There are visible paint losses that have been painted over creating recessed areas in the paint.
- There are broken blisters in the paint.

- Photographic and written documentation will be completed before, during and after treatment.
- Paint samples will be taken and color matched to identify an appropriate paint system for repainting.
- The deteriorated paint will be reduced by sanding, both by hand and with palm sanders.
- Corrosion will be reduced, and converted.
- Areas of corrosion will be spot primed with the primer from the chosen paint system.
- The chosen paint system will be applied including two coats of top paint.

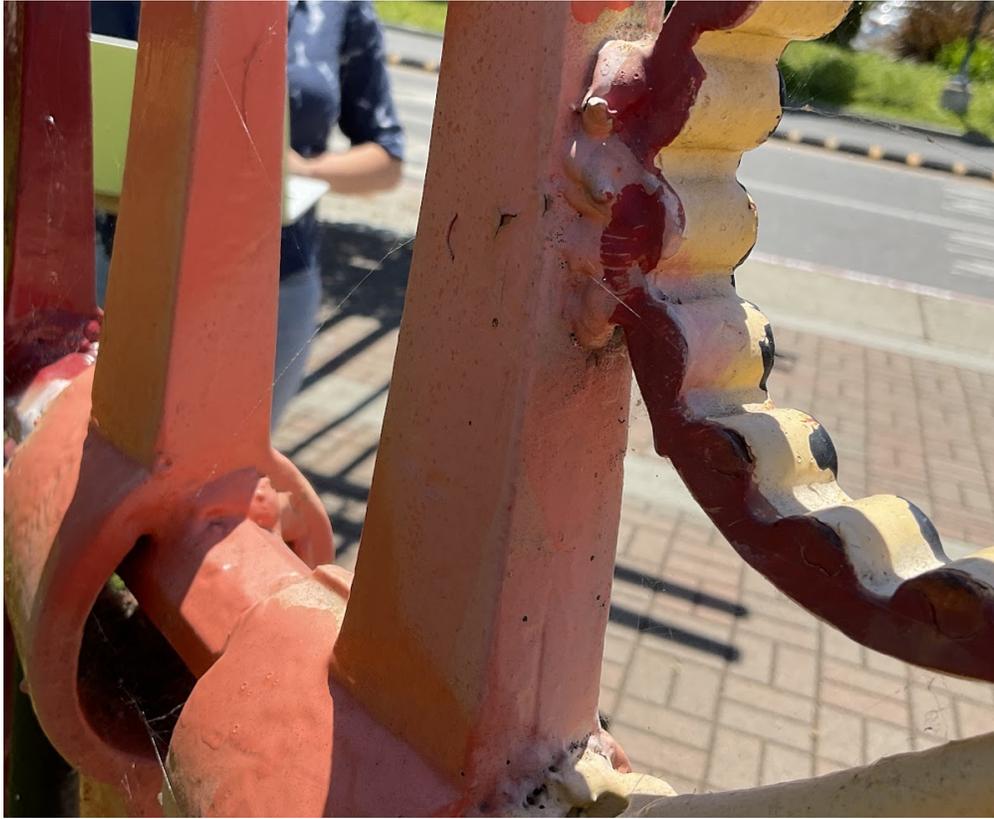
Detail Showing Blisters in Paint and Possible Corrosion

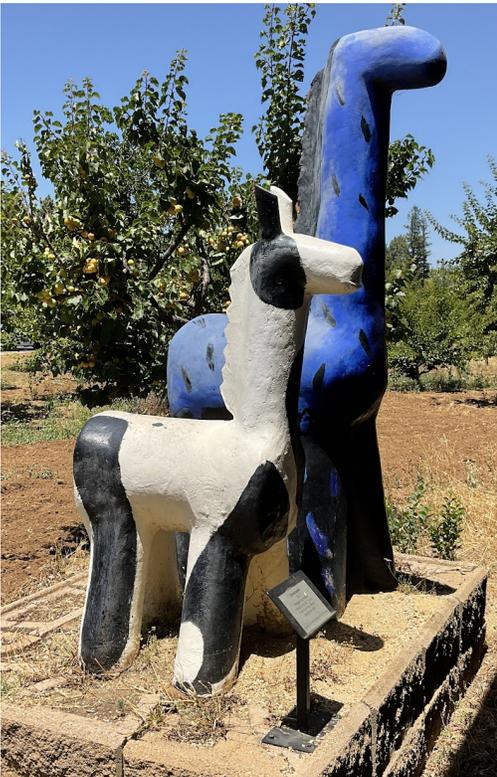
TITLE: Zooscapes

- The sculpture is structurally stable.
- Both sculptures are detached from their base and are at risk of loss.. When lifted there is a plastic footprint visible beneath each foot with several rusted screws pointing up from below. It appears that the bottom of each foot has become detached.
- There is cracking in the fiberglass and paint layers.
- There are cracks and losses to the fiberglass and paint, revealing the underlying wood especially on the necks. .
- A significant portion of the sculptures has been overpainted. The overpaint is blanching and delaminating from the underlying original paint.
- There is blanching, flaking and paint losses in both the original and secondary paint layers.

- Photographic and written documentation will be completed before, during and after treatment.
- Recommend that since the sculpture can be deinstalled, transfer them to PA studio.
- The areas of flaking paint will be gently sanded by hand to remove the loose and deteriorated paint.
- Areas of fiberglass loss and cracking will be filled and toned to match the surrounding surface.
- The sculptures will be repainted with matching colors.
- The sculptures will be reattached to the original feet bottoms using appropriate adhesive and hardware.

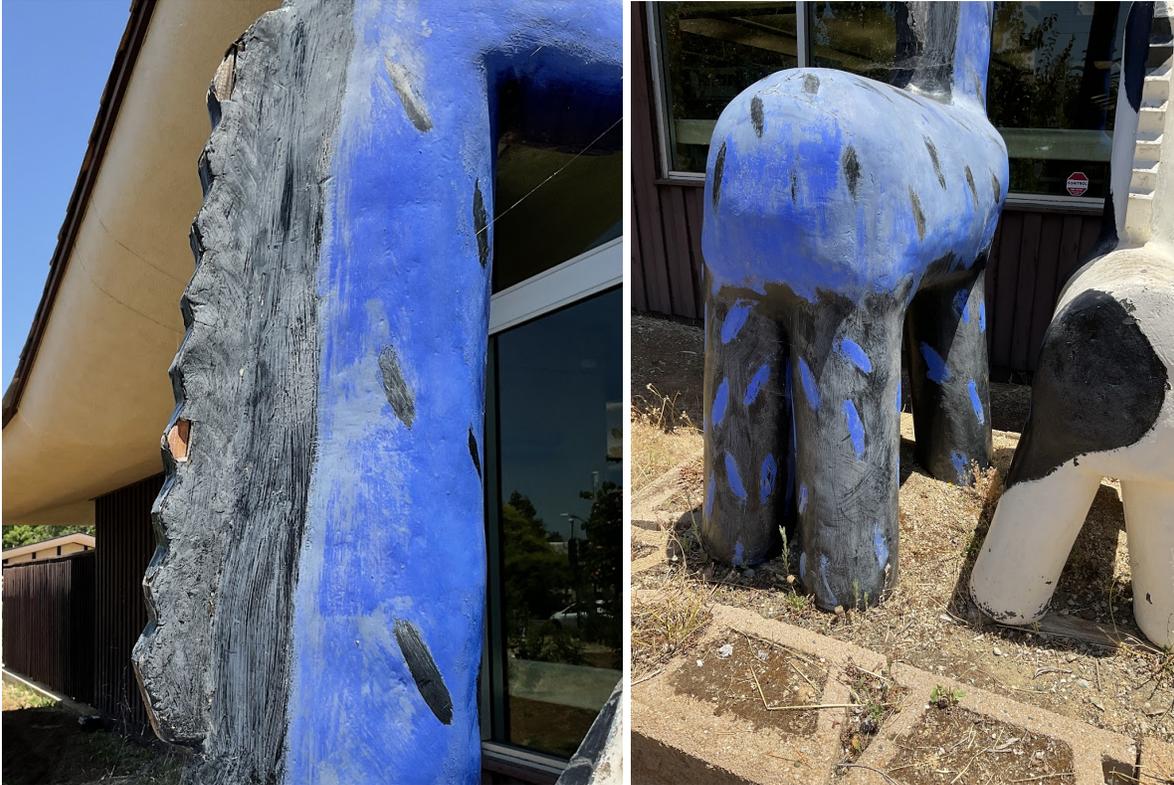
Detail of Losses Exposing Underlying Wood
