## California Tree and Landscape Consulting, Inc.

### REVISED FINAL ARBORIST REPORT, TREE INVENTORY, CONSTRUCTION IMPACT ASSESSMENT AND TREE PROTECTION PLAN

RE: 311 Hawthorne Lane, City of Los Altos, California [APN 170-25-045]

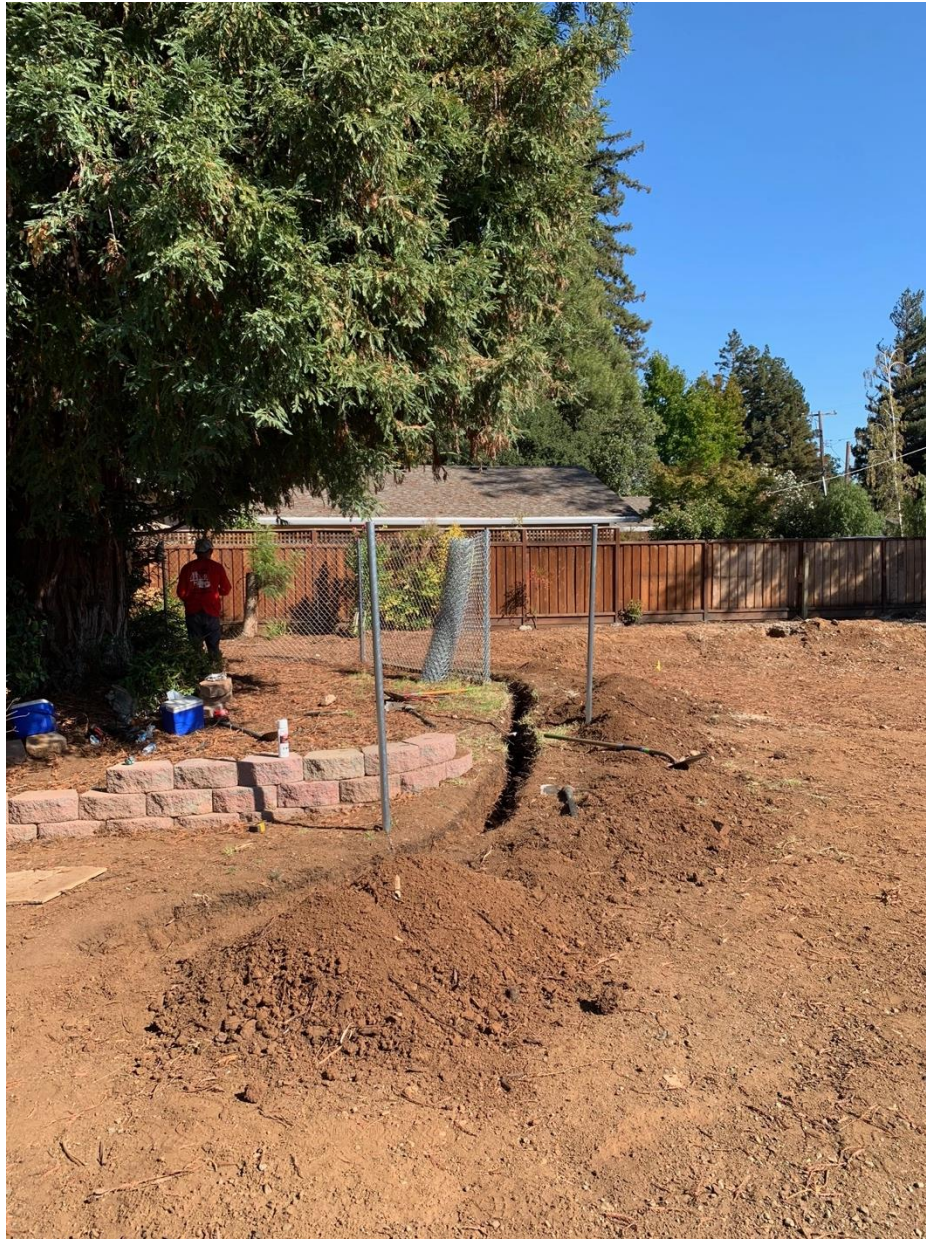
In addition to collecting data on the trees on this site, a trench was hand dug at the dripline of Tree #1. The purpose of the trench was to identify any structural roots growing toward the likely building envelope. The trench was approximately 35' in length, 12" in width and 18" in depth. One 3" diameter root was revealed. There was one 1-1/2" diameter root and two 1" roots. The remaining roots were 1/4" in diameter and less. Refer to the photograph below.
