Preliminary Arborist Report

**330 Distel Circle
Los Altos, CA**

September 2021
Revised February 3, 2022

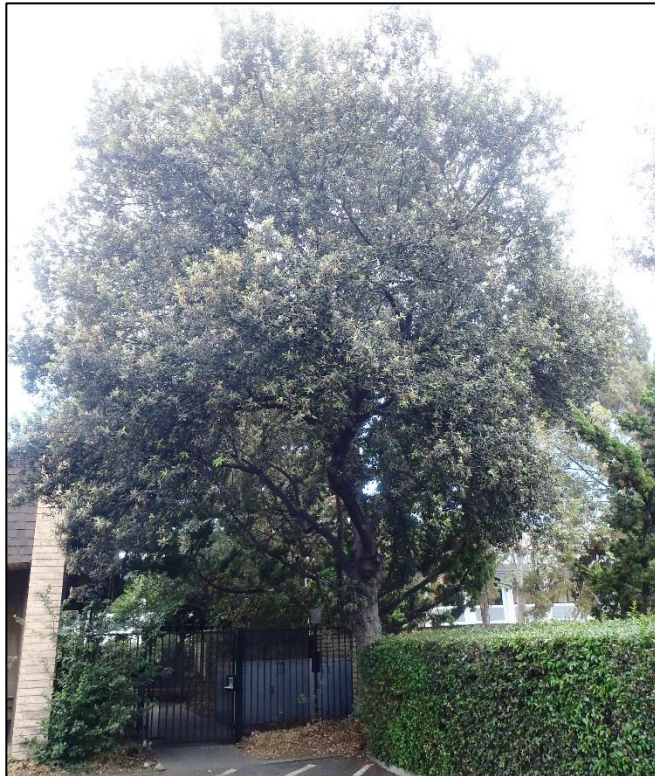
Photo 1: Looking north at holly oak #433. This was the only holly oak on the site that was mature (20" in diameter) and in good condition.

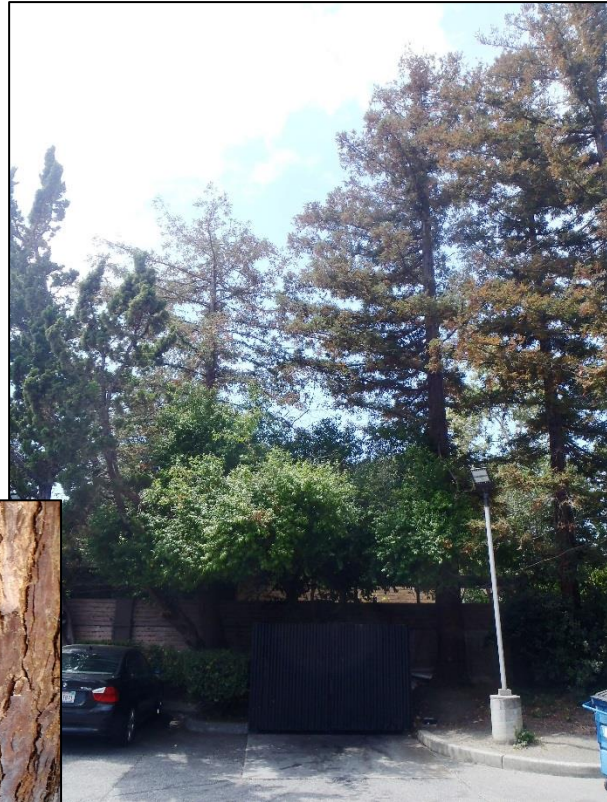
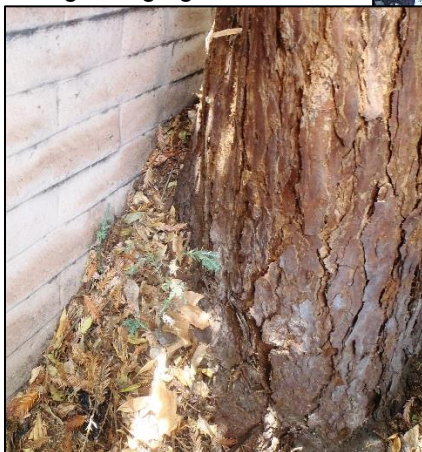
A row of off-site tree were assessed along the northern fence line and included the following. All of the trees had been planted too close to the wall, with the bases of trees #452 and 454 growing against the wall (**Photo 2**).

Photo 2: Looking southwest at trees #452-456 (L to R). The row of off-site trees were in fair condition but had been planted close to the wall separating the two properties. Inset below shows the base of coast redwood #454, which was growing against the wall.
