Kielty Arborist Services LLC

Revised March 6th, 2023

Site: 1219 Portland Avenue, Los Altos CA

As requested on Wednesday, September 29th, 2021, Kielty Arborist Services LLC visited the above site for the purpose of providing a Tree Inventory Report/Tree Protection Plan for the proposed construction. A new two-story home is proposed for this site, and as needed an Arborist Report is required when submitting plans to the city of Los Altos. Site plan A1.1 dated 3/6/23 was reviewed for writing this report. This Tree Inventory Report is not a Tree Risk Assessment. As such, no trees were assessed for risk in accordance with industry standards, nor are there any tree risk ratings or risk mitigation recommendations provided within this report unless stated otherwise. The owner/applicant, GC, and other contractors are all responsible for knowing and following the guidelines for the preservation of trees found in this report.

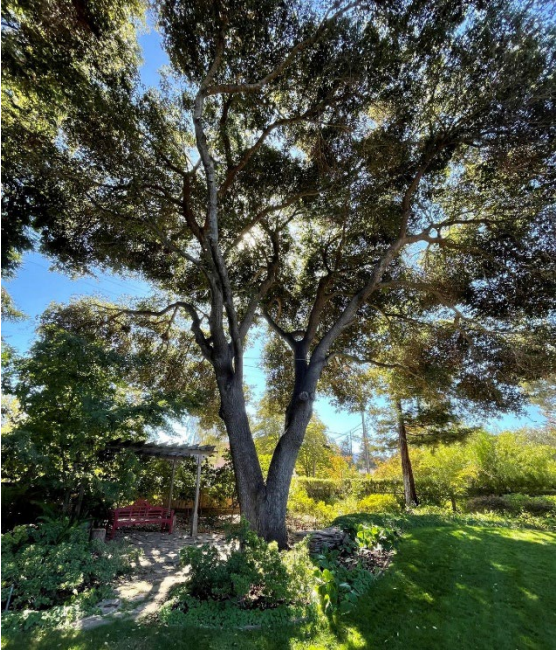
Showing Oak tree #1

Summary of protected trees to be retained:
 Coast Live Oak tree #1 is in good condition. The tree is well palced on the lot far from the building setback. The tree has poor form consisting of codominant leader at 5 feet with included bark. In the past the tree’s poor form has been mitigated through pruning and cabling of the codomiannt leaders. A new cable set at two thirds the tree’s height is recommended as well as minor crown reduction pruning. Due to the included bark, this tree is recommended to be inspected every 3 years by a Certified Arborist for any needed work to mitigate the tree’s form. Irrigation near this tree is recommended to be reduced as much as possible when within the tree’s dripline as dry season irrigaiton for native oak trees can raise risk of oak root fungus disease. A minimum no irrigation zone of 12 feet from the tree is recommended.

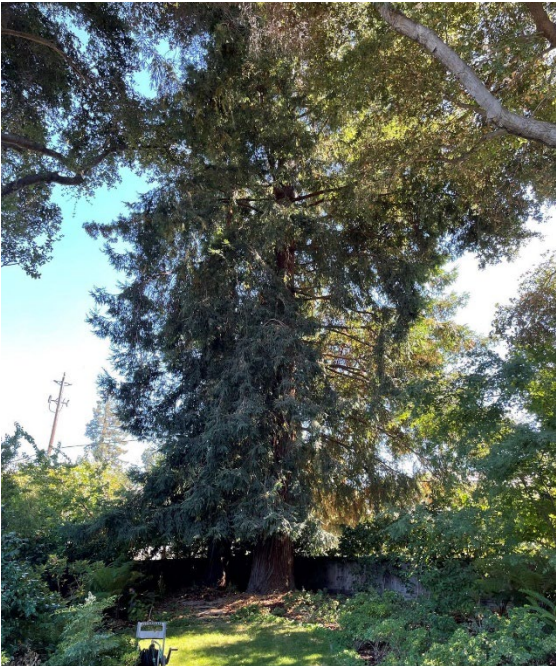
Redwood trees #2 and #3 are in excellent condition. Vigor is good and no tree structure flaws were observed. The trees are well placed on the lot far from the buildable space. Redwood trees need supplemental irrigation during the dry season to maintain a healthy canopy. It is recommended to irrigate the retained redwood trees every other week during the dry season until the top foot of soil within 20 feet from the trees is saturated.

Showing Redwood trees #2 and #3 in front corner of property

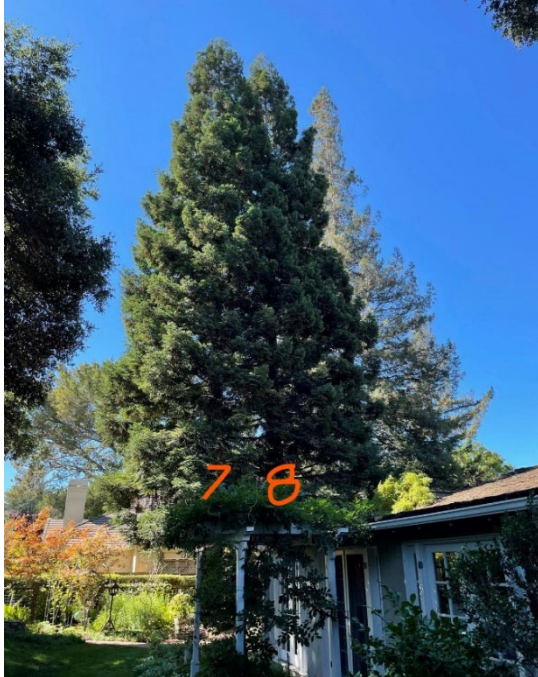
Redwood trees #7 and #8 are in excellent condition. Both trees have good vigor, and good structure.

Showing redwood trees #7 and #8

Redwood trees #7 maintains a 10'-8" clearance between the tree and the proposed foundation while redwood tree #8 maintains a 13'-9" clearance. Redwood trees have a good tolerance to construction impacts as seen in the Matheny & Clark tree tolerance chart. The foundation at within 25 feet from the Redwood trees is recommended to be excavated by hand under the Project Arborist supervision. The foundation of the home is recommended to be a pier and grade beam type of foundation to give the opportunity to bridge over tree roots were needed. All encountered roots measuring 1.5" in diameter or larger are recommended to be exposed and remain as damage free as possible for the Project Arborist to view and document. Where needed roots should be cleanly cut using a hand saw or loppers while under the Project Arborist supervision. Impacts are expected to be minor. The Redwood trees are recommended to be irrigated weekly using 50 gallons of water during the dry season. The Redwood trees are also recommended to be deep water fertilized before the start of construction. The irrigation and fertilizing will act as mitigation for the minor impacts. The proposed pathway near the trees is recommended to be built by hand on top of grade. No roots for any reason shall be cut for the pathway construction. During the pathway construction, the tree protection fencing will need to be reduced.

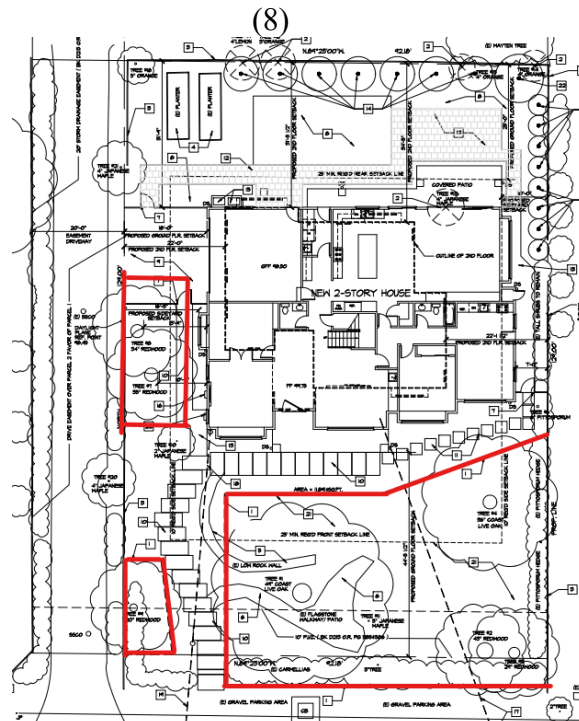
Showing the recommended tree protection fencing. During the construction of the pathway work near retained redwood trees #7 and #8, fencing will need to be reduced to the driveway edge
