Tree Inventory, Assessment, and Protection Report

14 Fourth Street
Los Altos, CA 94022

May 19, 2022
Revised August 4, 2022

Monarch Consulting Arborists

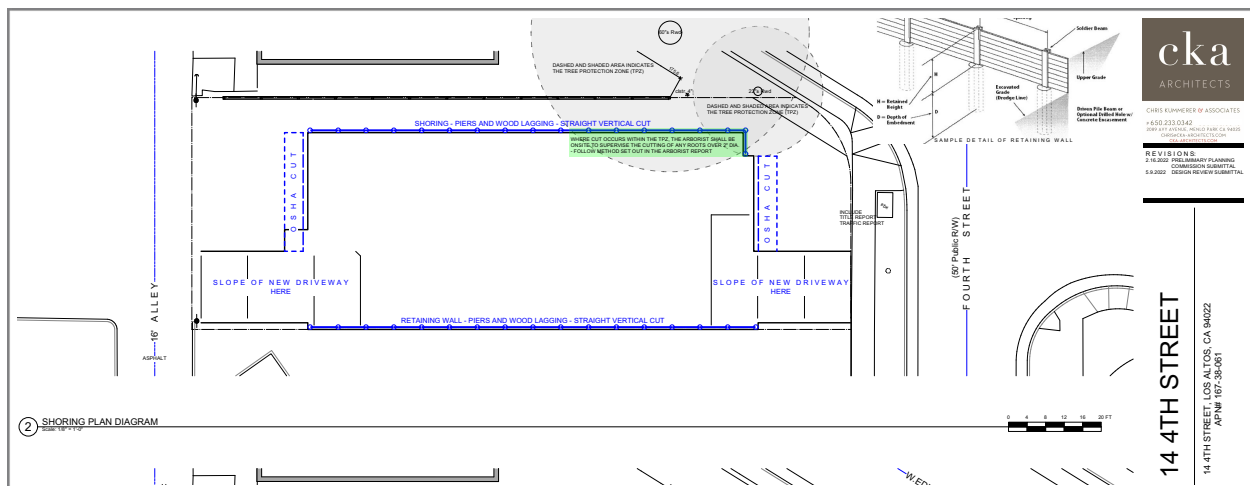
MCA: The applicant provided the A1.5 sheet and the shoring plan as provided below:

I have reviewed the plans regarding the proximity of the trenching and shoring adjacent to the trees.

It is the responsibility of the owners or contractors to schedule meetings and monitoring and to adhere to the recommendations. The proposed shoring encroaches six and ten percent into the suggested TPZ and is not expected to compromise the health or integrity of the trees.

I have suggested within the report in the “Expected Impacts”, “Tree Protection” and “Recommendations” sections to pre-trench and selectively remove roots as necessary. TO reiterate Recommendation #4 states the following:

4. Pre-trench along the proposed soil cut adjacent to the trees (#4 and #5). Have an ISA Certified Arborist® observe the trenching and provide guidance to selectively remove any significant roots (roots greater than one inch in diameter (1”) if encountered. Selective root removal requires pre-excavation, typically by hand or with a pneumatic excavating equipment such as an Air Spade®, Air Knife®, or similar tools. Selective removal allows for the roots to be exposed prior to cutting at the appropriate locations. This is the type of root removal that will need to occur at the building foundation. Roots greater than one inch in diameter should be pruned rather than left torn or crushed so as to leave “a clean flat surface with intact surrounding bark” (Costello, L., Watson, G., Smiley, E. T.. 2017).

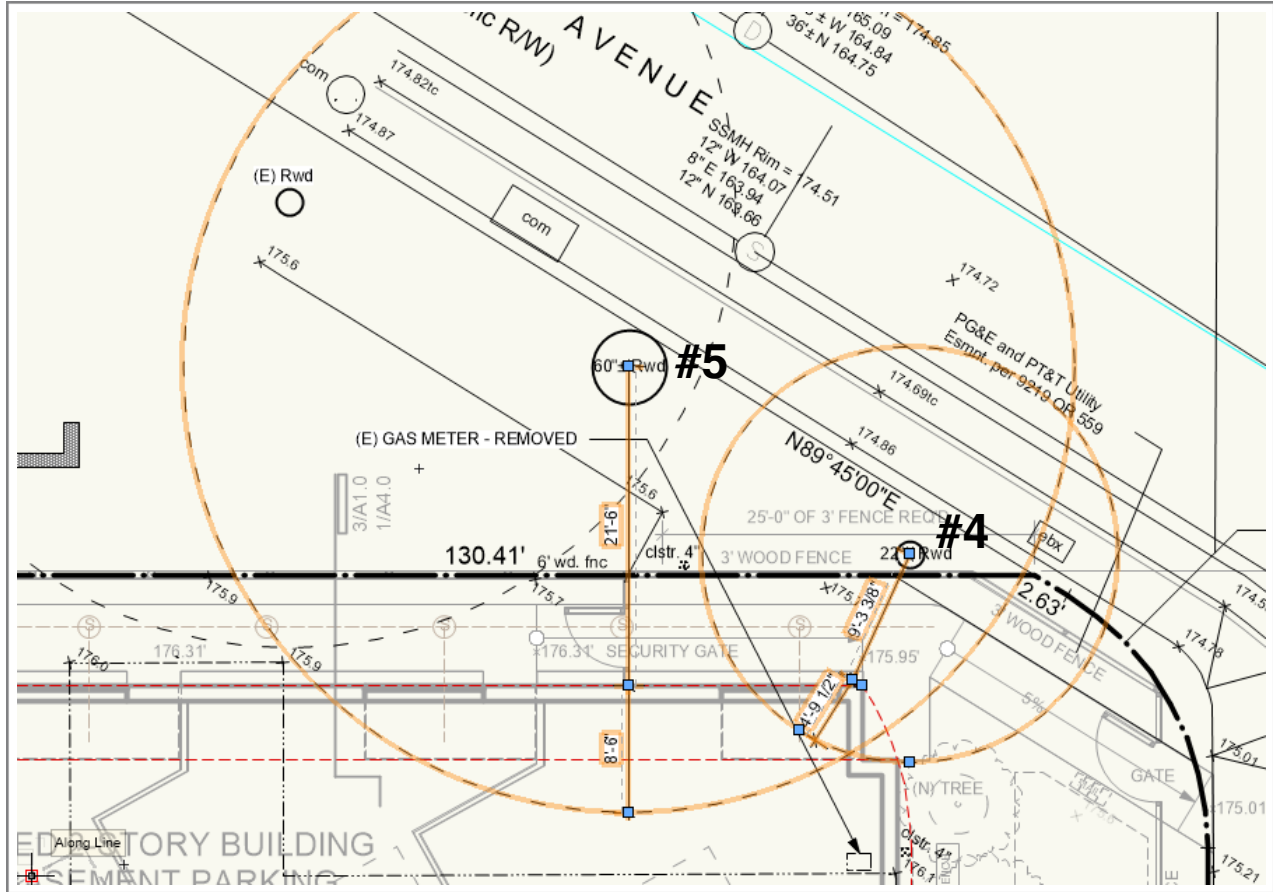
IMAGE 1: TREES #4 AND #5 IN RELATION TO THE PROPOSED CONSTRUCTION.

One "Street Tree" is expected to be removed (#2). One pittosporum shrub (#3) in front of the building and the two water gum (#7 and #8) in back with trunk diameters less than four inches in diameter are to be removed. The two coast redwoods #4 and #5 along the north side of the property could be moderately to highly impacted and tree protection, pre trenching, shoring and selective root removal will be required (Chart 3).

The snapshot below indicates the proximity of trees #4 and #5 to the proposed building and soil cut (Image 1).

4. Pre-trench along the proposed soil cut adjacent to the trees (#4 and #5). Have an ISA Certified Arborist® observe the trenching and provide guidance to selectively remove any significant roots (roots greater than one inch in diameter (1") if encountered. Selective root removal requires pre-excavation, typically by hand or with a pneumatic excavating equipment such as an Air Spade®, Air Knife®, or similar tools. Selective removal allows for the roots to be exposed prior to cutting at the appropriate locations. This is the type of root removal that will need to occur at the building foundation. Roots greater than one inch in diameter should be pruned rather than left torn or crushed so as to leave "a clean flat surface with intact surrounding bark" (Costello, L., Watson, G., Smiley, E. T.. 2017).

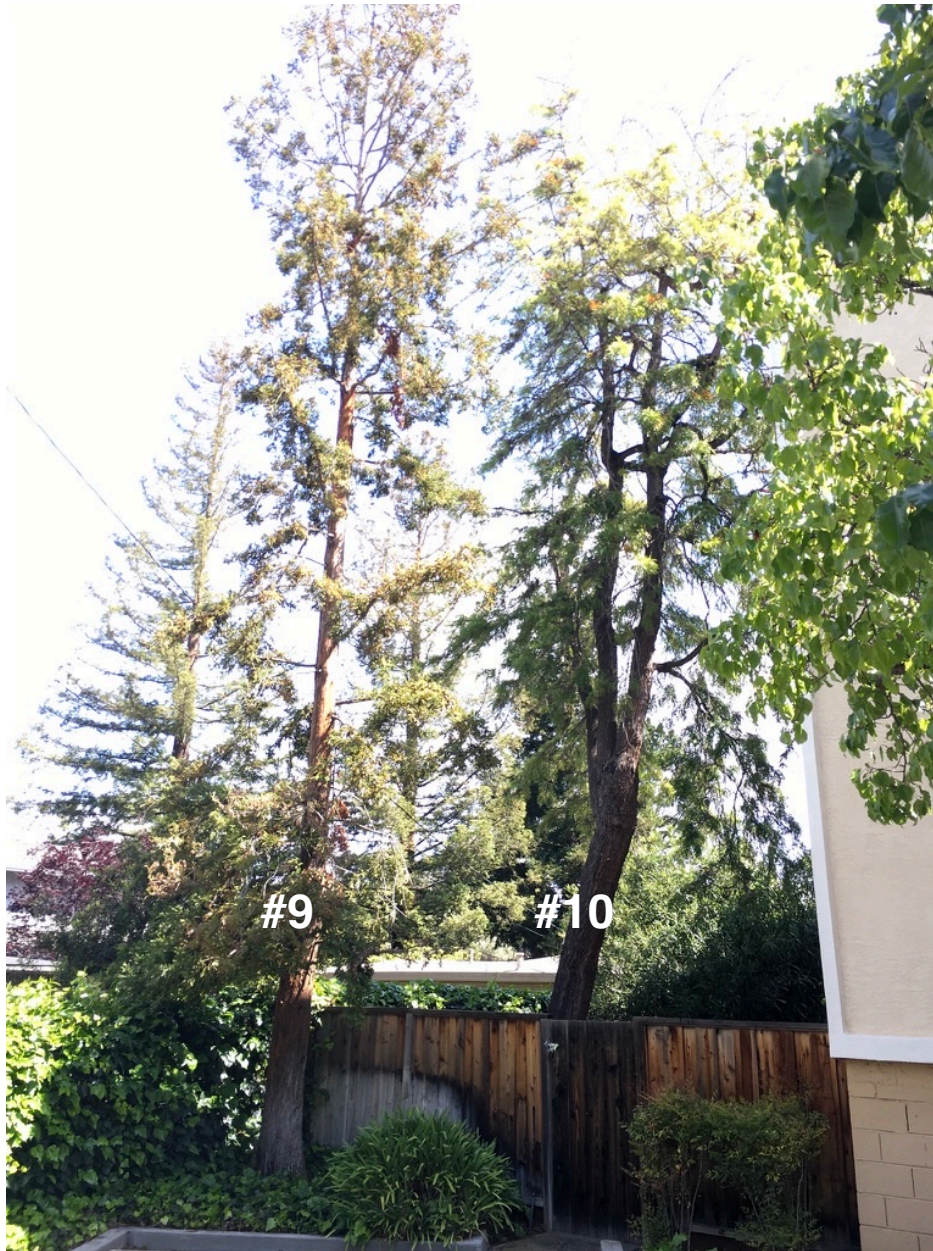
C2: Coast Redwood #9 and #10

Six trees are in good condition, three fair, and three are in poor shape including coast redwood #9, silk oak #10, and purple plum #12 all originating on adjacent properties (Chart 2).
