ATTACHMENT B

Kiely Arborist Services LLC
Certified Arborist WE#0476A TRAQ Qualified
P.O. Box 6187
San Mateo, CA 94403
650- 532-4418

August 17th, 2021, Revised May 9th, 2022

Site: 540 Patrick Way, Los Altos CA

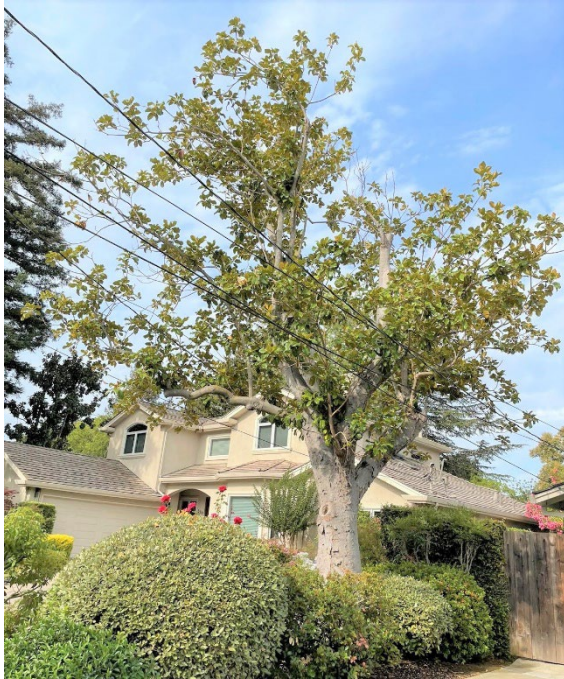
Showing Crape Myrtle tree #1

Crape myrtle tree #1 is in good condition and is not of a protected size in the city of Los Altos. The tree is located close to the existing home on site. This tree is proposed for removal as the new home is within the tree’s footprint.
