15650 Los Gatos Boulevard Development

Los Gatos, California

Prepared by: Neil Woolner ISA Certified Arborist WE-2329A ArborMD Tree Care, Inc.

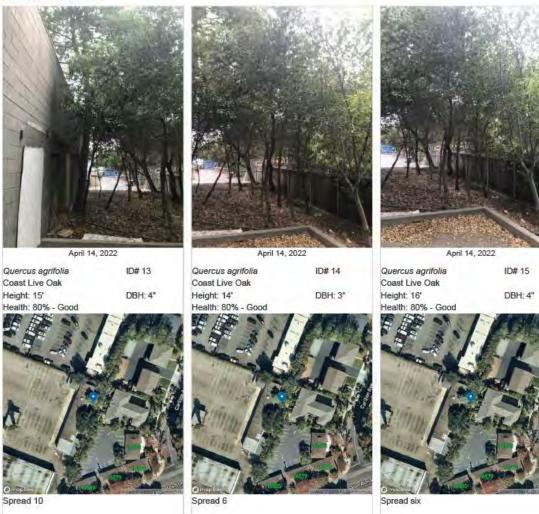
Against Building Removal Within parking lot Spread 25ft

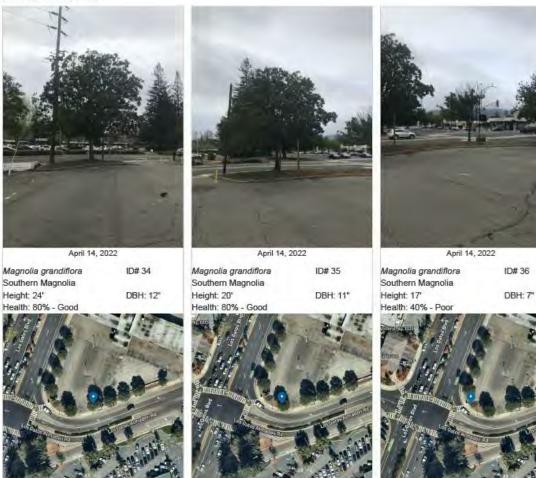
Near Power Lines Removal
