15650 Los Gatos Boulevard Development

Los Gatos, California

Prepared by:
Neil Woolner
ISA Certified Arborist WE-2329A
ArborMD Tree Care, Inc.

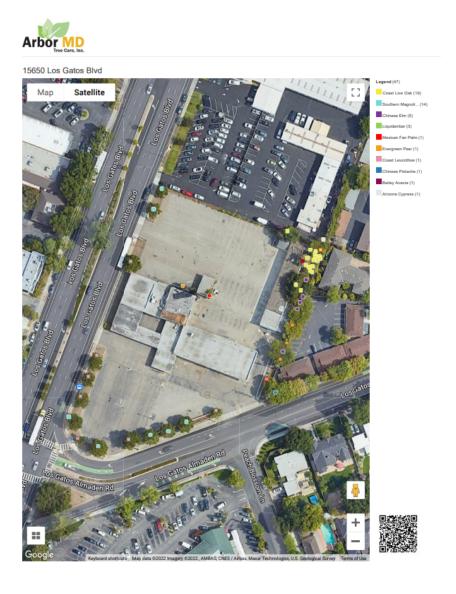
Site Map:

Below is an image of the site map built. As part of our inspection, the landscape services requested several trees be marked for potential removal. These trees can be seen with the red outline around their map pin.
