April 29, 2025

Re: Structural Condition Assessment  
313 University Avenue  
Los Altos, CA 94022  
SEI Project No. 5794.00

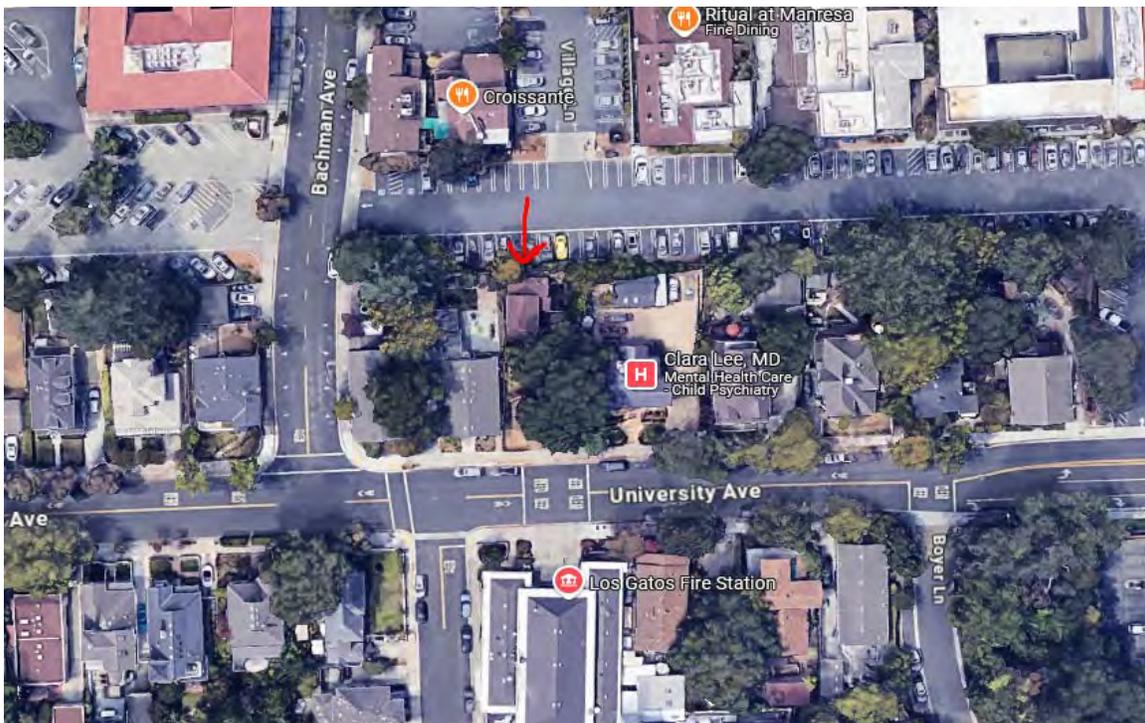
Exterior View East Side

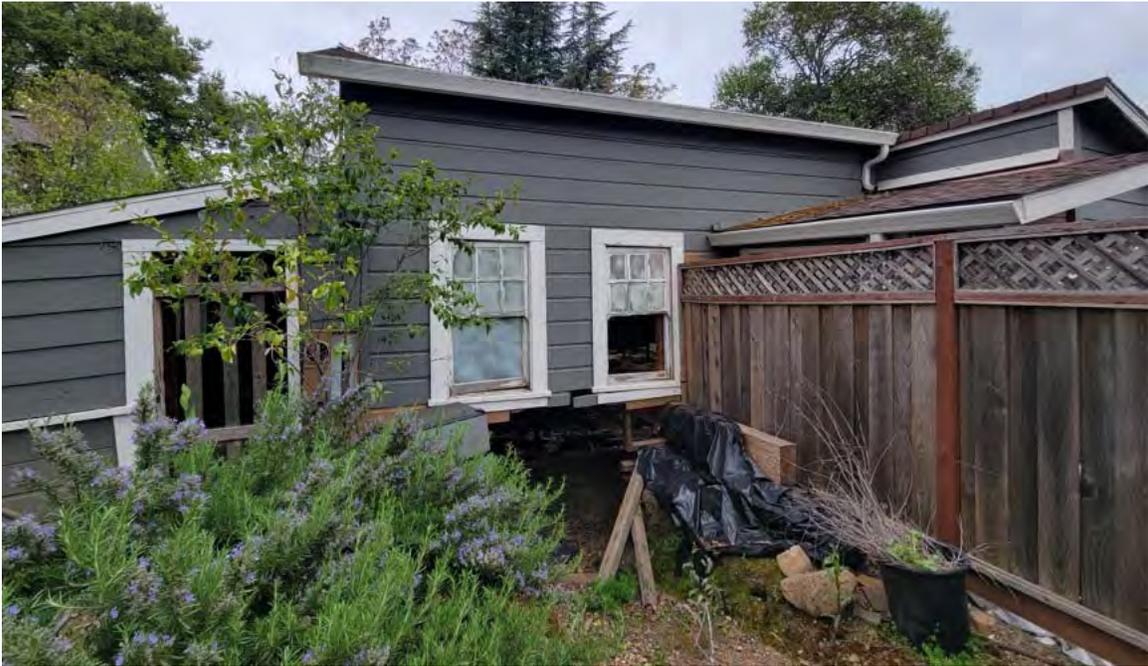
Exterior View - South Side

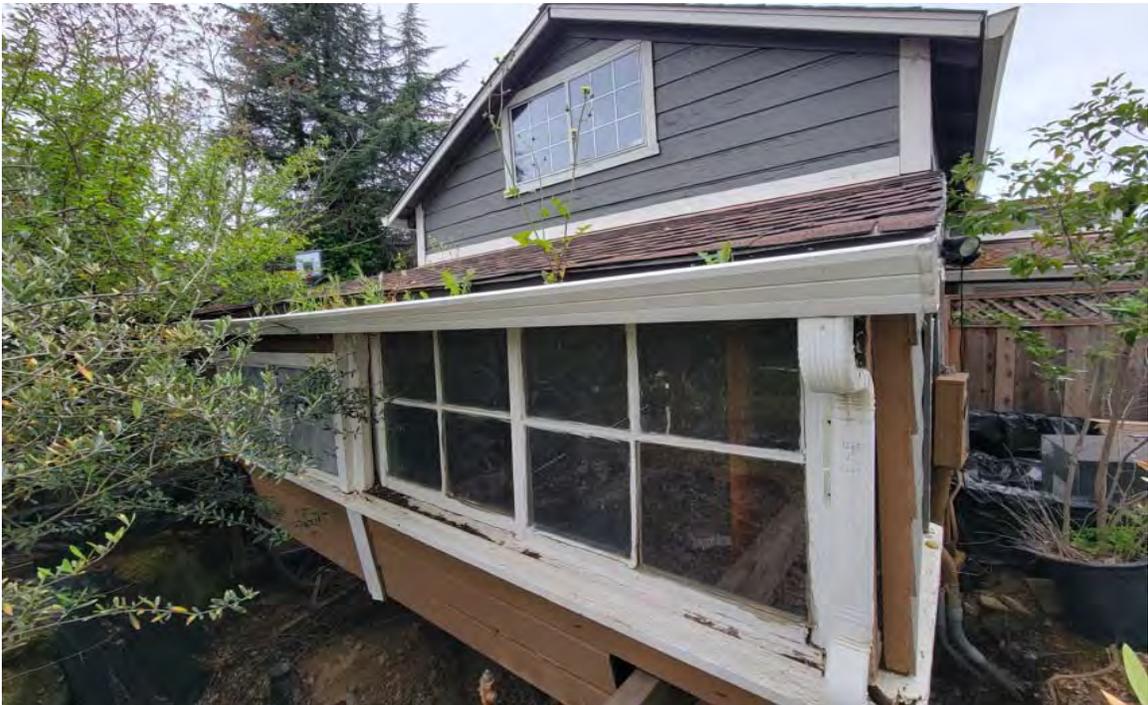
Exterior View – West Side

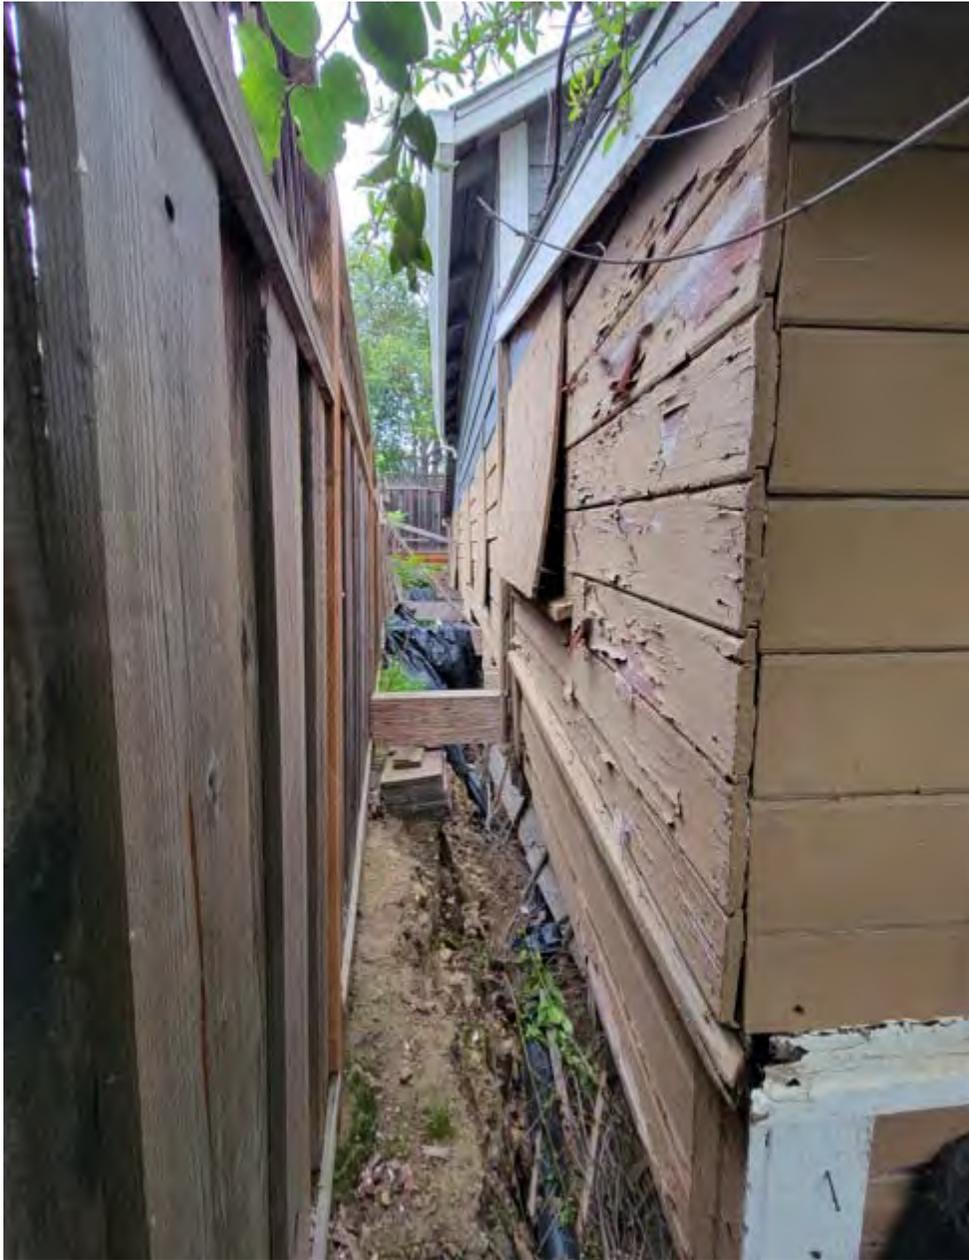
Inside View - Looking North

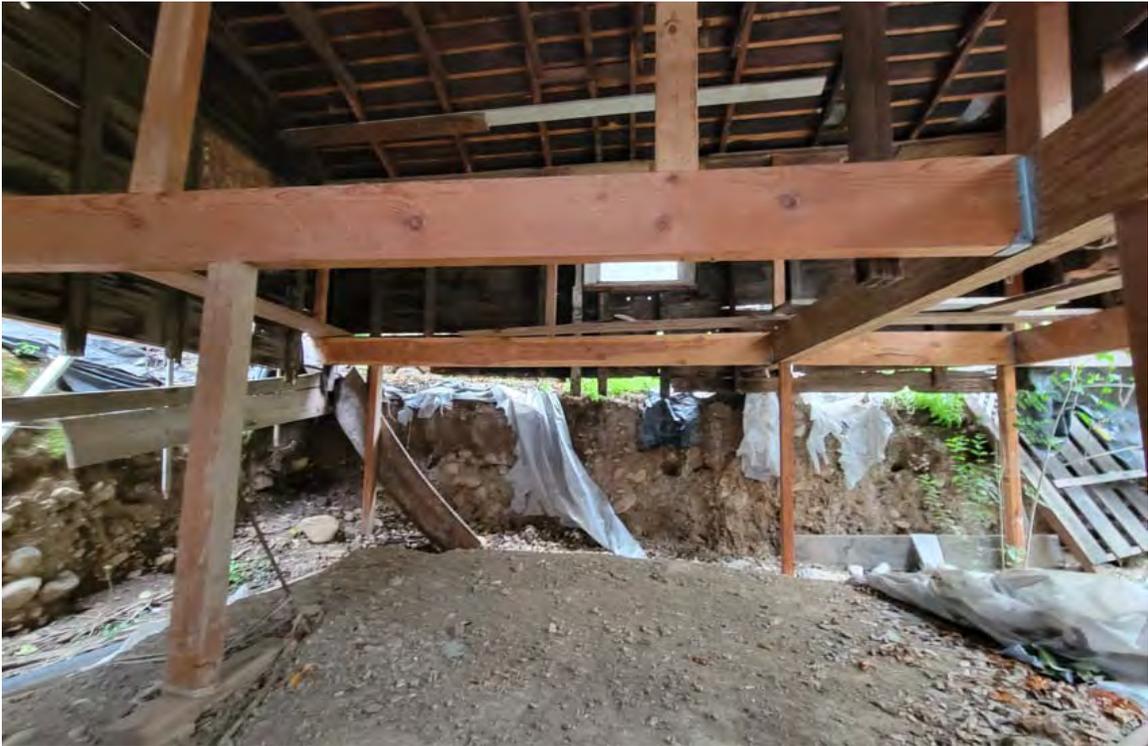
Inside View - Looking East

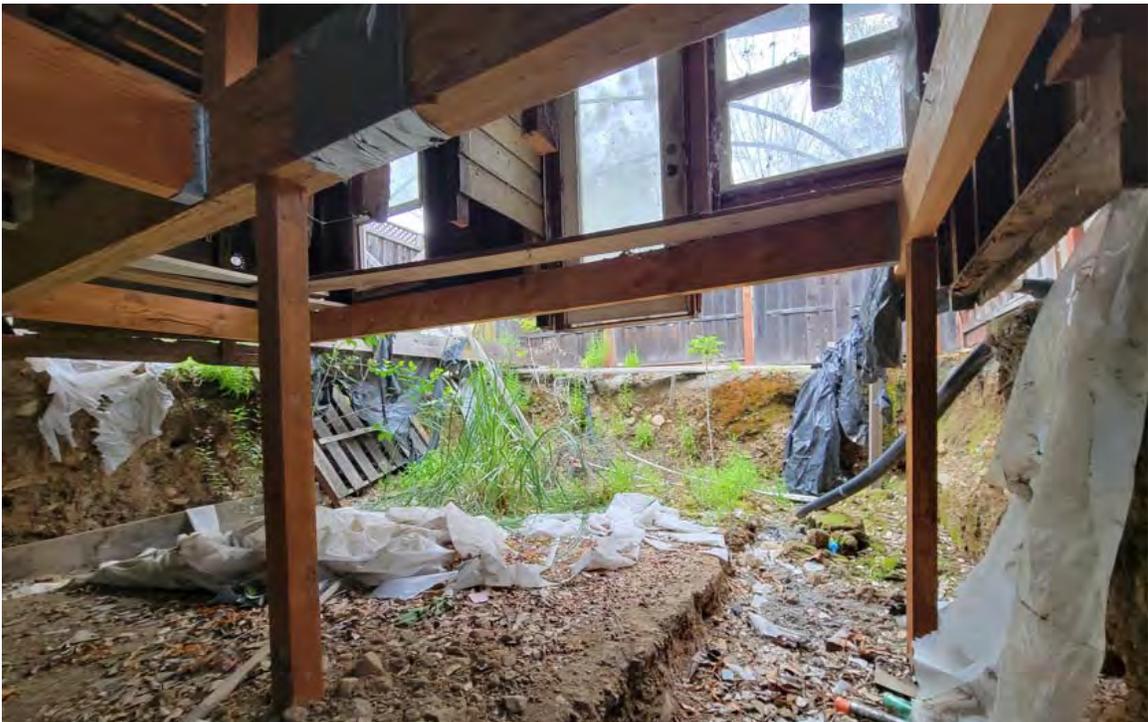
Inside View - Looking South/East

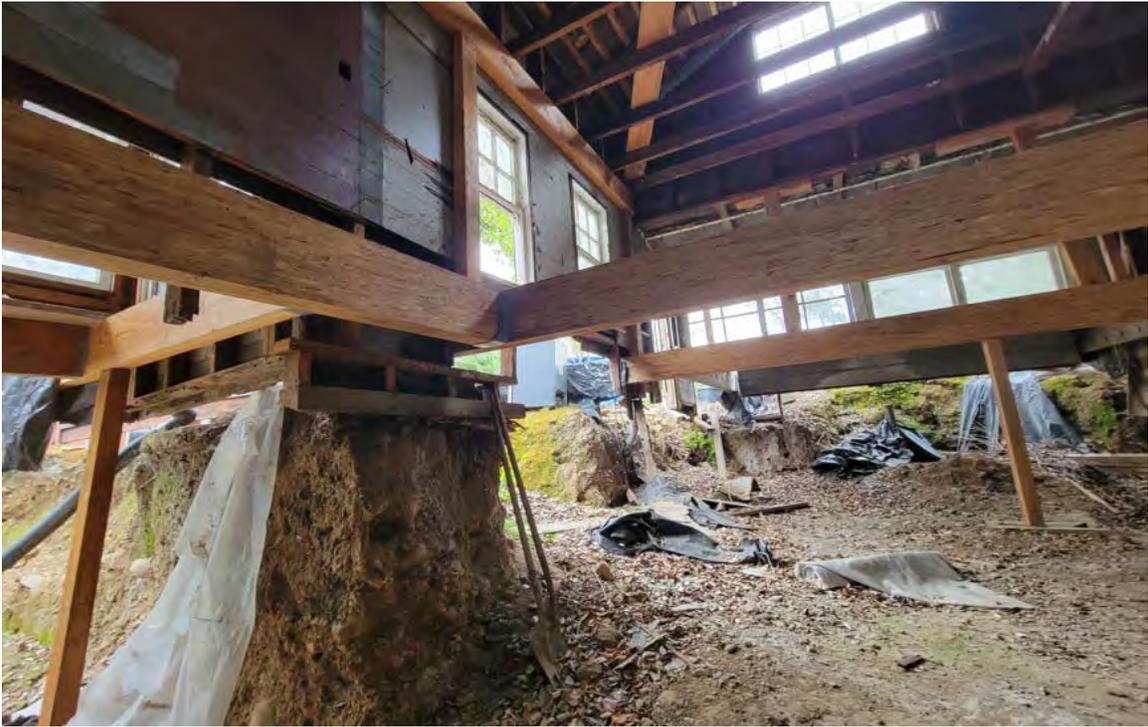
Inside View looking – South/West

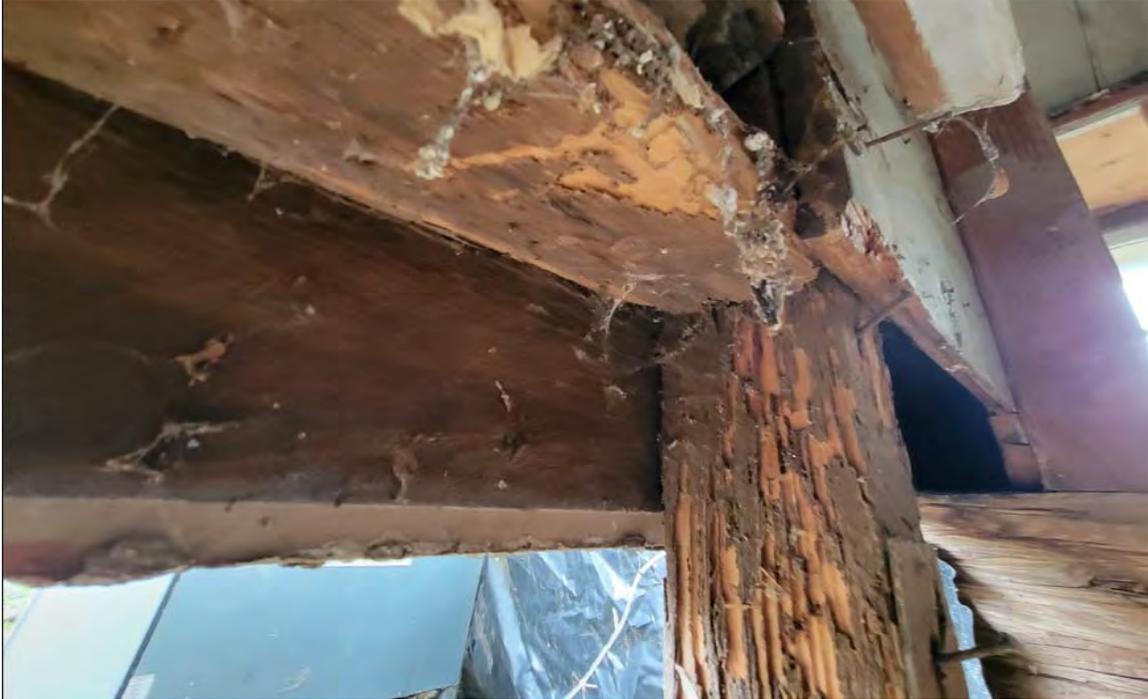
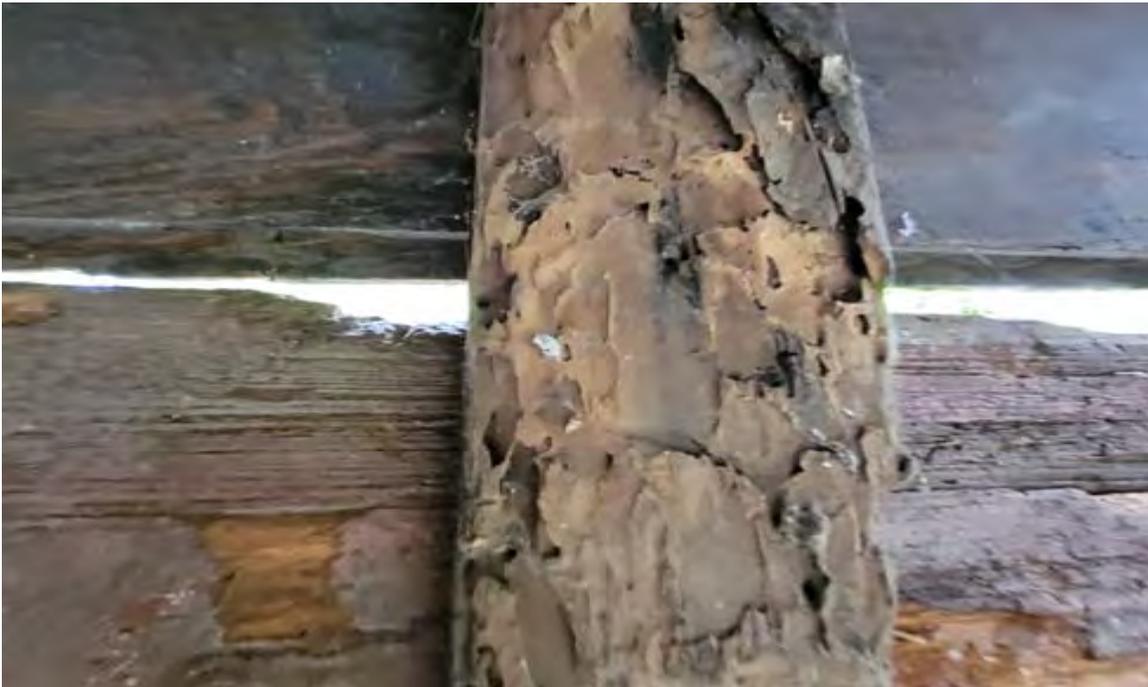
A close up evaluation of the existing framing reveals significant wood decay from both termite infestation as well as on going dry rot (fungal decay) occurring in much of the original perimeter stud framing and plank siding.

The building appears to be in significant disrepair with extensive decay, water damage and framing deficiencies. The current shoring is unstable and in eminent danger of collapse at the soil interface. We would expect that the cost to properly repair this structure would likely exceed the cost of replacement. In our opinion, the structure in its current state, poses an immediate life safety risk should someone enter the interior or stand too close to the perimeter of the excavation. We recommend that warning signs be posted immediately and that the structure be completely demolished as soon as is feasible.

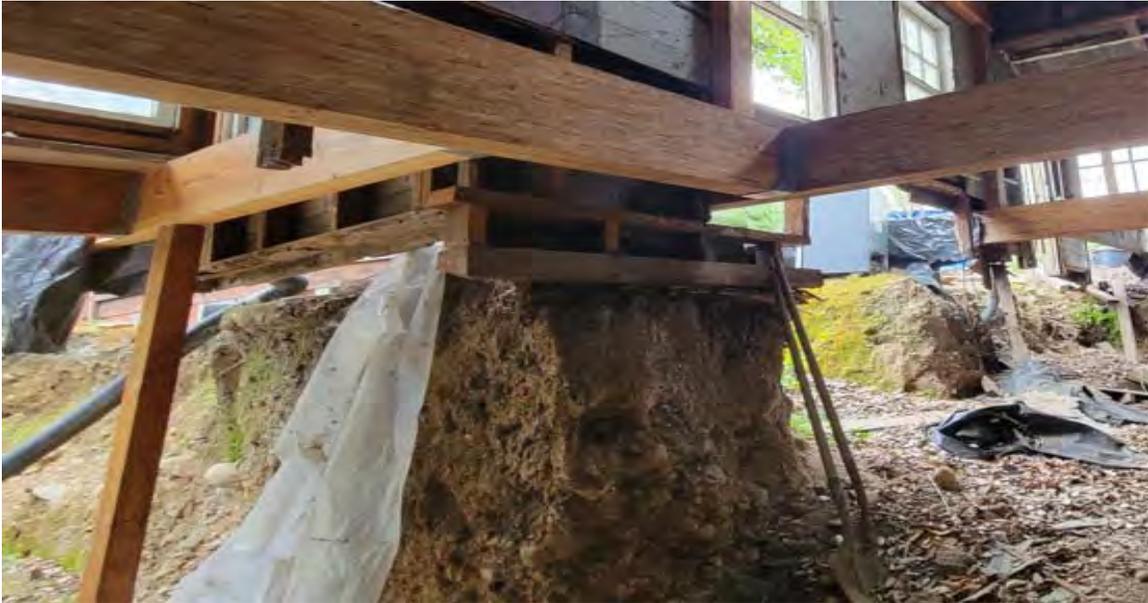
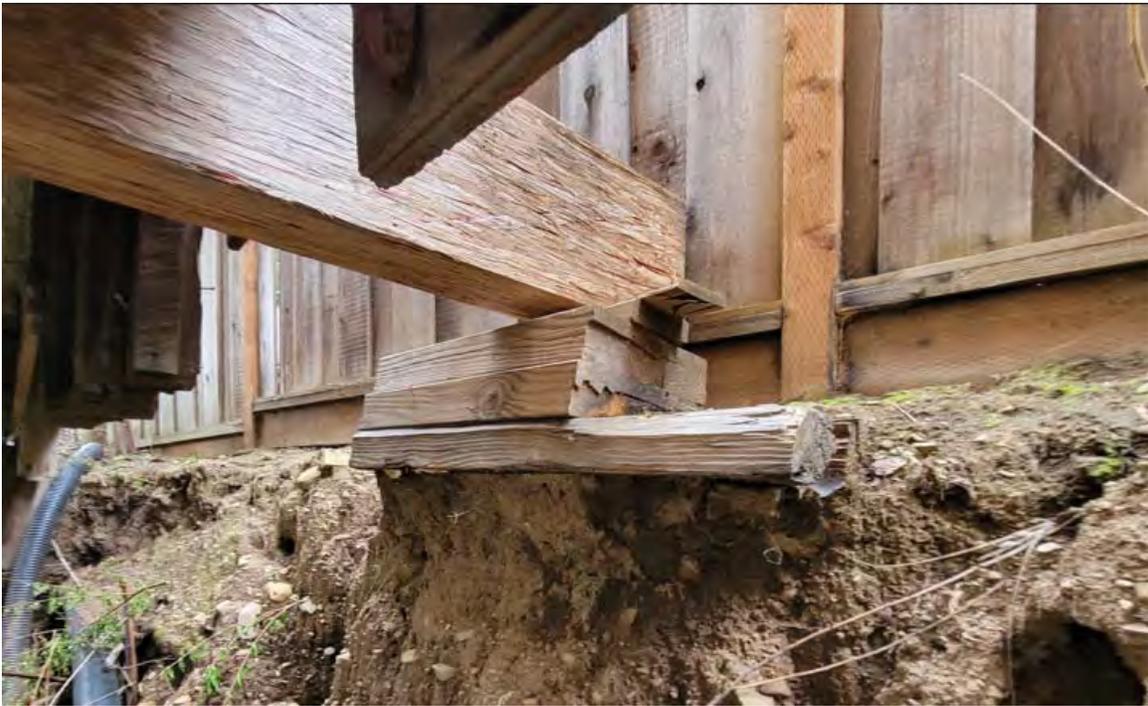
The slopping roof joists and ridge board are undersized and sagging. Proper ceiling/collar ties are not present in the construction. As expected, this has resulted in outward bowing of the exterior walls along the main plate line over time.

The observed shoring has been eroded with no mechanical anchorage.
