**Tree Inventory, Assessment,
and
Protection**

**15921 Linda Avenue
Los Gatos, CA 95032**

Town of Los Gatos

May 29, 2019

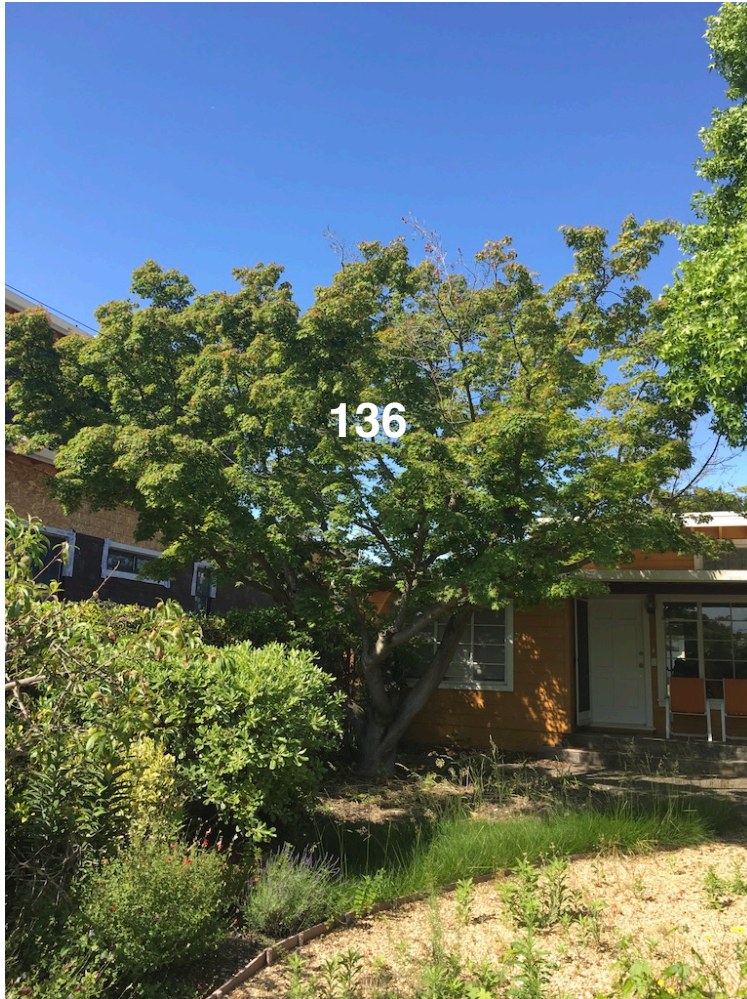
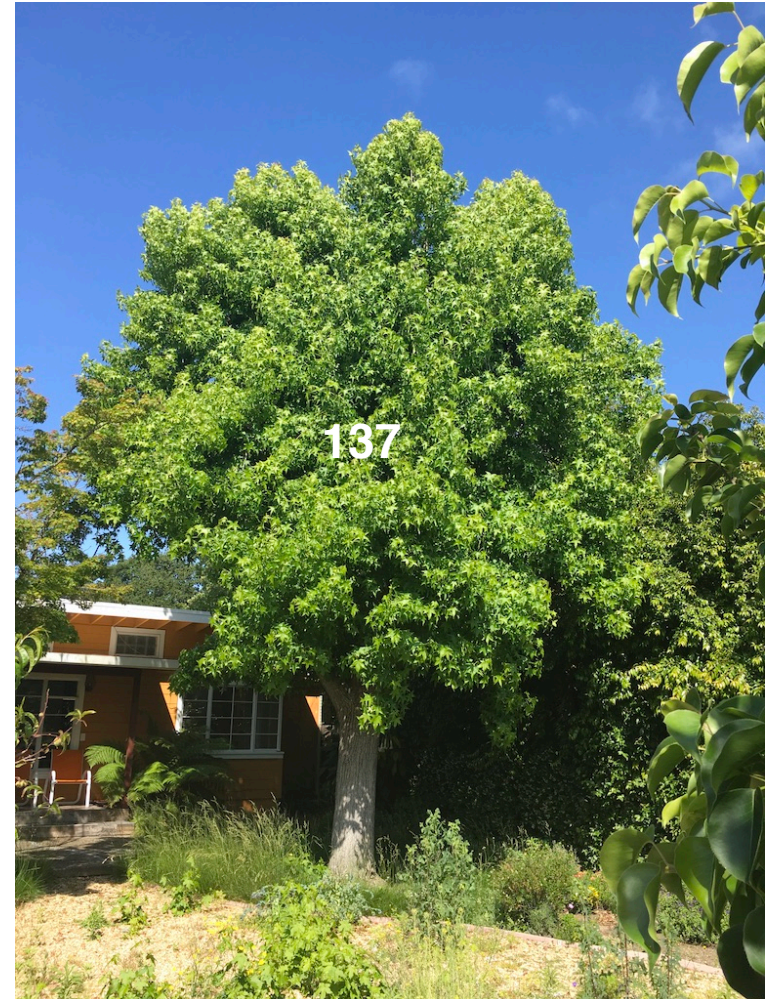
C1: Japanese maple #136 and Sweetgum #137

Two trees have fair suitability for preservation which are the Japanese maple and sweetgum that will be highly impacted and caused to be removed. The two fruit trees have poor suitability and the remaining nine originate on the adjacent sites.

All four trees originating on the site will be highly impacted and caused to be removed which are Japanese maple #136, Sweetgum #137, pear #138 and apple #139. The trees on the adjacent sites are not expected to be highly impacted by the project depending on the grading and drainage plans.
