April 29, 2025

Re: Structural Condition Assessment  
313 University Avenue  
Los Altos, CA 94022  
SEI Project No. 5794.00

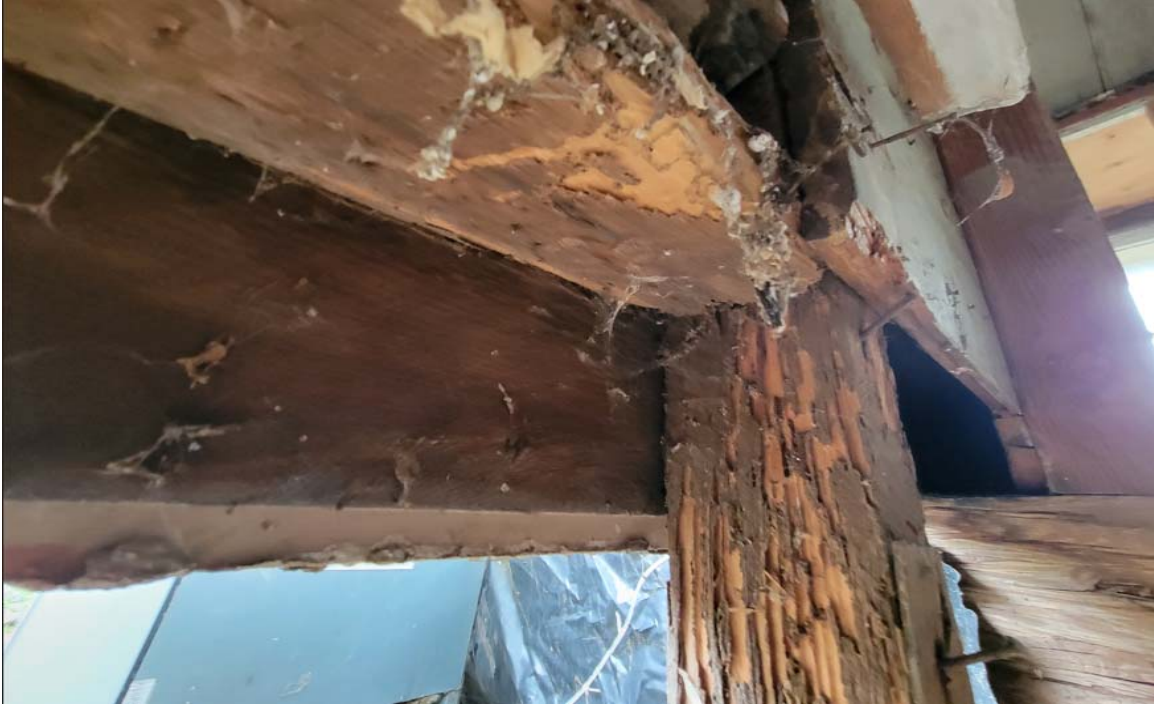
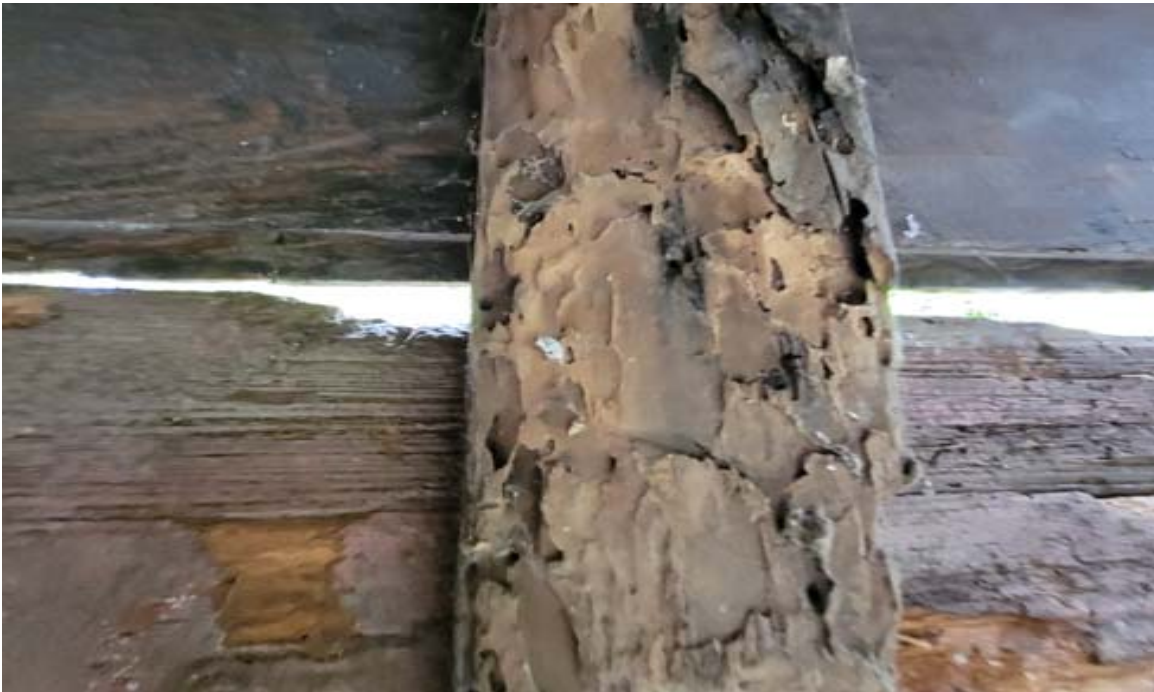
A close up evaluation of the existing framing reveals significant wood decay from both termite infestation as well as on going dry rot (fungal decay) occurring in much of the original perimeter stud framing and plank siding.

The building appears to be in significant disrepair with extensive decay, water damage and framing deficiencies. The current shoring is unstable and in eminent danger of collapse at the soil interface. We would expect that the cost to properly repair this structure would likely exceed the cost of replacement. In our opinion, the structure in its current state, poses an immediate life safety risk should someone enter the interior or stand too close to the perimeter of the excavation. We recommend that warning signs be posted immediately and that the structure be completely demolished as soon as is feasible.

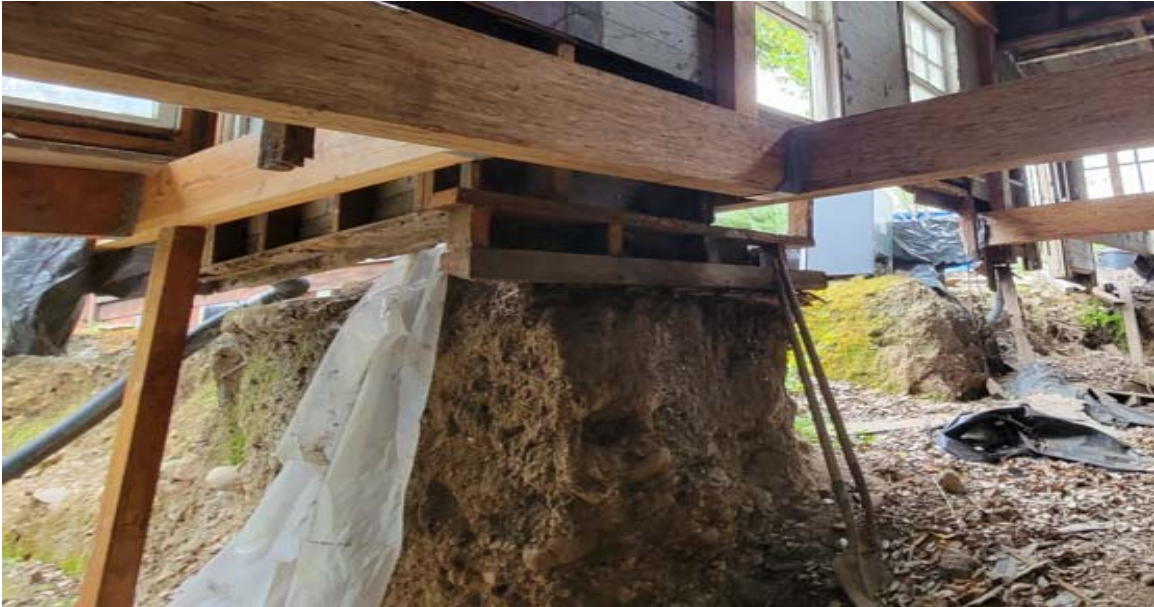
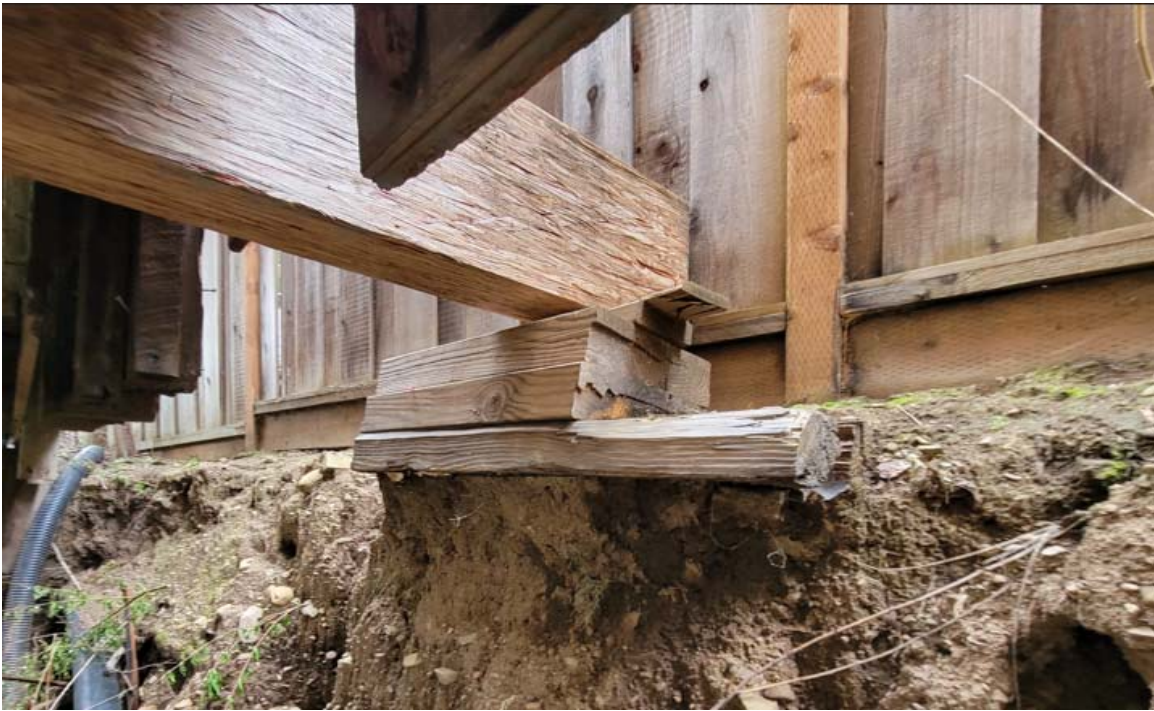
The slopping roof joists and ridge board are undersized and sagging. Proper ceiling/collar ties are not present in the construction. As expected, this has resulted in outward bowing of the exterior walls along the main plate line over time.

The observed shoring has been eroded with no mechanical anchorage.
