**Tree Inventory, Assessment,
and
Protection Report**

**APN 510-47-045
145 Wood Road
Los Gatos, CA 95032**

March 22, 2021

Monarch Consulting Arborists

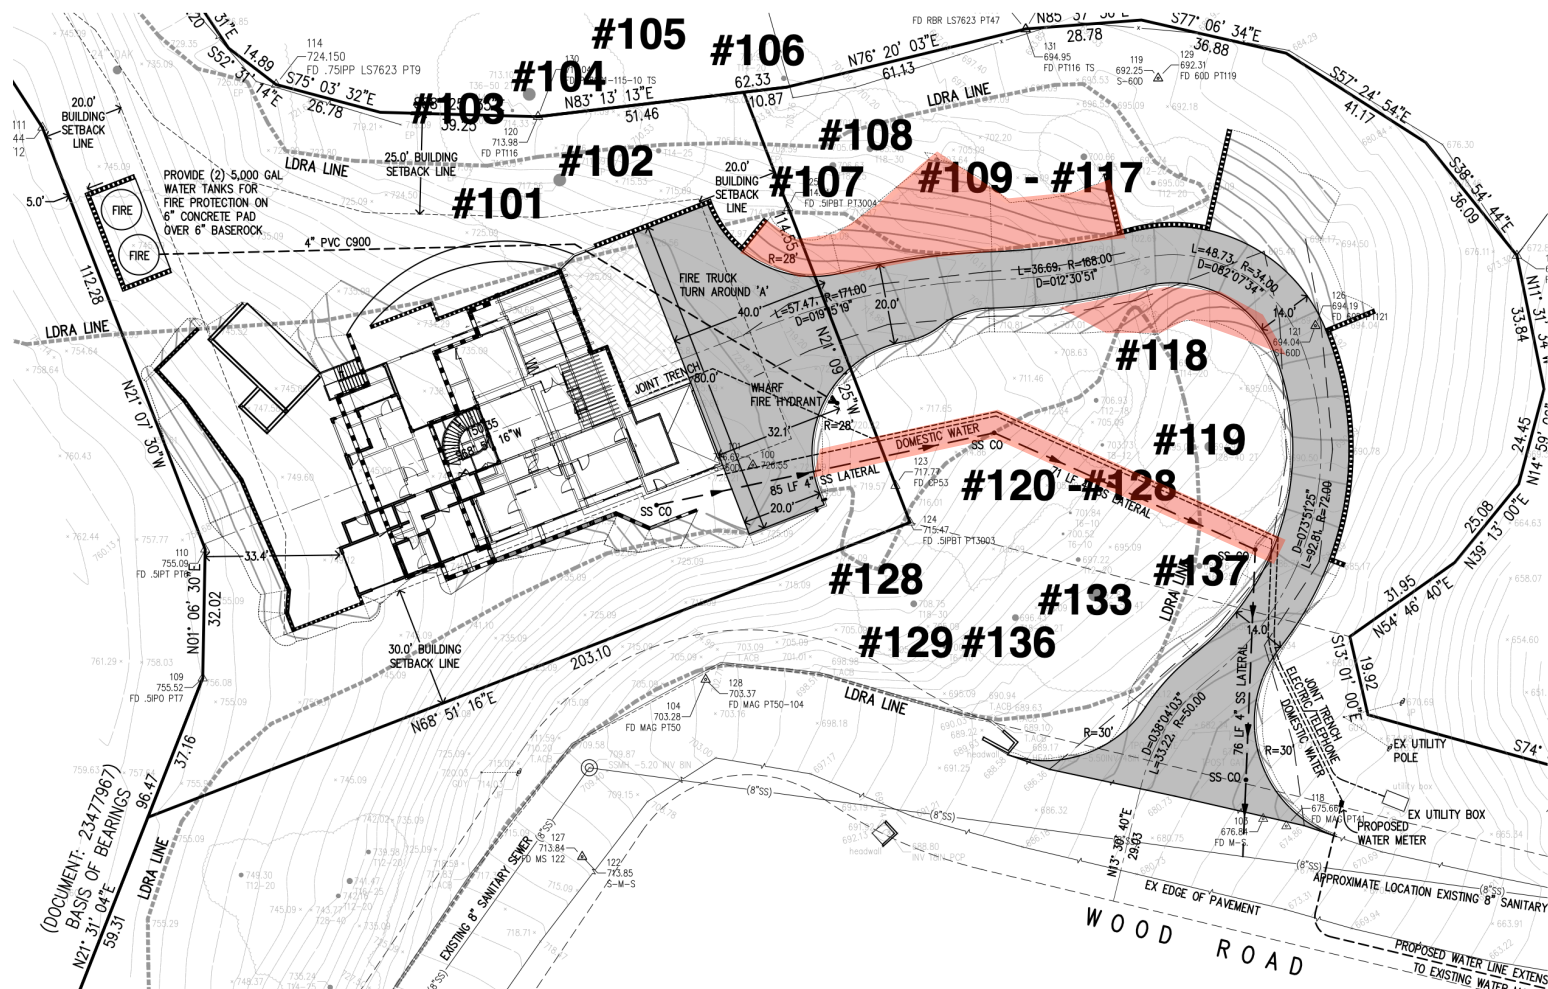
Ten trees could be moderate to highly impacted primarily from the proposed retaining wall near #115 - #117, driveway grading near #118, and the water and sanitary sewer bisecting the lower stand near trees #120 through #128.

The plan below indicates the area of expected impacts (Image 1). Highlighted in red are the areas where modifications could alleviate some issues. Running the water and sanitary sewer under the driveway or directly down the slope adjacent to valley oak #128 would remove the utility issues. The retaining wall and grading around #109-#117 would need to be altered.

2. Consider relocating the utilities to an area that does not bisect the southern grove of trees, possibly follow the driveway.
3. Consider adjusting the grading at the driveway radius to avoid the tree on both sides.

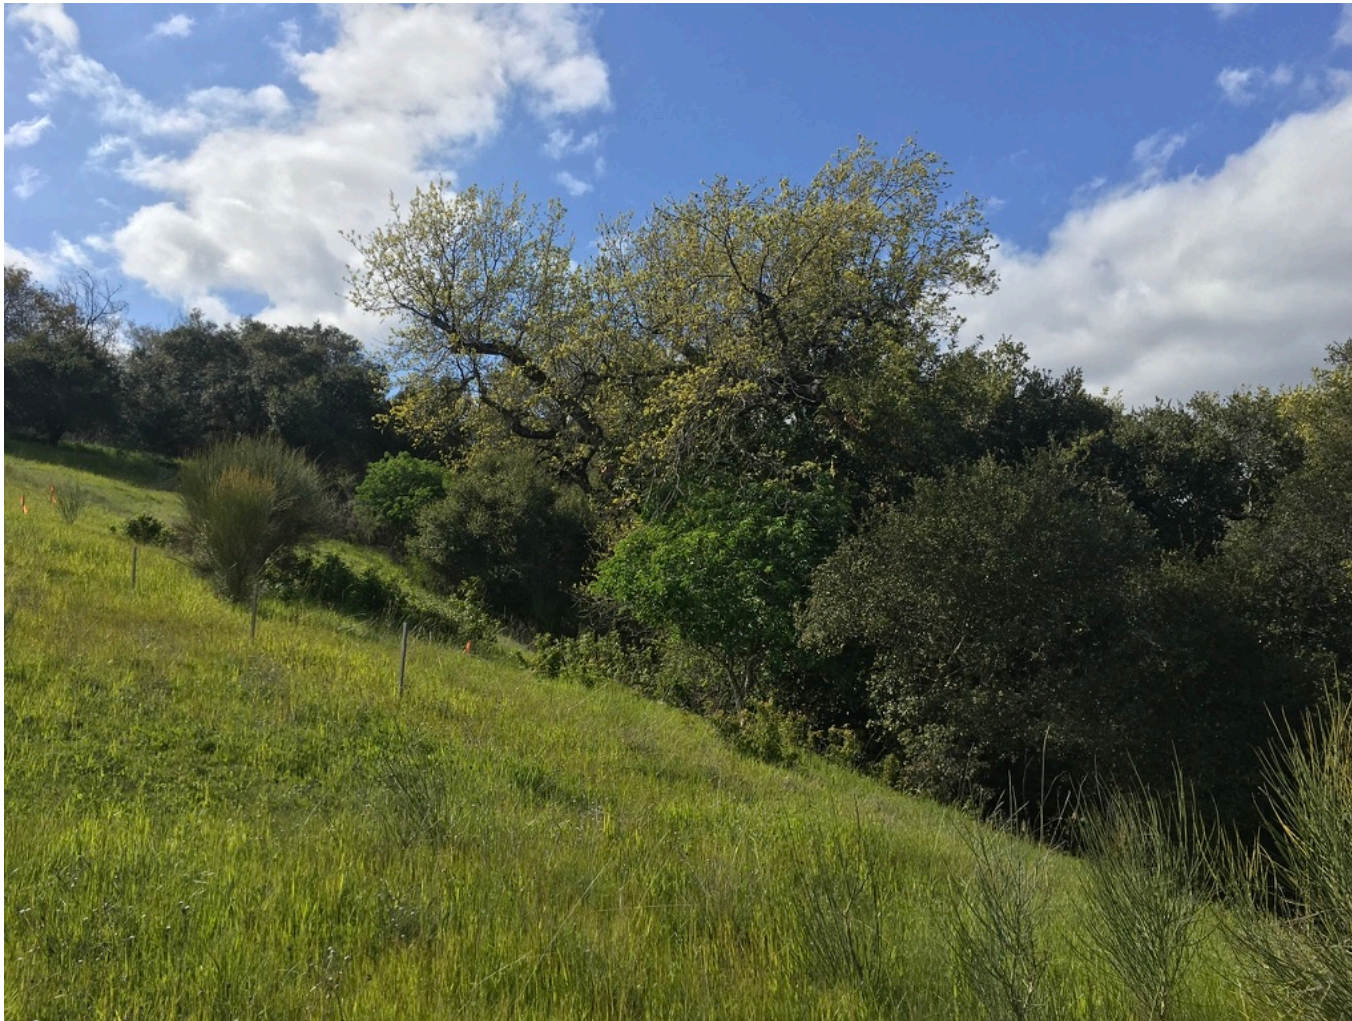
C1: North stand

The trees are all in good or fair condition. None of them have been maintained as these are natural stands of trees with typical broken limbs and cavities. Eighteen are in good shape which are mostly smaller specimens and eighteen fair as they are older and have typical issues for mature trees.

4. Place tree protection fence at the drip line radius around both the north and south stands of trees and eliminate grading in these areas.
5. All tree maintenance and care shall be performed by a qualified arborist with a C-61/D-49 California Contractors License. Tree maintenance and care shall be specified in writing according to American National Standard for Tree Care Operations: *Tree, Shrub and Other Woody Plant Management: Standard Practices* parts 1 through 10 and adhere to ANSI Z133.1 safety standards and local regulations. All maintenance is to be performed according to ISA Best Management Practices.
