## Home Inspection Report

**8 Central Court, Los Gatos**

**Ordered by:** Peter Myers

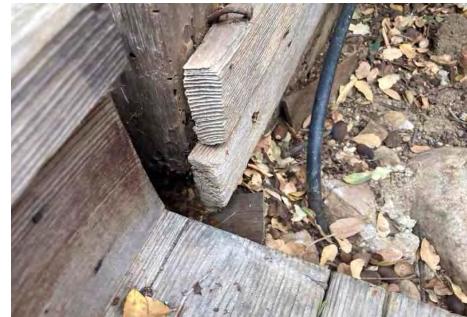
Photo 58

1. The wood members under the left front corner and various areas show evidence of water damage. We recommend the services of a licensed structural pest control operator for investigation of this condition. (See Photo 58) (See Photo 59)

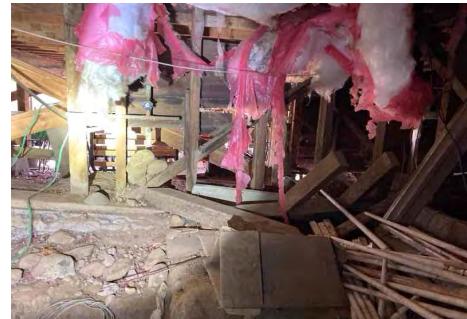
Photo 43

2. Wood/soil contacts at the crawl space should be eliminated. This condition is conducive to rot and wood boring insect activity. We recommend a minimum clearance of six inches be maintained between the soil and the bottom of the wood line. (See Photo 43)

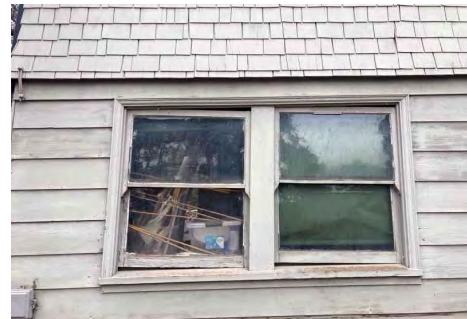
Photo 17

3. Substantial interior floor sloping, drywall cracking and/or exterior cracking was observed in the structure. This implies that structural movement of the building may have occurred. The rate of movement cannot be predicted during a one-time inspection. A structural engineer should be consulted for further evaluation of this condition. (See Photo 17) (See Photo 37)

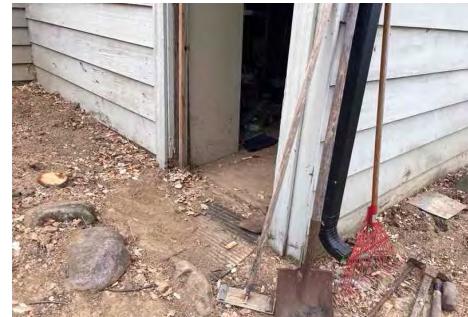
Photo 14

4. The foundation for the addition is wood mudsill. This is not considered a true foundation as this term applies to present building standards. The mudsill for conventional foundations is the first wood member, usually a 2"x 6" or 2"x 8" treated lumber, to be placed over the top of the concrete foundation stem wall, it is then secured to the foundation with anchor bolts. In this case, there is not a concrete foundation, only wood directly in contact with the soil. This exposes this structure to various forms of wood damaging organisms and activity. Additionally, there is no method that will effectively secure this structure for earthquake safety. A structural pest control operator and a licensed foundation specialist should be consulted. (See Photo 14)

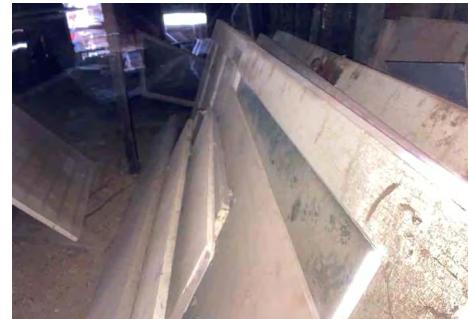
Photo 41

5. Personal storage was blocking access to the basement/crawl space area. Therefore, the back area is considered inaccessible and was not fully inspected. With access and an opportunity for a complete inspection, conditions in need of attention may be discovered. Ideally, the personal belongings should be removed so the area may be inspected. (See Photo 41) (See Photo 42)

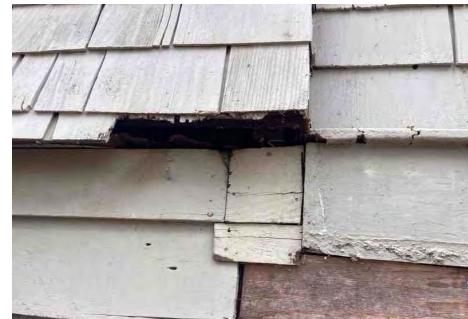
Photo 20

6. Shingle siding is missing and/or loose from the exterior wall. We recommend they be replaced to restore both cosmetic appearance and maximum protection for the underlying surface. (See Photo 20)

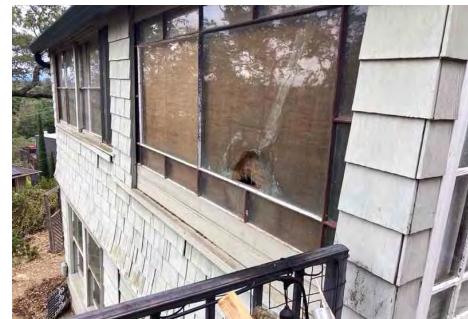
Photo 04

7. Cracked or broken exterior window glass at the back wall and various areas should be replaced. (See Photo 4) (See Photo 5) (See Photo 25)

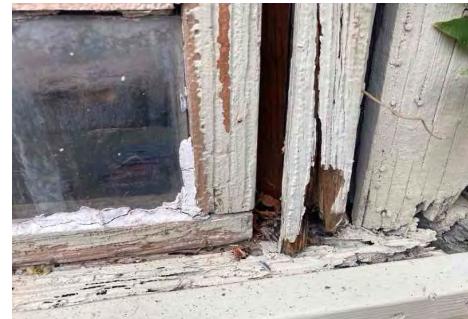
Photo 28

8. The window at the front and right side wall shows evidence of water damage to the sill/jamb. We recommend the advice and services of a general contractor and/or structural pest control company regarding repairs. (See Photo 28) (See Photo 53)

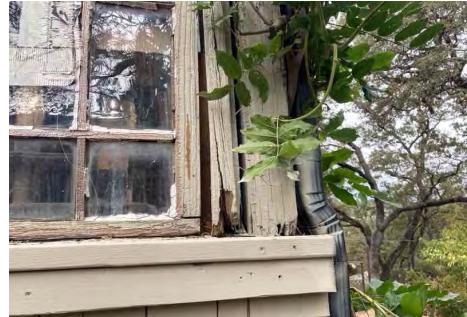
Photo 27

9. The window frames/sash at the right side wall shows evidence of water damage. We recommend the advice and services of a general contractor and/or structural pest control company regarding repairs. (See Photo 27) (See Photo 31)

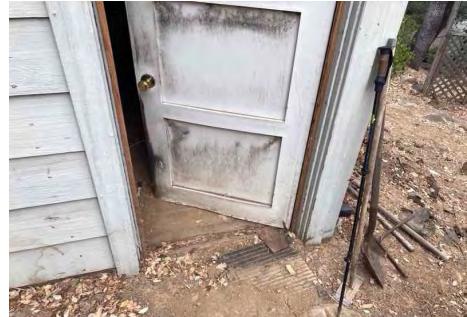
Photo 10

10. Water damage was noted at the back storage shed door. We recommend the services of a licensed general contractor and/or structural pest control company regarding repairs. (See Photo 10)

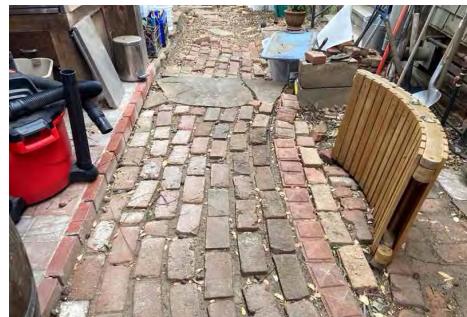
Photo 55

11. The cracked and heaved walkway section(s) at the front present a trip hazard. This condition should be corrected for improved safety. (See Photo 55)

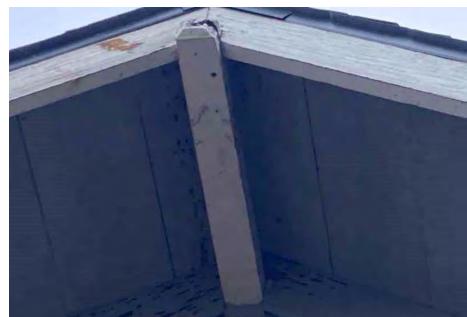
Photo 03

12. Mechanical damage was observed to the roof eaves/sheathing at the left side. We recommend the services of a licensed general contractor and/or structural pest control company. (See Photo 3)

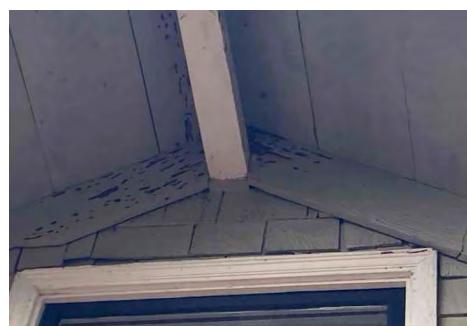
Photo 02

13. Mechanical damage was observed to the rafters at the left side and various areas. We recommend the services of a licensed general contractor and/or structural pest control company. (See Photo 2) (See Photo 29)

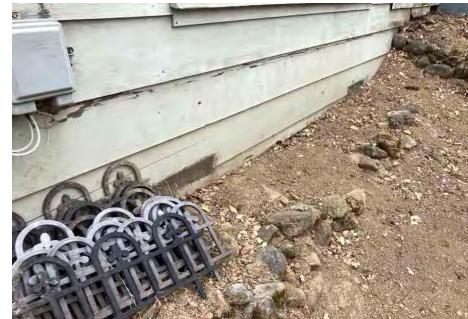
Photo 06

14. Wood/soil contact at the base of the wood siding at the front and various areas should be eliminated. If rotted or damaged siding is found consult a licensed structural pest control operator regarding repairs. (See Illustration 3S) (See Photo 6) (See Photo 7) (See Photo 57)

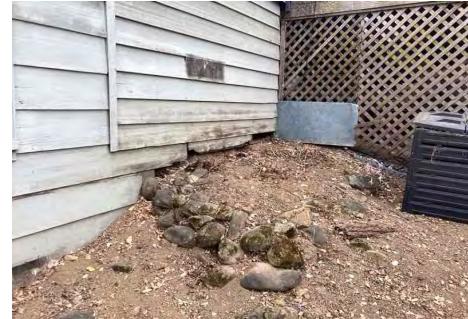
Photo 16

15. Water damage was observed to the wood siding at the front and various areas exterior walls. We recommend the services of a licensed general contractor and/or structural pest control company. (See Photo 16) (See Photo 26) (See Photo 54)

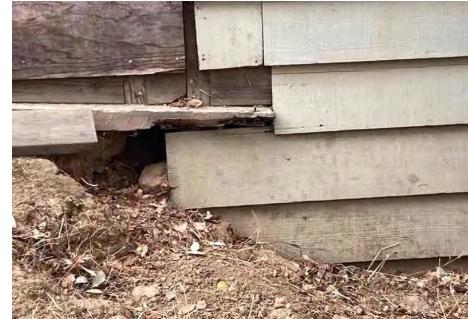
Photo 19

16. Water damage was observed to the exterior trim at the back and left rear corner. We recommend the services of a licensed general contractor and/or structural pest control company. (See Photo 19) (See Photo 21)

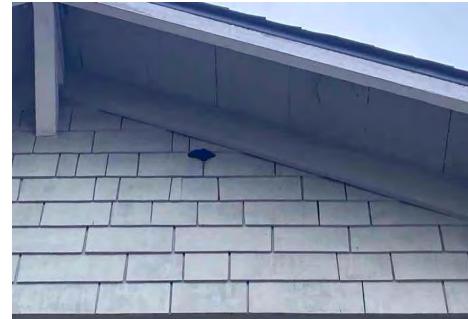
Photo 18

17. There is an opening or hole in the siding at the right side and various areas of the rear exterior wall. We recommend this area be repaired or replaced to eliminate moisture or rodent entry. (See Photo 18)

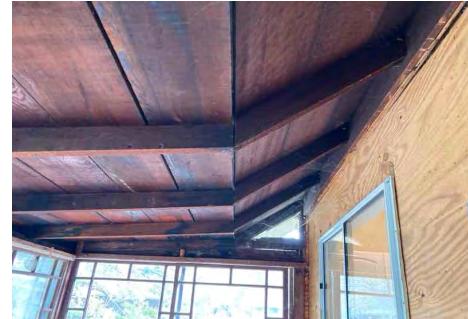
Photo 39

18. The patio cover is improperly constructed. The existing configuration indicates improper design and/or workmanship and is a major safety issue should the patio cover give way due to lateral forces or seismic activity. We recommend the patio cover be removed or replaced according to local building codes. (See Photo 39)

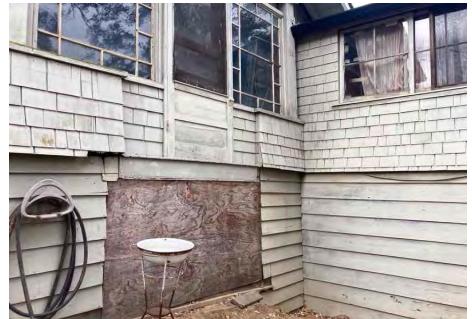
Photo 22

19. The installation of a proper porch, step, landing or deck at the exterior door should be considered for additional safety. (See Photo 22)

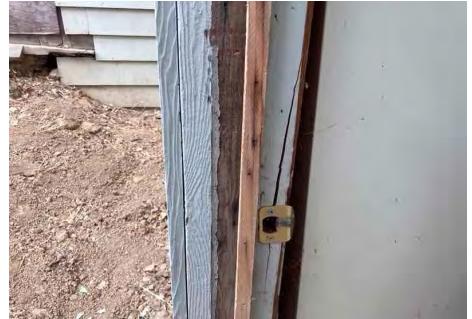
Photo 12

20. The jamb is cracked, split or damaged at the back storage shed door. We recommend it be repaired or replaced. (See Photo 12)

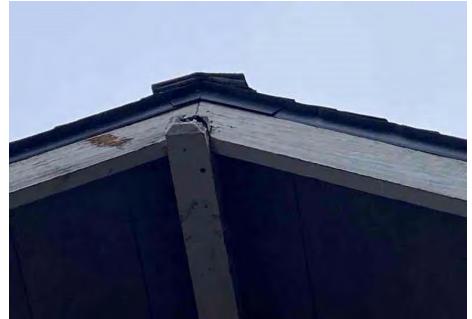
Photo 01

21. Mechanical damage was observed to the beam ends at the left and right side. We recommend the services of a licensed general contractor and/or structural pest control company. (See Photo 1)

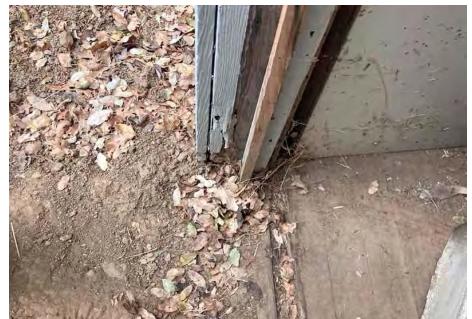
Photo 11

22. Water damage was noted at the back storage shed door jamb. We recommend the services of a licensed general contractor and/or structural pest control company. (See Photo 11)

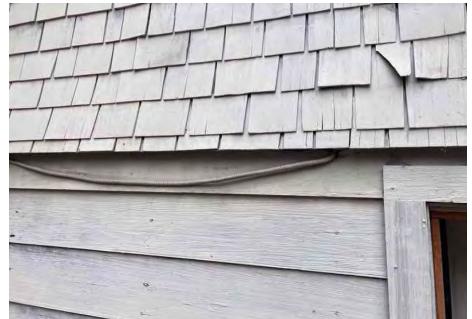
Photo 09

23. The exterior metal conduit and/or connectors installed at the back is not designed for use where exposed to weather. We recommend that the conduit and/or connectors be removed and approved exterior conduit, boxes and/or fittings be installed (See Photo 9)

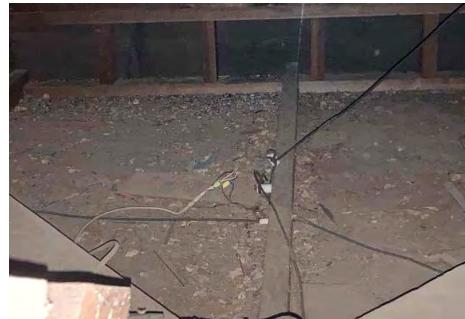
Photo 33

24. Running splices, which are improper connections outside of a junction box, were observed in the attic. We recommend connections be joined with approved connectors inside a junction box to prevent accidental contacts or mechanical damage. (See Photo 33) (See Photo 47)

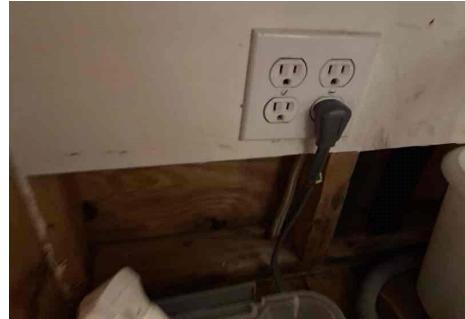
Photo 40

25. Exposed wiring inside the kitchen cabinet should be relocated, covered or protected by rigid conduit. (See Photo 40)

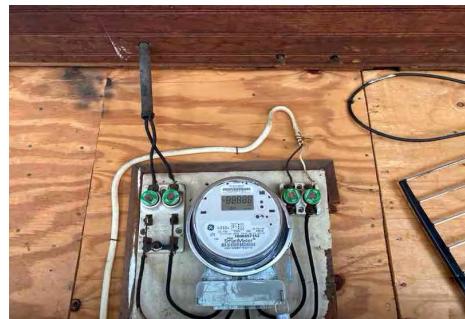
Photo 38

27. The branch/auxiliary panel cover plate (sometimes called the "Dead Front") is missing. It should be replaced. (See Photo 38)

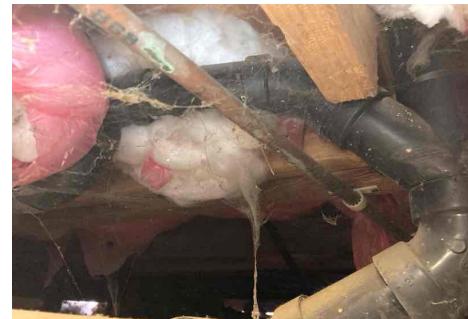
Photo 49

30. The drain system adjacent to the laundry area and master bathroom shower was improperly installed. We recommend the drains be reconfigured according to industry standards. (See Photo 49) (See Photo 51)

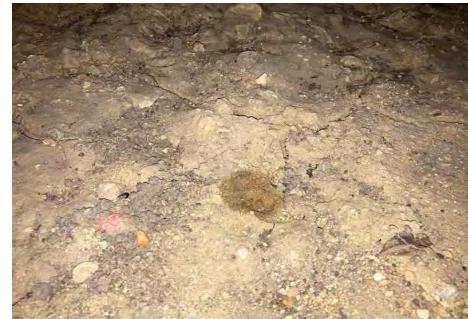
Photo 52

31. The plastic/metallic waste piping is leaking at the front bathroom toilet. We recommend all leaks be repaired. (See Photo 52)

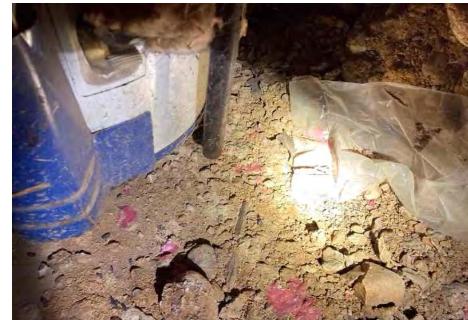
Photo 45

32. The temperature and pressure relief discharge pipe for the water heater is improper. We recommend the installation of a proper discharge pipe to an approved location. (See Photo 45)

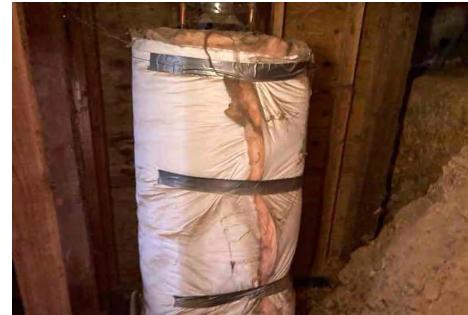
Photo 46

33. The water heater was not strapped. All water heaters (gas or electric) in seismic zones should be properly anchored or strapped in the upper and lower section of the tank to resist movement during earthquake conditions. Specifically California state code is as follows.

1. All water heaters gas or electric must be strapped.
2. Tanks up to 52 gallons require two straps, one in upper one-third and one in the lower one-third of the fixture. Water heaters with a capacity of 52 or above require three, one in upper one-third, one in middle and one in lower one-third are required. There are cases where there is an exception to this rule, we recommend consulting the local building authority regarding the adequacy of the seismic restraints for the water heater at this property.
3. Straps may consist of either plumbers tape (at least 24 gauge) or half-inch

4. Straps must wrap around the body of the water heater and any gaps between the wall and tank should be blocked to prevent movement.
5. Straps should be secured to adjacent wall or stud and from opposing directions
6. Straps should be secured to the wall or studs using 1/4" diameter by 3" long lag bolts with washers. (See Illustration 8E) (See Photo 46)

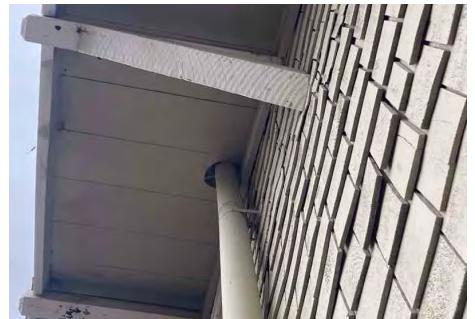
Photo 30

34. There is insufficient clearance between the water heater exhaust flue and combustible materials. This condition should be corrected. (See Illustration 8C) (See Photo 30)

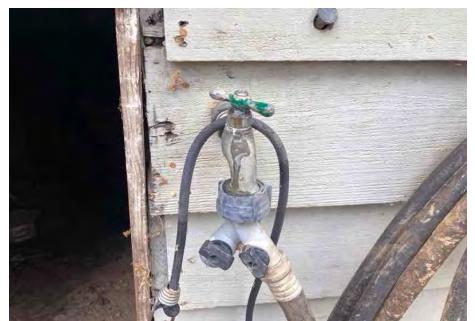
Photo 23

35. The exterior hose bib at the back is leaking. We recommend all leaks be repaired. (See Photo 23)

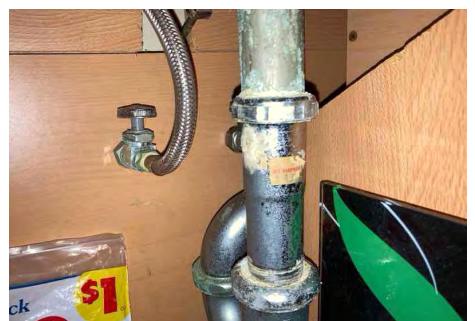
Photo 35

36. There is evidence of heavy corrosion and rust, but no leakage on the exterior of the exposed and accessible metal drain piping in the front bathroom. This piping should be monitored for leakage and repaired as necessary. Upgrading this piping and connections should also be considered. (See Photo 35)

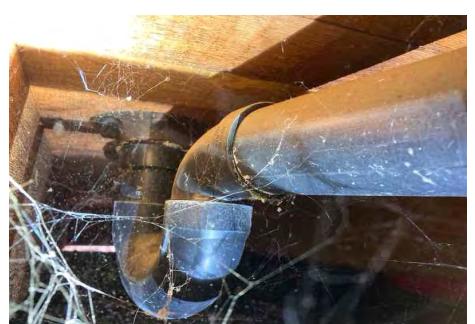
Photo 50

37. There is a cracked and leaking Plastic drain pipe at the front bathroom stall shower. This is a potential health hazard. We recommend the piping in question be repaired or replaced. (See Photo 50)

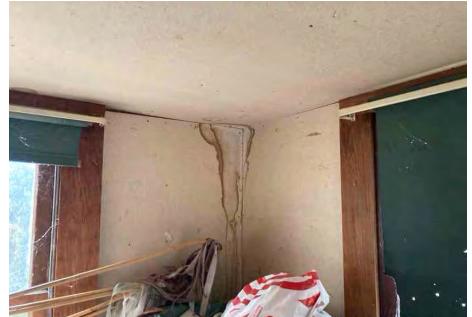
Photo 15

38. The ceiling at the back shed and side shed shows evidence of water stains. It is recommended that the source of these stains be identified and corrected and the surface be refinished. (See Photo 15)

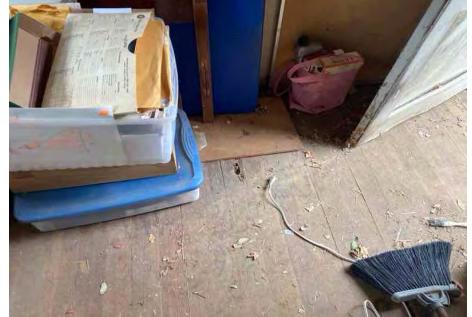
Photo 13

39. Damage to the front bathroom and bathroom storage shed hardwood flooring was observed. The extent of damage is difficult to predict without removing floor coverings. It is recommended that the source of the damage be identified and corrected by the appropriate trades. (See Photo 13) (See Photo 34)

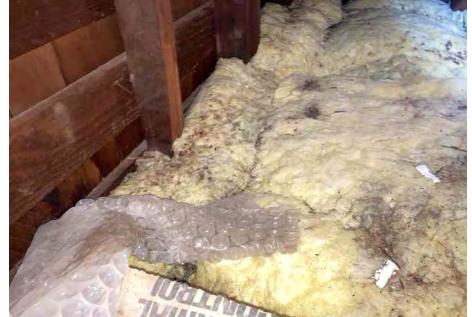
Photo 32

40. Evidence of vermin activity was observed within the structure. It is likely this evidence will extend into inaccessible areas. The owner is advised to contact the appropriate trade for further evaluation and remedial measures if necessary. (See Photo 32)

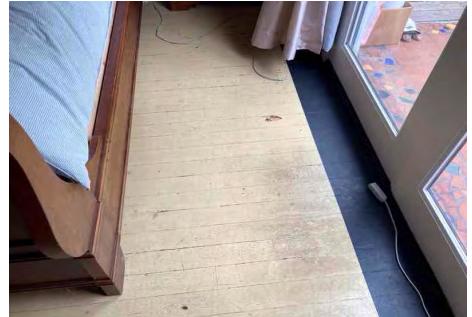
Photo 36

41. Minor water damage to the master bedroom hardwood flooring was observed. It is recommended that the source of the damage be identified and corrected, and the surface be repaired and refinished to restore its appearance. (See Photo 36)

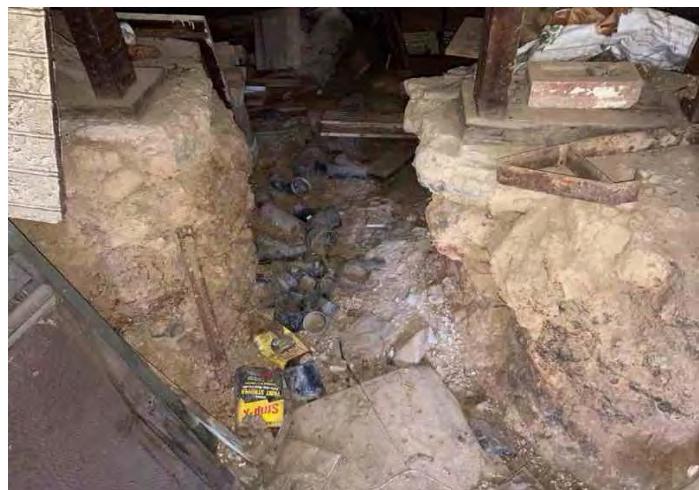
Photo 24

- 4. There is evidence of soil movement at the crawl space soil wall and there is no retaining wall. To eliminate possible movement or erosion of the surrounding soil a properly installed retaining wall may be necessary. We recommend a licensed structural engineer be consulted. (See Photo 24) (See Photo 44)
