WOOD DESTROYING PESTS AND ORGANISM INSPECTION REPORT

Building No.	Street	City	ZIP	Date of Inspection	Number of Pages
8	Central Court	Los Gatos	95030	9/18/2024	Page 1 of 16

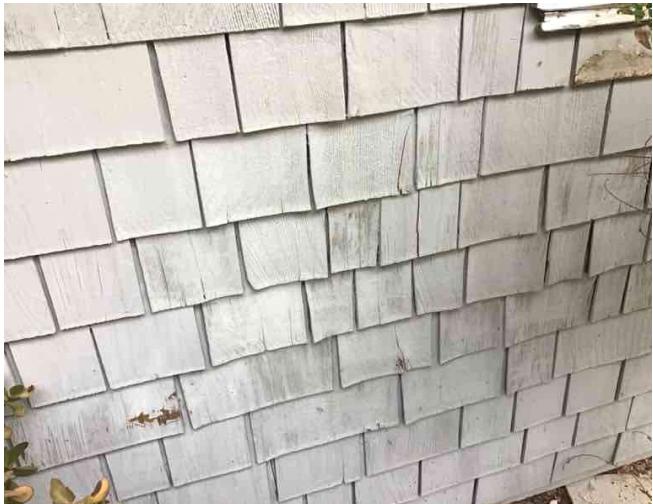
Photo 01

1A. FINDING: The siding has been damaged by fungus at the exterior as indicated on the diagram. The contributing moisture source appears to be exposure to the weather. [\(See Photo 1\)](#) [\(See Photo 16\)](#)

RECOMMENDATION: Remove and replace all the damaged wood members. If any damage is found to *Estimated Cost* extend into any enclosed areas a supplemental report and bid will be issued.

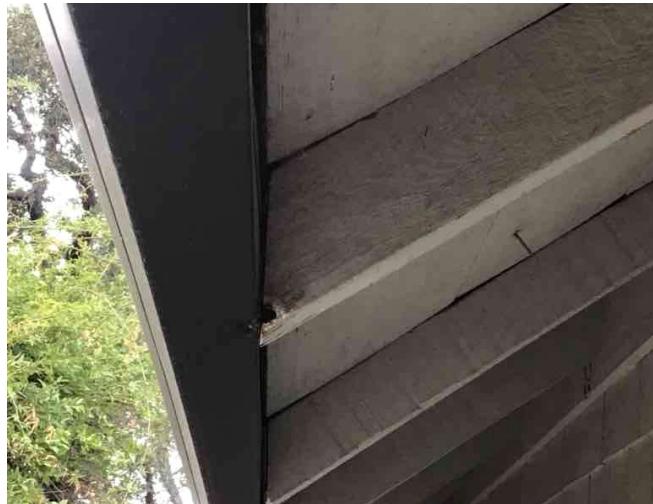
Photo 02

1C. FINDING: The rafter tail(s) as indicated on the diagram are damaged by fungus. The contributing moisture source appears to be exposure to the weather. [\(See Photo 2\)](#)

RECOMMENDATION: Remove and replace the end of the damaged rafter tail(s) and install a new sister *Estimated Cost* section alongside for support.

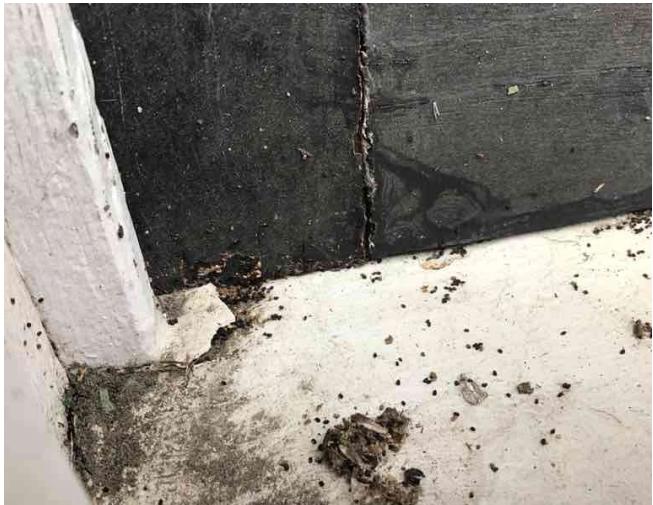
Photo 03

1S. FINDING: Infestation by Drywood Termites was noted at the exterior, interior. (See Photo 3) (See Photo 11) (See Photo 33)

1T. FINDING: Drywood termite pellets were evident as noted in the above recommendation. (See Photo 3) (See Photo 17) (See Photo 33)

RECOMMENDATION: Due to the nature of these infestations, it will be necessary to seal the entire *Estimated Cost* structure and fumigate it with Vikane (sulfuryl fluoride), using Chloropicrin as a warning agent. The entire structure must be vacant for this process. It is the owners responsibility to make any preparations required by the fumigators or to have someone to do so at a separate expense and to have the gas turned back on when the fumigation is complete. "NOTICE: The charge for service that this company subcontracts to another registered company may include the company's charges for arranging and administering such services that are in addition to the direct costs associated with paying the subcontractor. You may accept HomeGuard Incorporated's bid or you may contract directly with another registered company licensed to perform the work.

RECOMMENDATION: Remove and/or mask over all accessible termite pellets. It is possible for the *Estimated Cost* drywood termite pellets to sift down or reappear in these areas where they have been masked over.

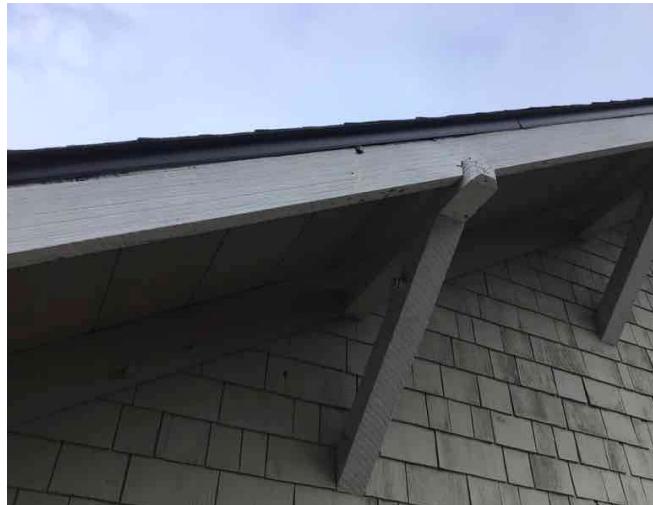
Photo 04

1D. FINDING: The barge rafter(s) as indicated on the diagram are damaged by fungus. The contributing moisture source appears to be exposure to the weather [\(See Photo 5\)](#) [\(See Photo 4\)](#)

1E. FINDING: The end of the support beams have been damaged by fungus at the right side and left side exterior. (See Photo 4) (See Photo 6) (See Photo 5)

RECOMMENDATION: Remove and replace the entire barge rafter to correct this condition. This bid *Estimated Cost* includes repair of the roof covering if disturbed by our repairs. If existing gutters need to be removed to perform the repairs then our bid also includes reinstallation of original gutters. If it becomes necessary or desirable to install new gutters this will be done only if authorized and at an additional cost. The guarantees on the roof covering are limited to the areas where the repairs were performed.

RECOMMENDATION: Remove and replace the damaged end of the beam. If damage were to extend *Estimated Cost* into inaccessible areas or if the damage extends beyond what can be repaired, a supplemental report will be issued with additional findings and recommendations.
******(SECTION 1 ITEM)*****

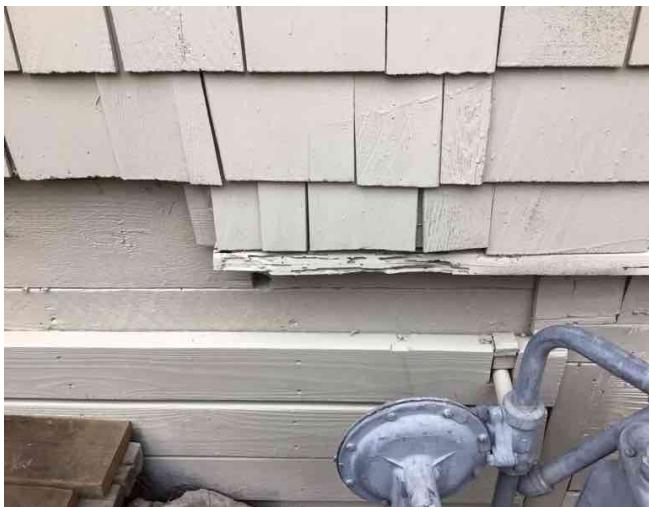
Photo 07

1F. FINDING: The trim has been damaged by drywood termites at the right side exterior as indicated on the diagram. Refer to item(s) 1S for recommendations to control contributing moisture source and or infestation. (See Photo 7) (See Photo 8)

RECOMMENDATION: Remove and replace all the damaged wood members. If any damage is found to *Estimated Cost* extend into any enclosed areas a supplemental report and bid will be issued.
******(SECTION 1 ITEM)*****

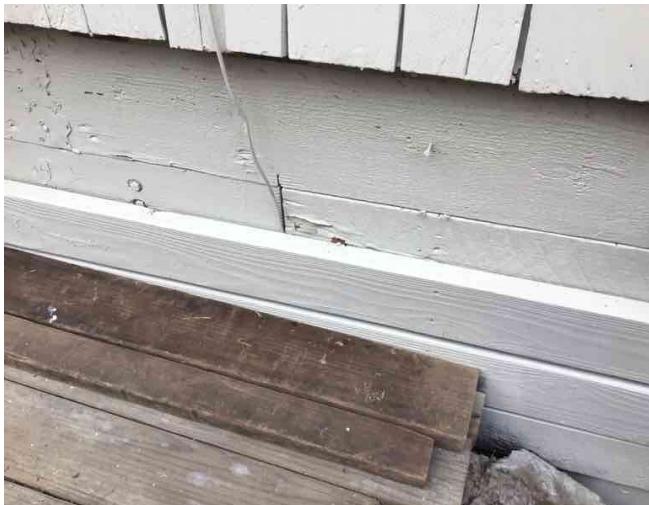
Photo 09

1G. FINDING: The siding has been damaged by fungus and/or drywood termites at the exterior as indicated on the diagram. Refer to item(s) 1S for recommendations to control contributing moisture source and or infestation. (See Photo 9)

RECOMMENDATION: Remove and replace all the damaged wood members. If any damage is found to *Estimated Cost* extend into any enclosed areas a supplemental report and bid will be issued.
******(SECTION 1 ITEM)*****

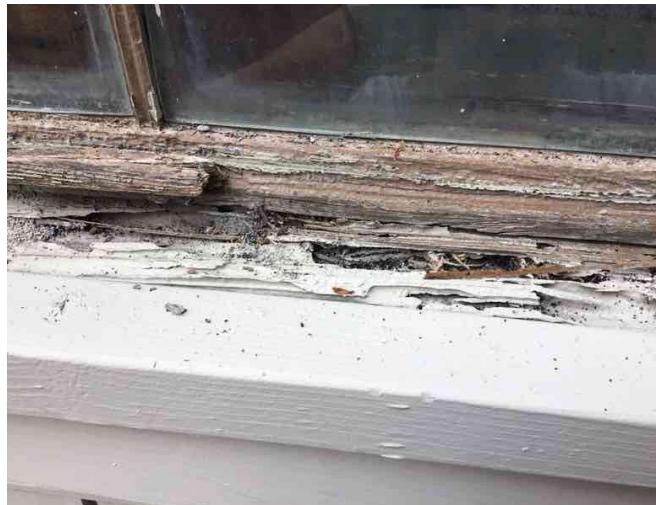
Photo 10

1H. FINDING: The window sill and trims have been damaged by drywood termites at the right side exterior as indicated on the diagram. Refer to item(s) 1S for recommendations to control contributing moisture source and or infestation. (See Photo 10) (See Photo 11)

RECOMMENDATION: Remove and replace all the damaged wood members. If any damage is found to *Estimated Cost* extend into any enclosed areas a supplemental report and bid will be issued.
******(SECTION 1 ITEM)*****

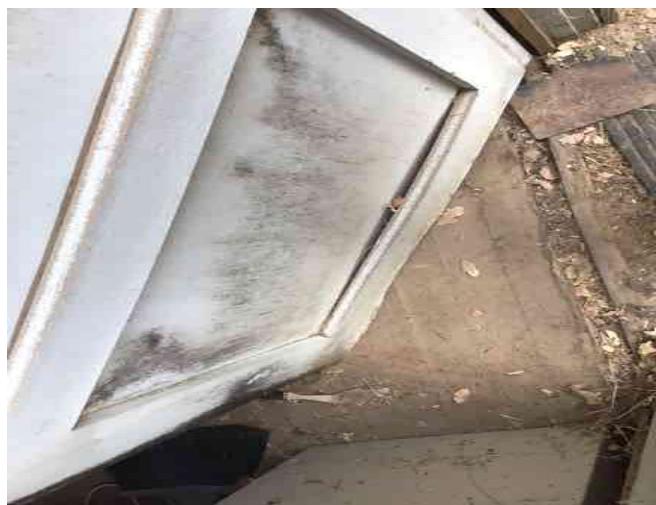
Photo 12

1I. FINDING: The storage closet door and jamb were found to be damaged by fungus and drywood termites. (See Photo 12) (See Photo 13) (See Photo 14)

RECOMMENDATION: Supply and install a new pre-hung door and jambs to correct this condition. Note: *Estimated Cost* The existing door knob and dead bolt if any will be re-installed in the new door unless prior arrangements are made. We at HomeGuard Incorporated are upgrade experts and can provide proposals that include upgraded fixtures, and doors or any other option you may desire. This bid is based on the installation of a readily available door of similar size. An exact match of the existing door may not be possible. If a more exact match is desired, additional fees may apply. Please note that if a special order door is needed to complete this item, there could be a three week delay in getting a replacement door.
******(SECTION 1 ITEM)*****

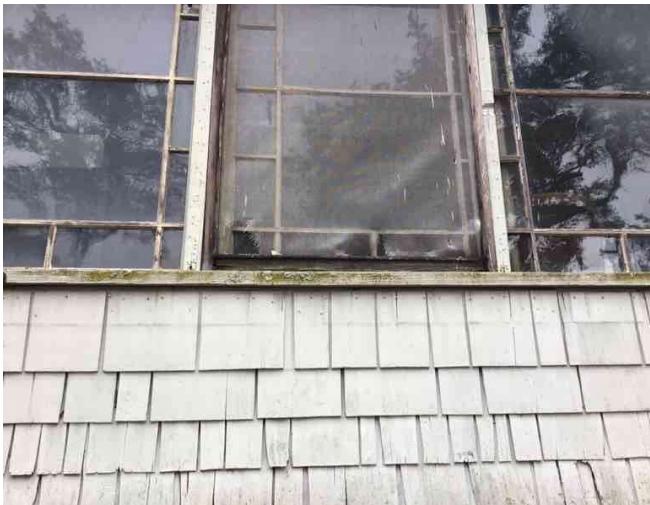
Photo 15

1J. FINDING: The wooden windows and window screens have been damaged by fungus. The contributing moisture source appears to be exposure to the weather. (See Photo 15) (See Photo 16) (See Photo 25)

RECOMMENDATION: Owner is advised to contact the appropriate trades to have the windows and *Estimated Cost* screens replaced.
******(SECTION 1 ITEM)*****

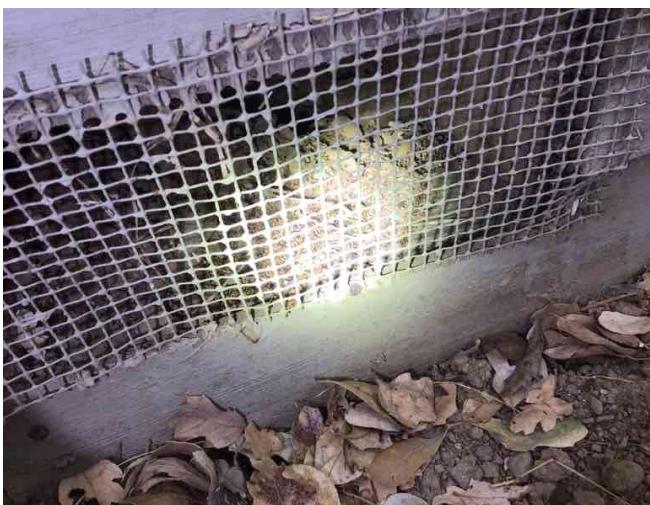
Photo 17

1L. FINDING: A portion of the structure at the downstairs storage closet appears to be a sleeper floor construction and was inaccessible for inspection. Visible fungus damage and drywood termite pellets were observed. (See Photo 17) (See Photo 20)

RECOMMENDATION: Remove the flooring from the perimeter of this area to allow for further inspection.

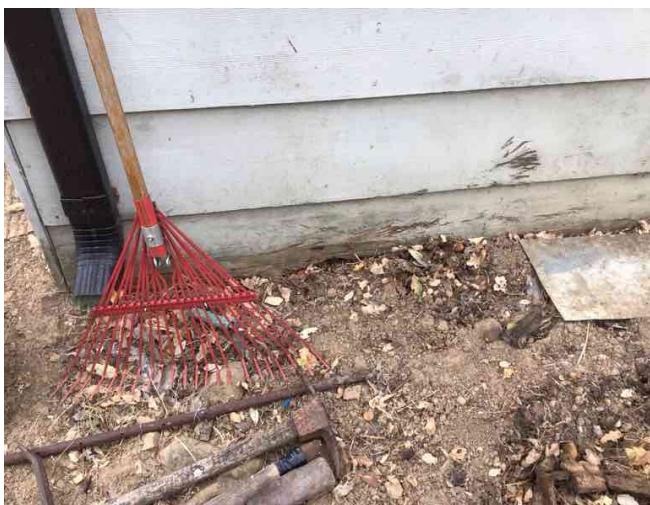
Photo 18

1K. FINDING: The siding is in earth wood contact at the exterior as indicated and has been damaged by fungus. The contributing moisture source appears to be exposure to the weather. (See Photo 18) (See Photo 24)

RECOMMENDATION: Remove and replace the damaged siding and grade the soil away from the *Estimated Cost* structure to eliminate the earth wood contact. Note: If additional damage is found when the soil is graded or if damage is found to extend into an enclosed area a supplemental report and bid will be issued.

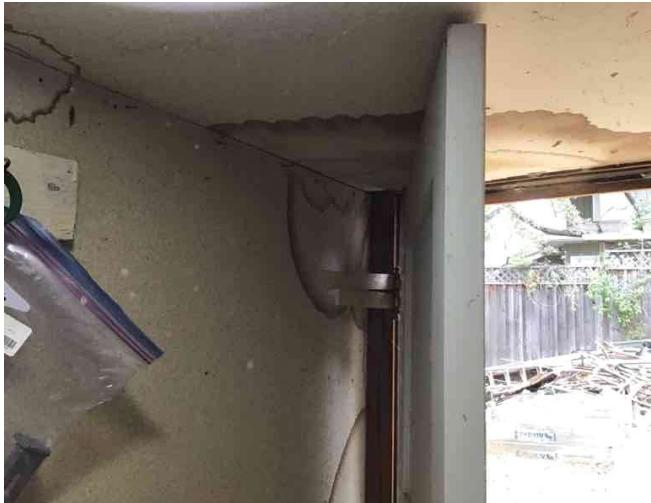
Photo 21

3A. FINDING: Water stains were noted on the ceiling in the downstairs storage closet. (See Photo 21) (See Photo 22) (See Photo 23)

RECOMMENDATION: Open this area to determine the source of these stains and if any damage exists. *Estimated Cost* All findings, recommendations, and bids will be issued in a supplemental report. This bid is to open the area and further inspection only.

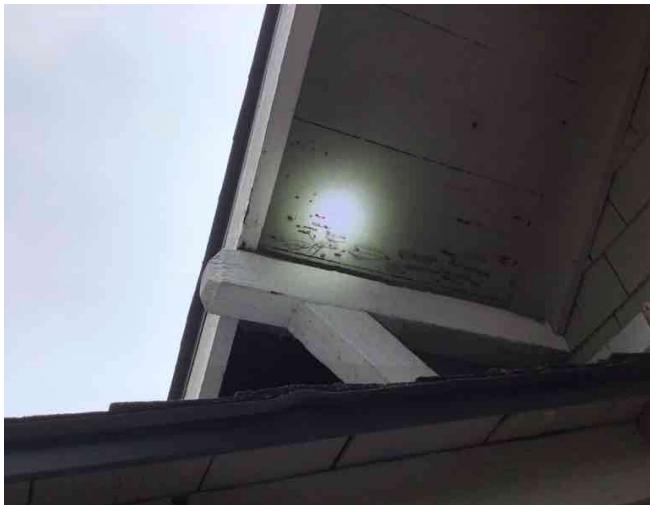
Photo 28

1M. FINDING: The roof sheathing has been damaged by carpenter bees where indicated on the diagram. (See Photo 28) (See Photo 29)

RECOMMENDATION: Remove and replace the damaged sheathing to correct this condition. This bid *Estimated Cost* includes repair of the roof covering if disturbed by our repairs. If existing gutters need to be removed to perform the repairs then our bid also includes reinstallation of original gutters. If it becomes necessary or desirable to install new gutters this will be done only if authorized and at an additional expense. The guarantees on the roof covering are limited to the areas where the repairs were performed.

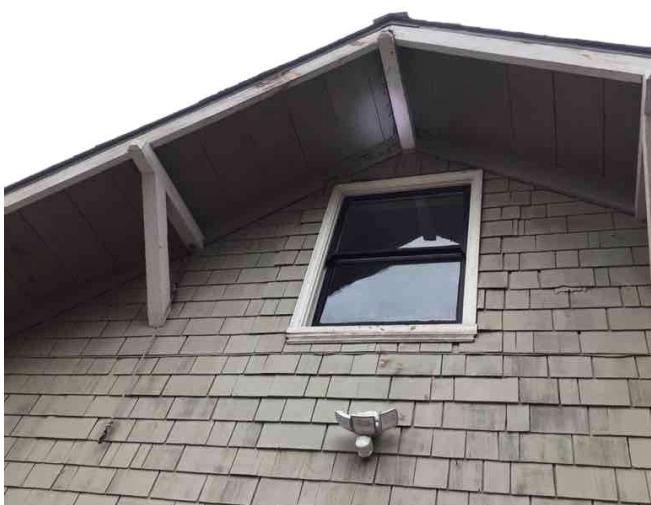
Photo 29

1N. FINDING: The trim has been damaged by carpenter bees at the left side exterior as indicated on the diagram. (See Photo 29)

RECOMMENDATION: Remove and replace all the damaged wood members. If any damage is found to *Estimated Cost* extend into any enclosed areas a supplemental report and bid will be issued.

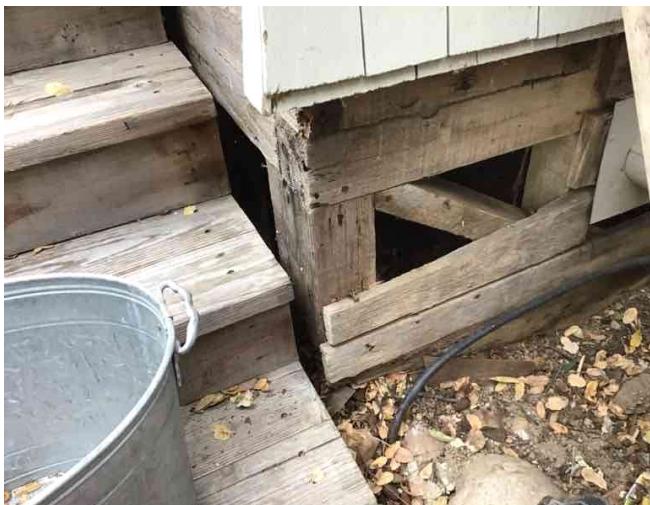
Photo 30

1U. FINDING: Earth to wood contact and fungus damage was noted to several wood members of the foundation. (See Photo 30) (See Photo 38) (See Photo 39)

RECOMMENDATION: Owner to contact the appropriate trades to make the necessary repairs. *Estimated Cost*

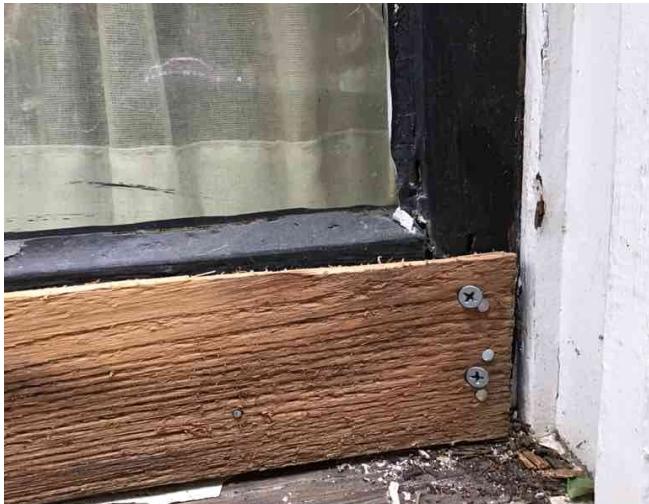
Photo 31

1O. FINDING: The window has been damaged by fungus at the front exterior. This damage appears to be minor. The contributing moisture source appears to be exposure to the weather. (See Photo 31)

RECOMMENDATION: Hollow out this area and fill the void with an appropriate wood filler. If damage is *Estimated Cost* found to extend into inaccessible areas a supplemental report with findings, recommendations and bids will be issued.

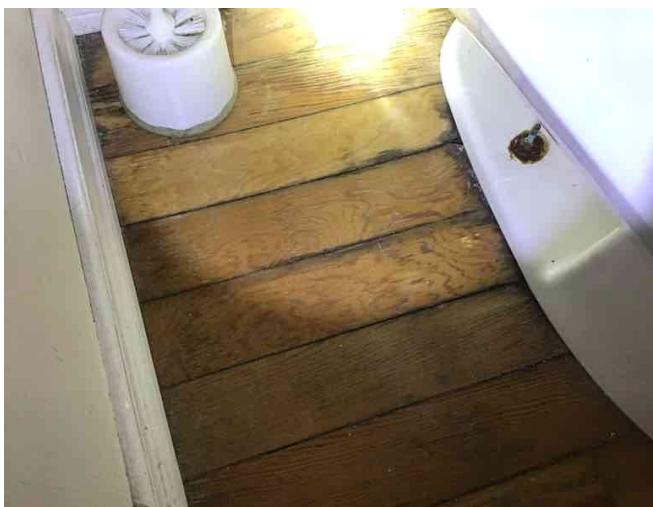
Photo 32

1W. FINDING: Water has gotten under the hardwood floor in the bathroom. This has caused fungus damage to the subfloor and hardwood floor. (See Photo 32)

RECOMMENDATION: Remove the toilet and remove the existing floor. Remove and replace the *Estimated Cost* damaged subfloor. Install new hardwood floor where removed. If damage is found to extend into inaccessible areas or additional contributing factors are found, a supplemental report will be issued with any findings, recommendations, and bids. We at HomeGuard Incorporated are upgrade experts and can provide proposals that include tile, marble, granite, upgraded fixtures, upgraded windows and doors or any other option you may desire.

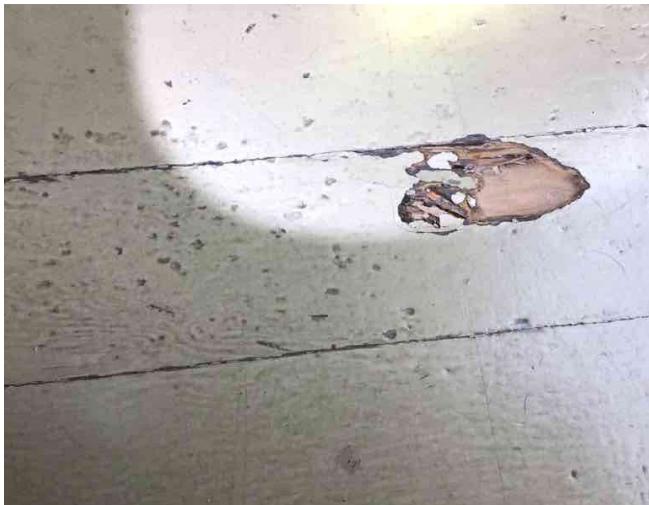
Photo 33

1P. FINDING: The hardwood flooring at the master bedroom adjacent to the French door has been damaged by drywood termites. Refer to item(s) 1S for recommendations to control contributing moisture source and or infestation (See Photo 33)

RECOMMENDATION: Remove and replace the damaged hardwood flooring. Our bid does not include *Estimated Cost* refinishing of the hardwood floor.

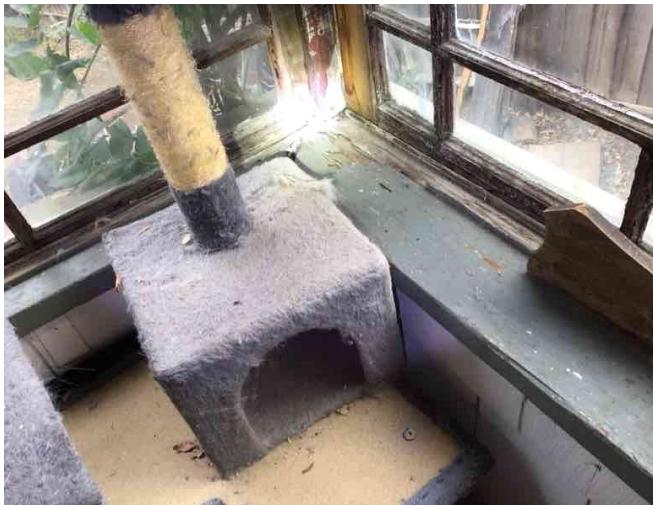
Photo 34

1Q. FINDING: The trim has been damaged by drywood termites at the interior sunroom as indicated on the diagram. Refer to item(s) 1S for recommendations to control contributing moisture source and or infestation. (See Photo 34)

RECOMMENDATION: Remove and replace all the damaged wood members. If any damage is found to *Estimated Cost* extend into any enclosed areas a supplemental report and bid will be issued.

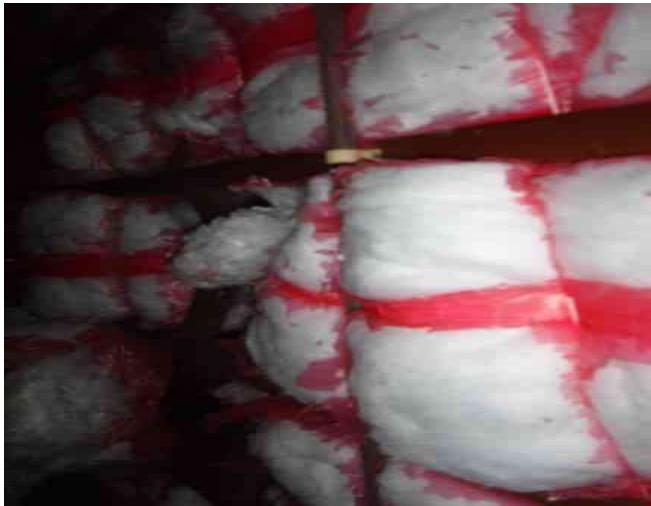
Photo 37

3D. FINDING: The subfloor was insulated; however, no outward infections or infestations were noted at this time. Further inspection is recommended. (See Photo 37)

RECOMMENDATION: Remove the insulation from the perimeter of the structure and at all water pipe *Estimated Cost* penetrations. Inspect the exposed wood members, and issue a supplemental report listing all findings, recommendations, and bids. Reinstall the insulation where removed upon completion.

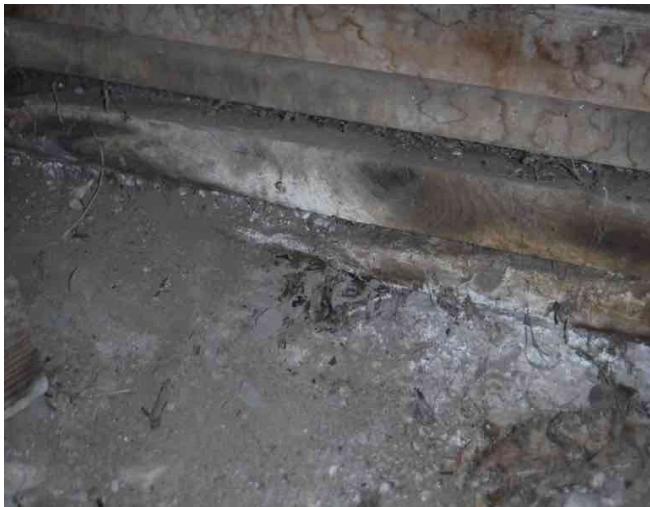
Photo 40

1R. FINDING: There is a plumbing leak at the front hall bathroom toilet and shower drain. This led to the damage outlined in item 1W. (See Photo 40) (See Photo 41)

RECOMMENDATION: The owner should have a licensed plumber repair the leakage. All guarantees *Estimated Cost* desired should be secured from the persons or firm that performed the repairs.

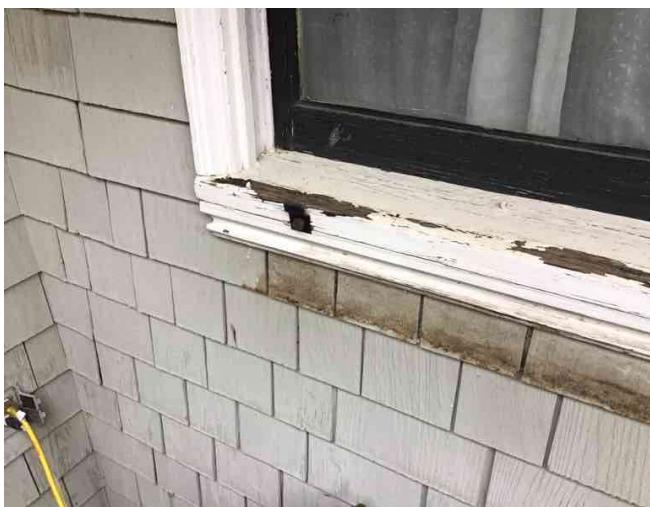
Photo 43

1B. FINDING: The window sill has been damaged by fungus at the front exterior window as indicated on the diagram. The contributing moisture source appears to be exposure to the weather. [\(See Photo 43\)](#)

RECOMMENDATION: Remove and replace all the damaged wood members. If any damage is found to *Estimated Cost* extend into any enclosed areas a supplemental report and bid will be issued.
