PROJECT SIDING REQUEST

TO: LOS GATOS HPC

RE: REQUEST TO REMOVE AND REPLACE SIDING

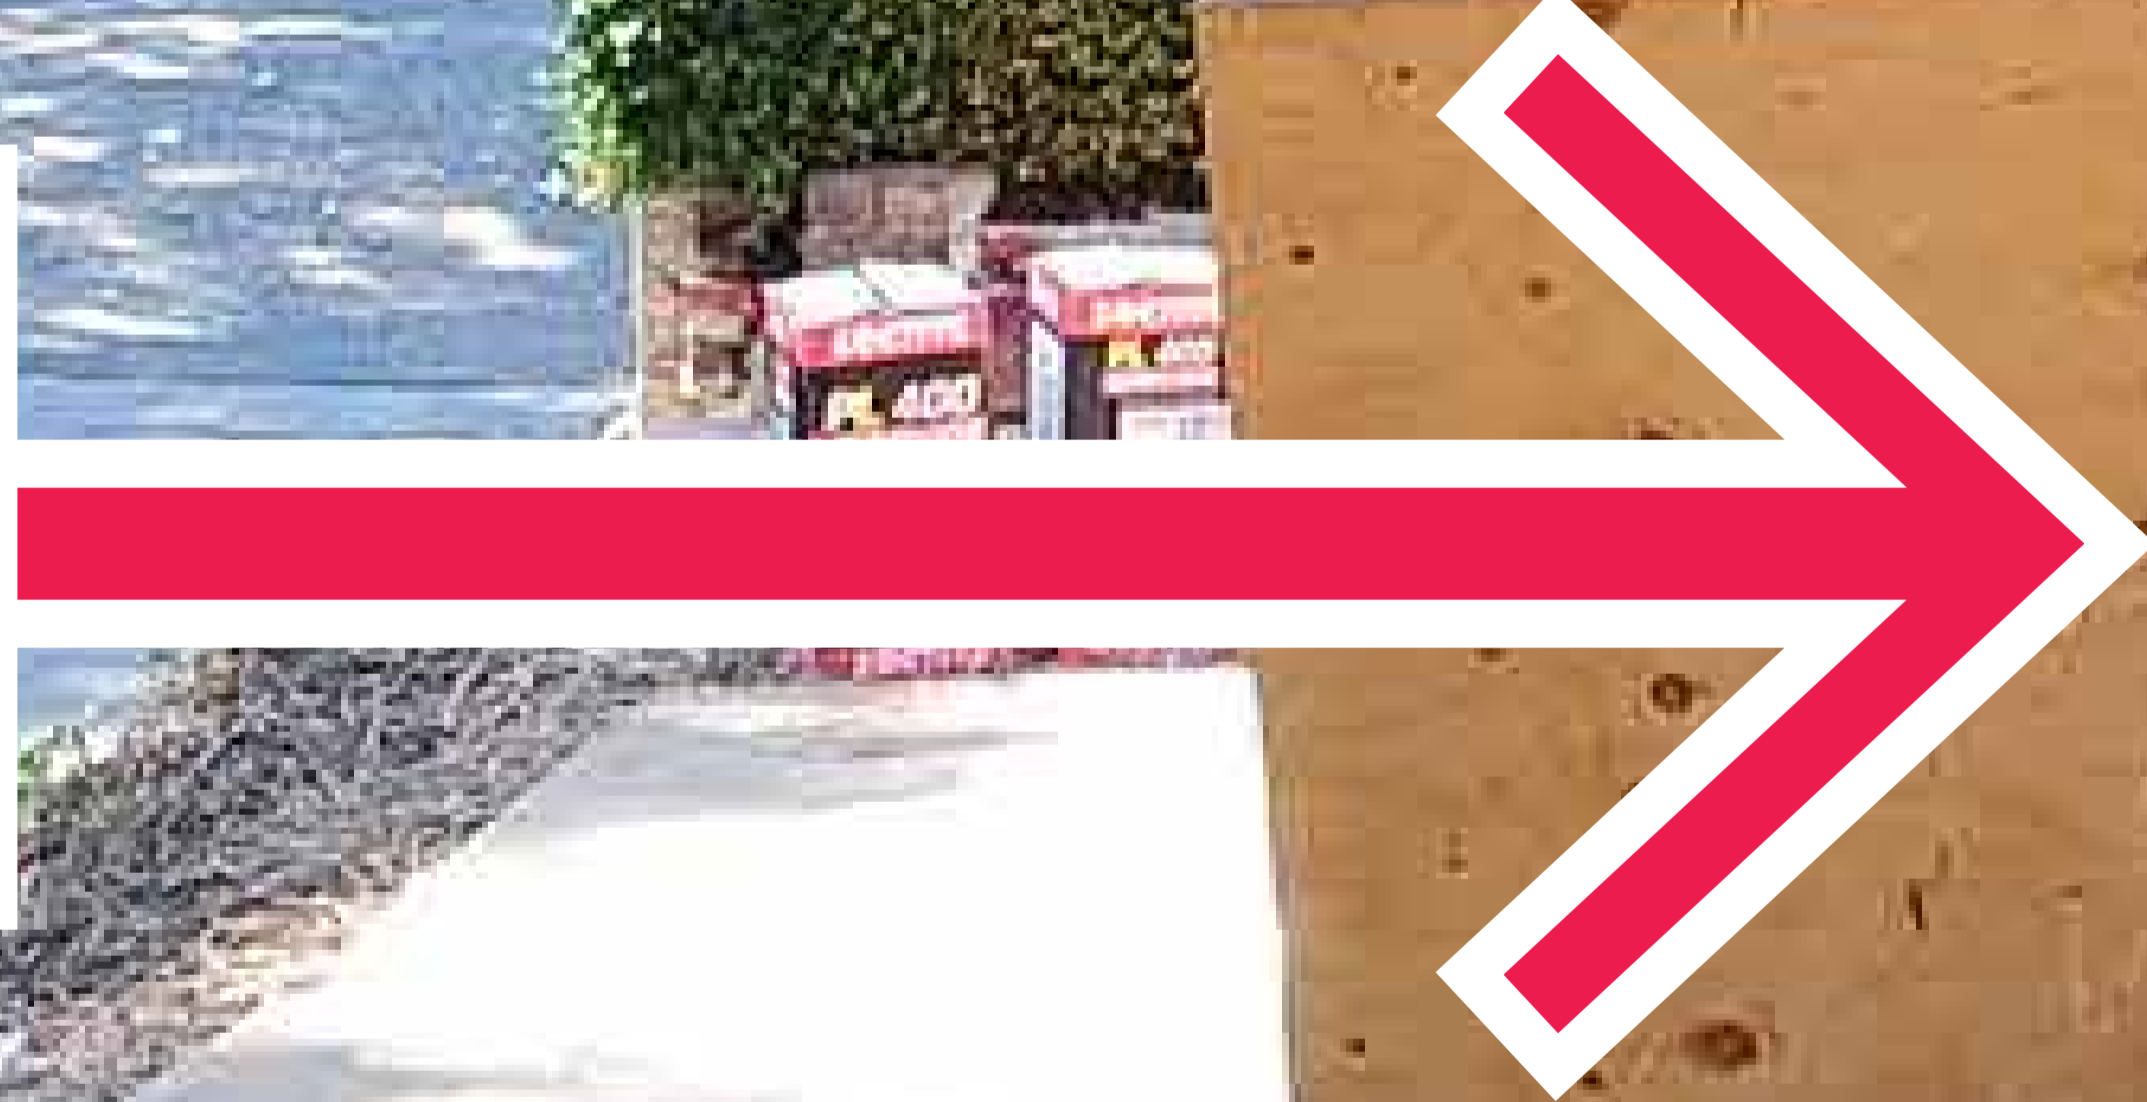
3

THE HOME'S EXISTING SIDING CONSISTS OF THREE DIFFERING PROFILES. REFER TO PHOTOS 1, 2, 3.

WE WOULD LIKE TO REPLACE THE EXISTING SIDING OF THE HOME WITH NEW SIDING TO MATCH THE PROFILE OF THE NEW SIDING TO BE APPLIED TO THE ADDITION.

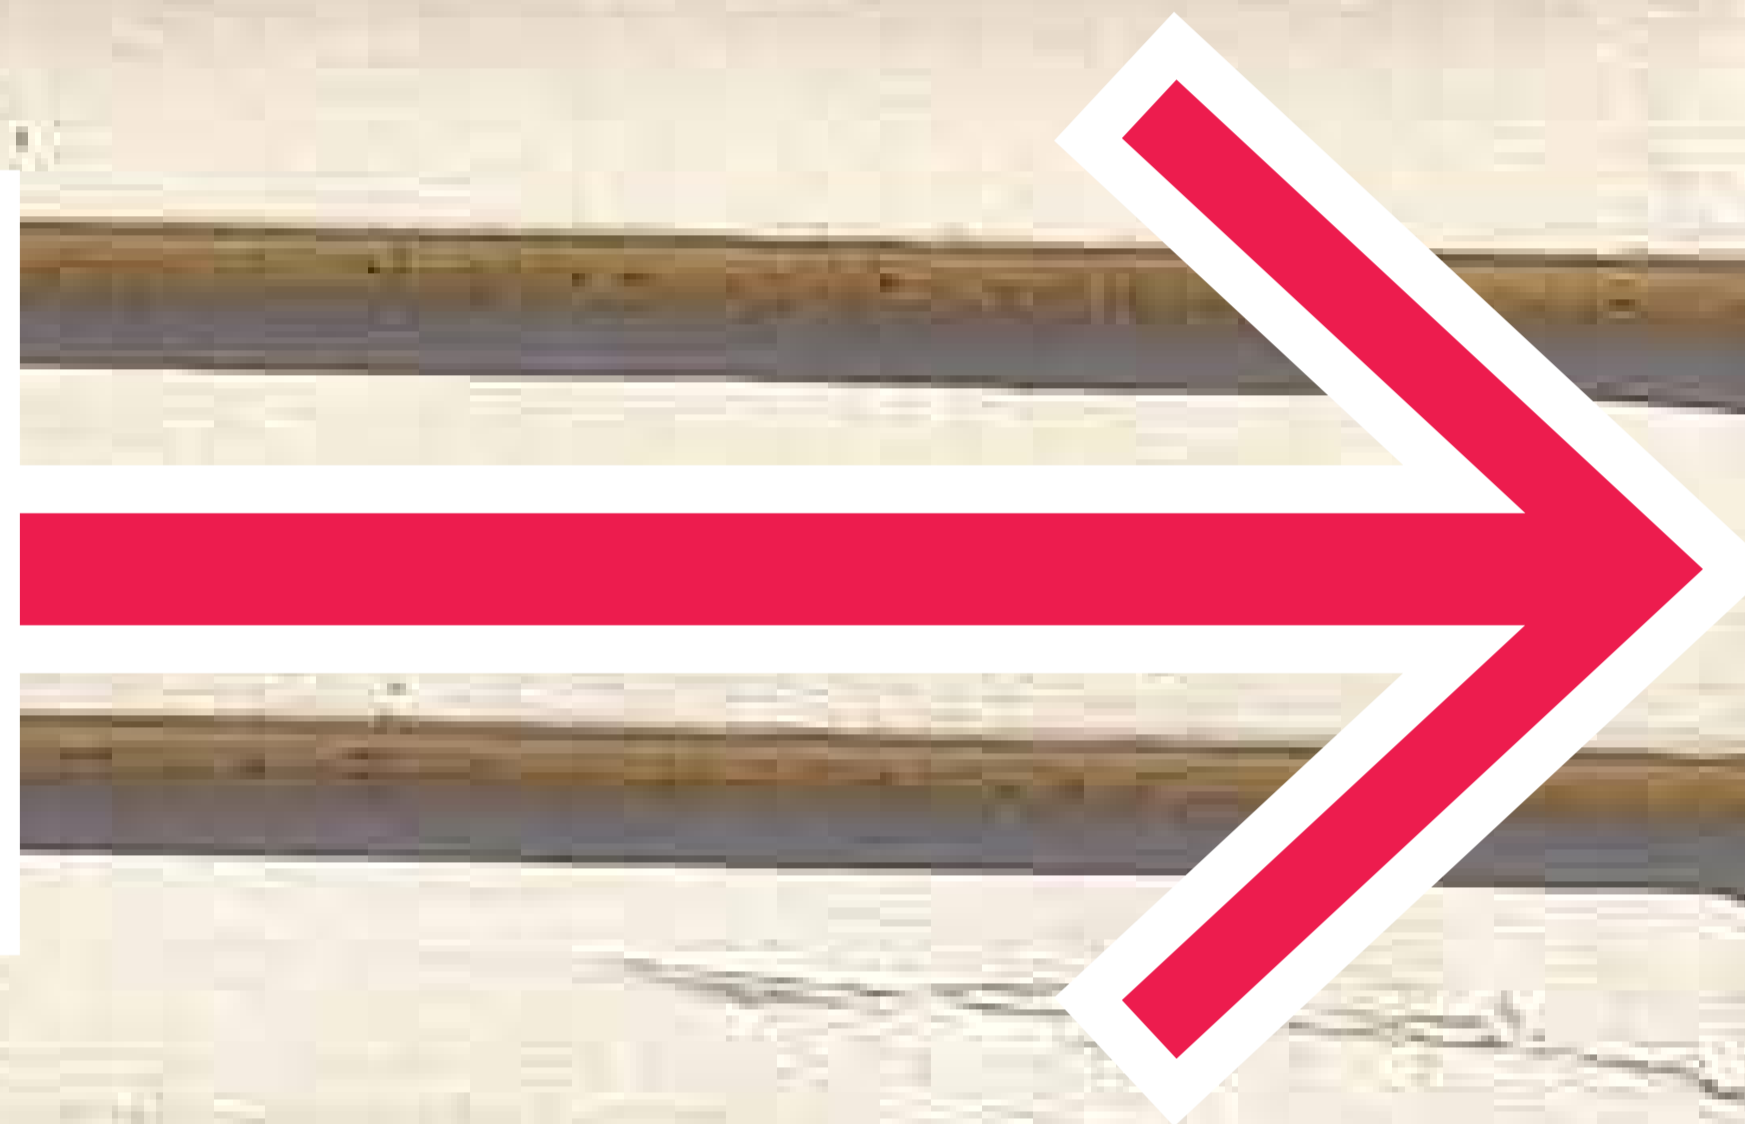
4

DURING PRIOR REMODELS, THE FRONT OF THE HOME HAS BEEN PATCHED WITH NON-MATCHING SIDING APPLIED WITHOUT CARE TO BLEND IT IN WITH EXISTING SIDING - REFER TO PHOTOS 4, 5, 6, 7.
