**Tree Inventory, Assessment,  
and  
Protection Report**

**16195 George Avenue, Los Gatos  
Los Gatos, CA 95032**

**Town of Los Gatos**

**August 9, 2021**

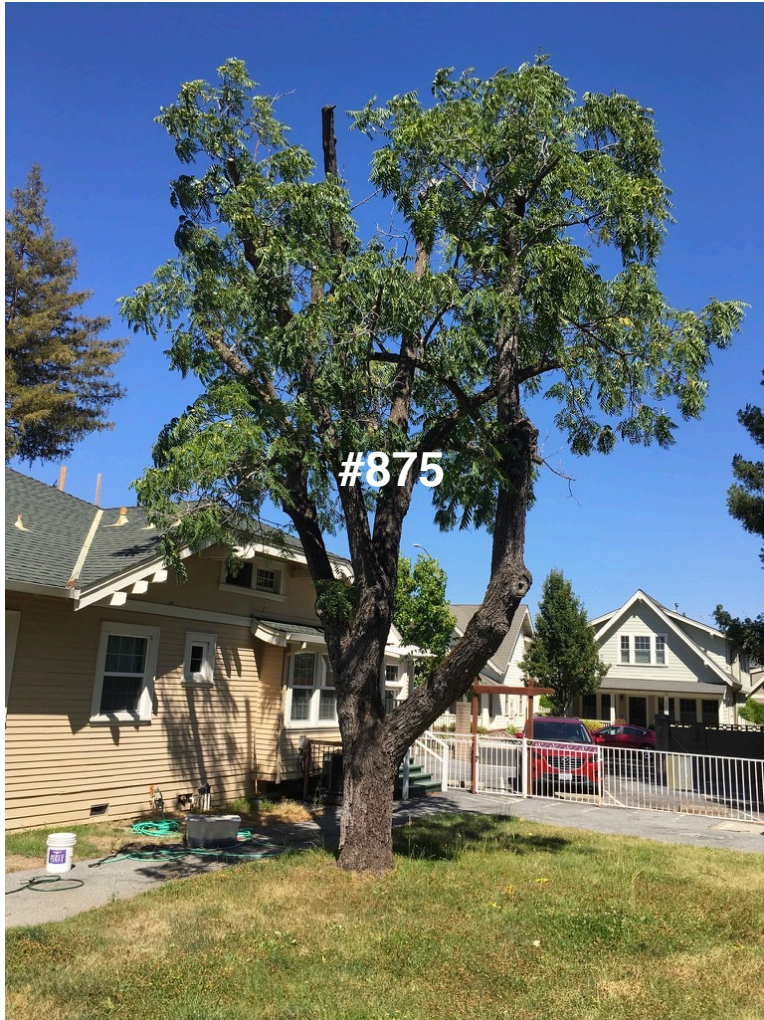
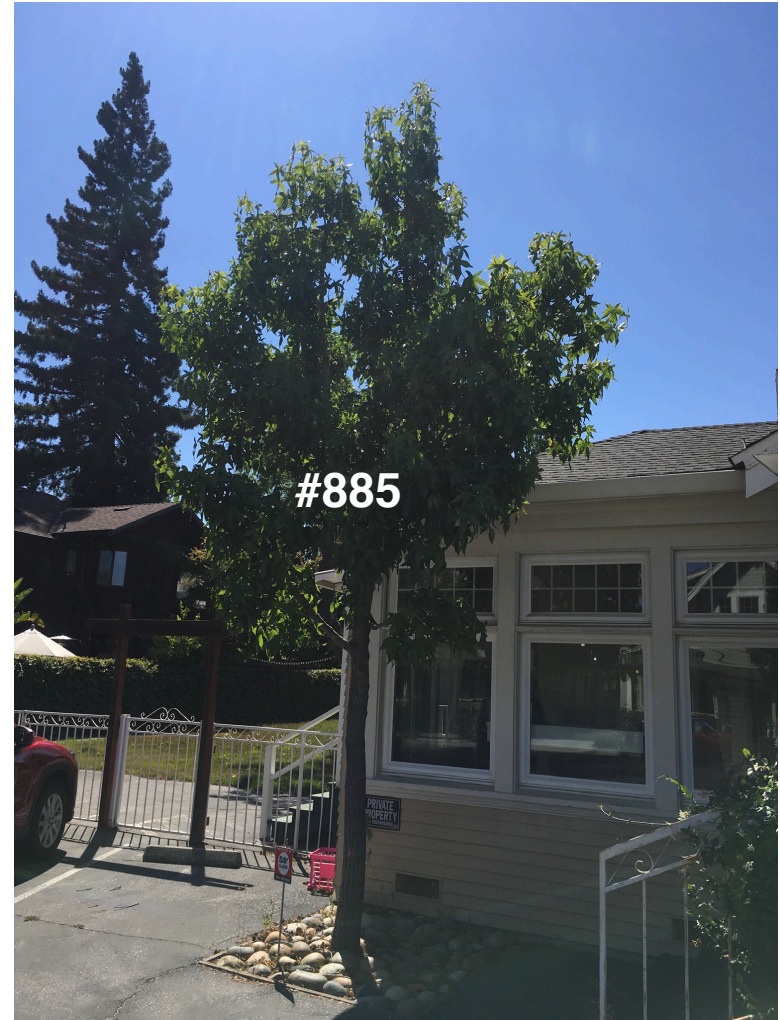
### C1: Black walnut #875 and sweetgum #885

Walnut #875 and sweetgum #885 are both poor condition. The mulberries are in fair shape and the two adjacent coast redwoods #884 and #886 are in good condition. The mulberries are all pollarded (type of pruning system that removes all annual growth to “knuckles”).

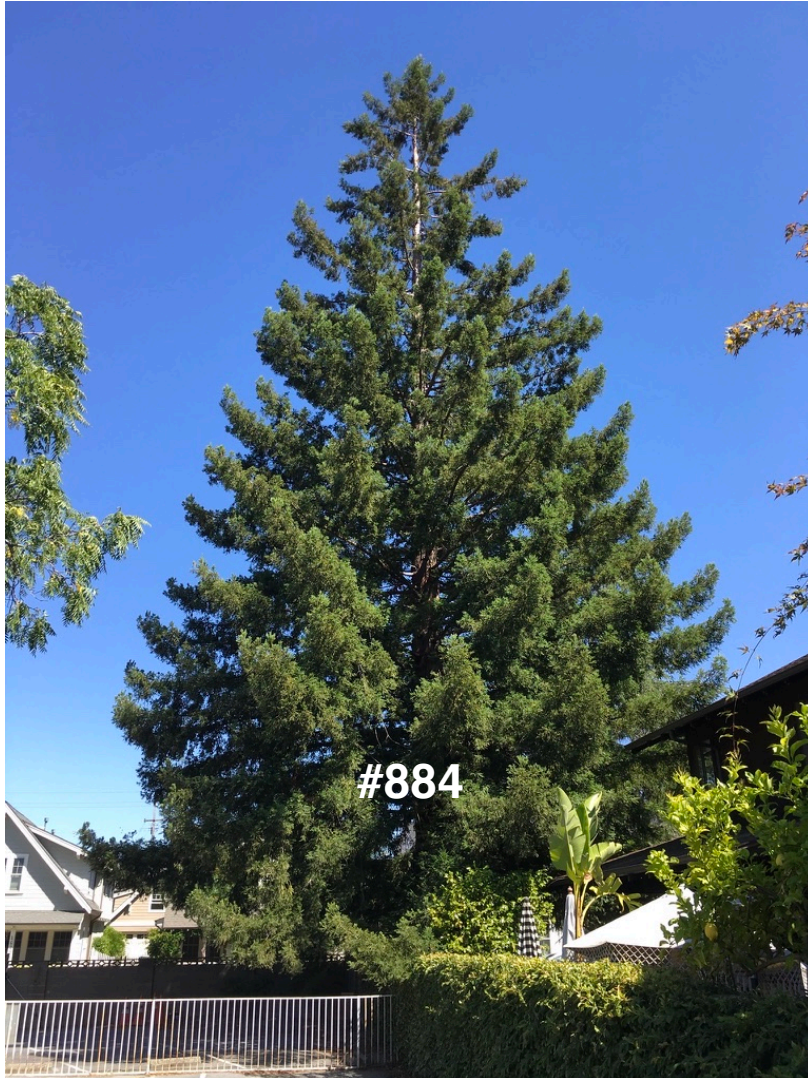
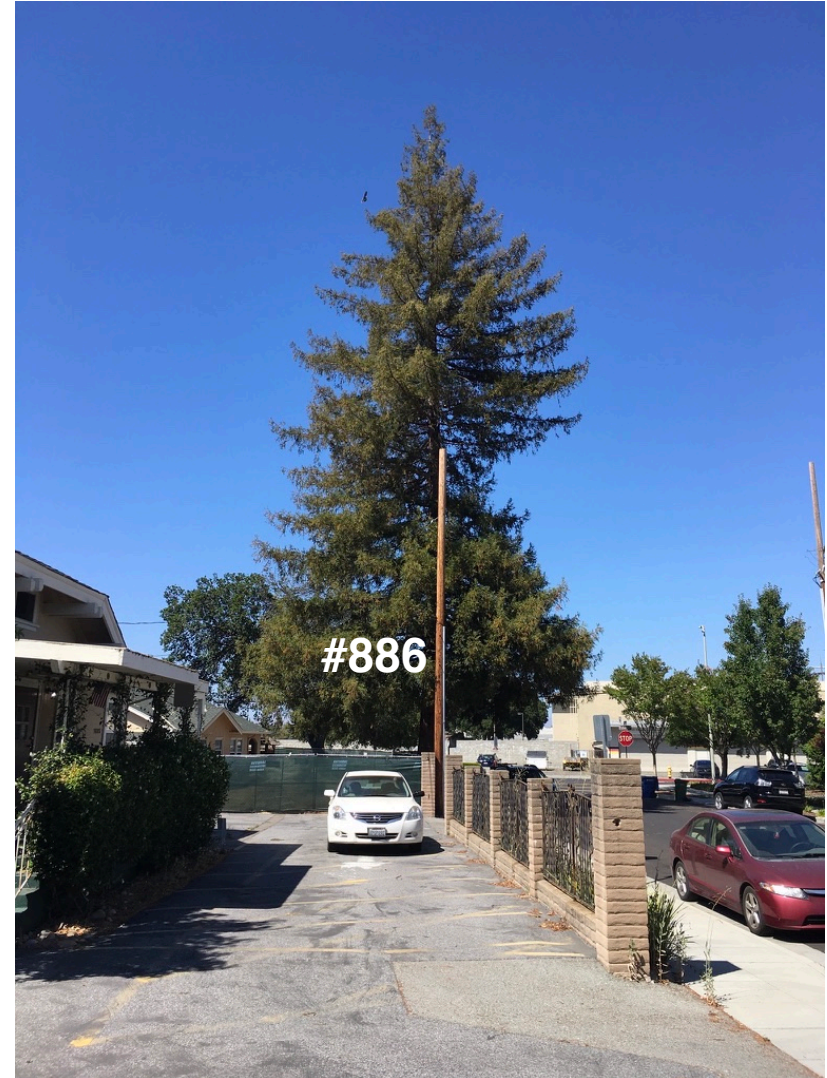
## C5: Coast redwood #884 and #886

Ten trees on the site are expected to be highly impacted and removed. Two trees, coast redwoods #884 and #886, originate on the adjacent site. The storm drain and connection near coast redwood #884 should be moved closer to the interior or plans revised to avoid the tree. The impact is moderate to high in this location around this particular tree. No other impacts are expected.

Tree protection will be focussed around adjacent coast redwood #884 and any associated grading or utilities nearby. The protection fence will need to be placed at the property boundary at a radius of 30 feet where possible. If not possible construction monitoring and bridging will be required for activity under the tree.

2. Place tree protection fence around #884 at a radius of 30 feet. Move the storm drain adjacent to the tree closer to the center of the property and avoid grading within 30 feet of the outer trunk. Install temporary irrigation or soaker hoses in all tree protection zones and provide supplemental watering during construction within all TPZ areas. Monitor watering times or amounts to ensure adequate soil saturation. (A 5/8" soaker hose requires about 200 minutes to deliver one inch of water to a garden. This number is affected by the length of the hose and the overall rate of flow from the faucet. A good rule of thumb is to expect about ½ GPM as a standard faucet flow rate.). Infrequent deeper watering is preferred.
