April 29, 2025

Re: Structural Condition Assessment
313 University Avenue
Los Altos, CA 94022
SEI Project No. 5794.00

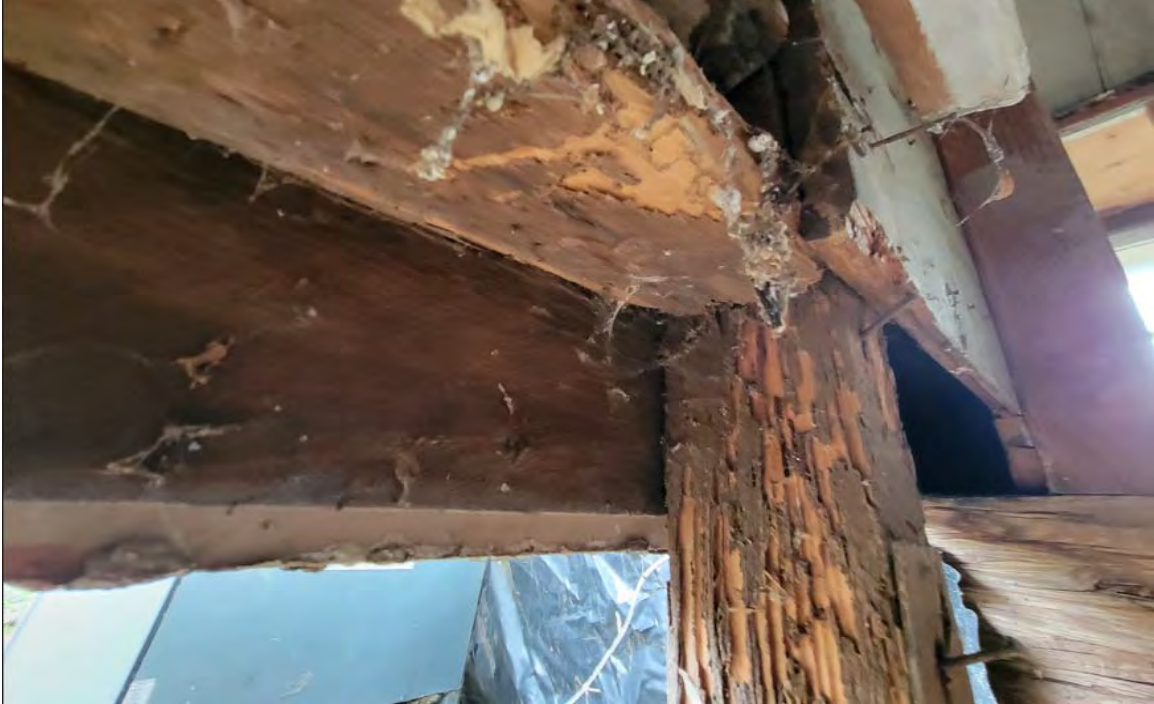
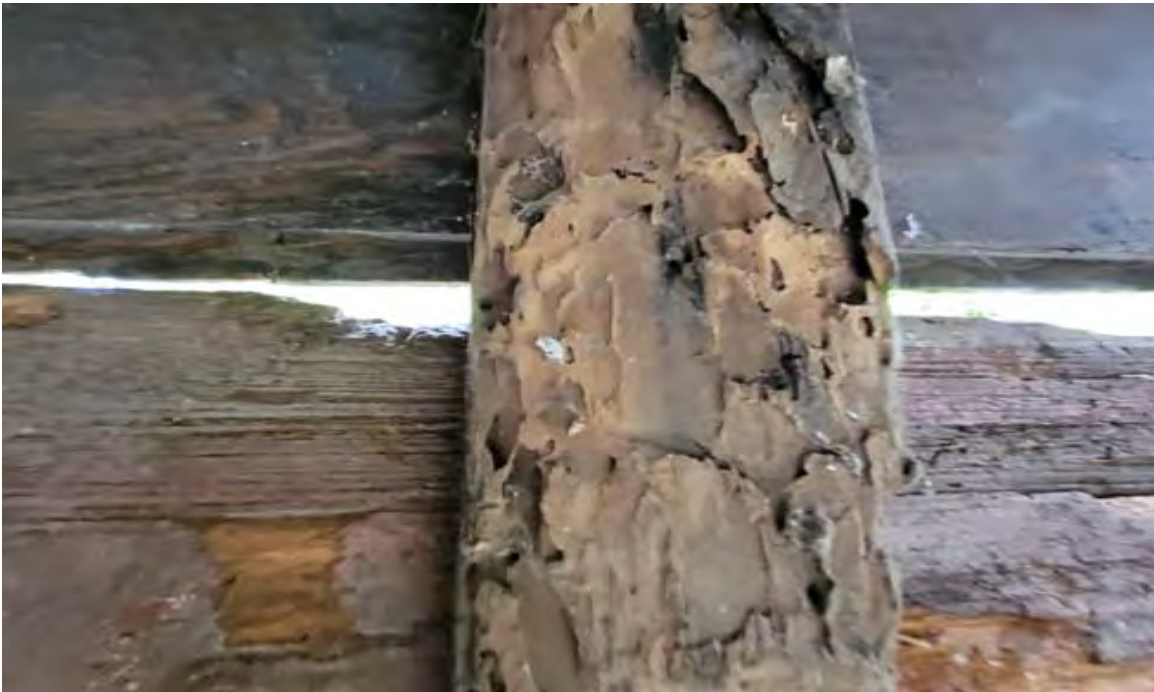
A close up evaluation of the existing framing reveals significant wood decay from both termite infestation as well as on going dry rot (fungal decay) occurring in much of the original perimeter stud framing and plank siding.

The building appears to be in significant disrepair with extensive decay, water damage and framing deficiencies. The current shoring is unstable and in eminent danger of collapse at the soil interface. We would expect that the cost to properly repair this structure would likely exceed the cost of replacement. In our opinion, the structure in its current state, poses an immediate life safety risk should someone enter the interior or stand too close to the perimeter of the excavation. We recommend that warning signs be posted immediately and that the structure be completely demolished as soon as is feasible.

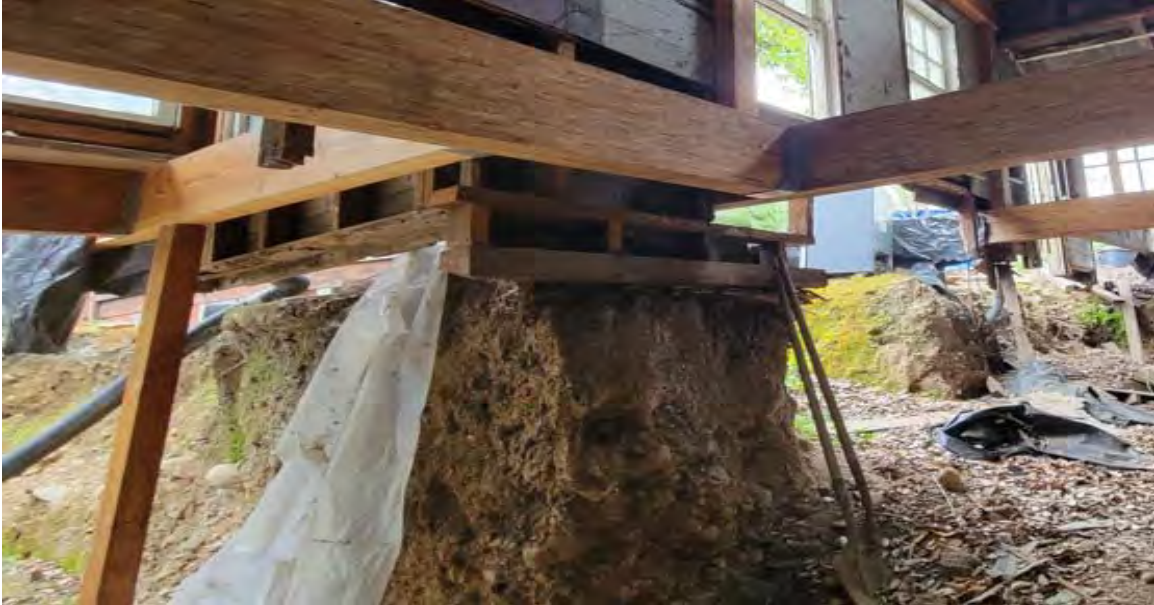
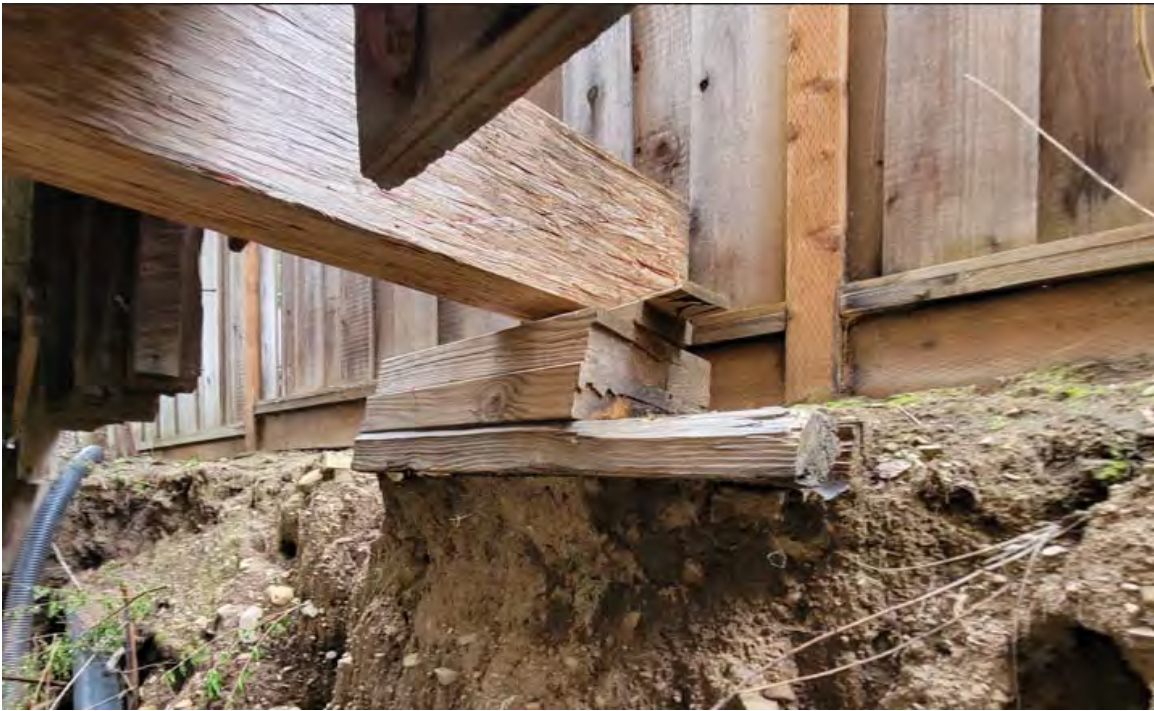
The slopping roof joists and ridge board are undersized and sagging. Proper ceiling/collar ties are not present in the construction. As expected, this has resulted in outward bowing of the exterior walls along the main plate line over time.

The observed shoring has been eroded with no mechanical anchorage.
