Arborist Report Update

**Los Gatos Meadows
Los Gatos, CA**

October 12, 2020

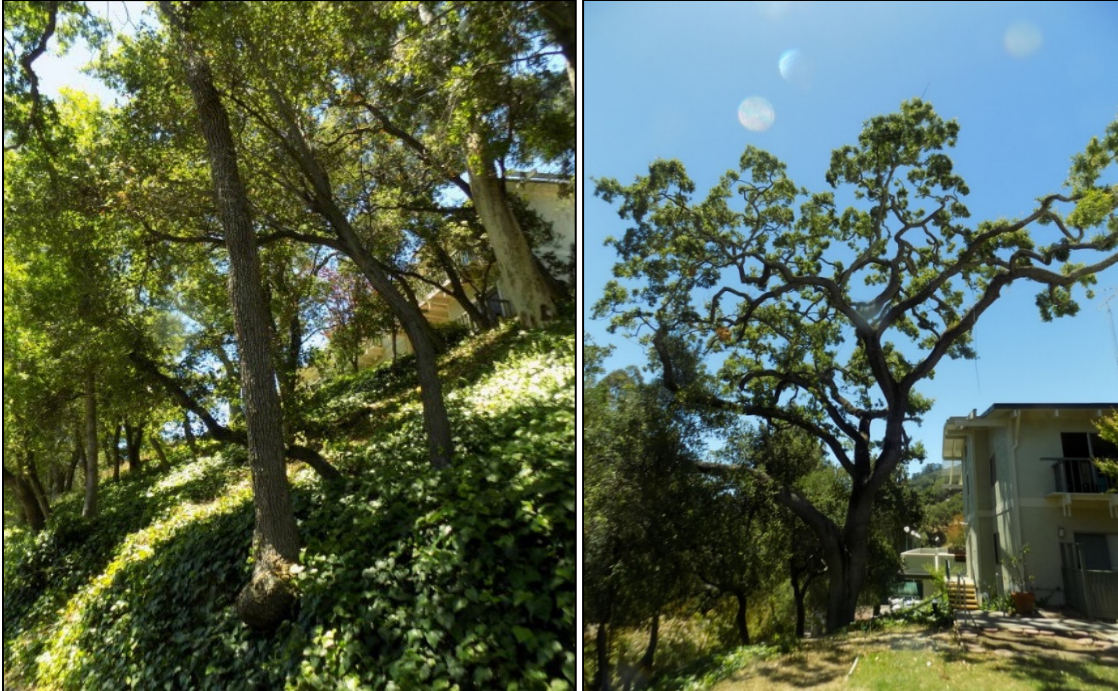
The most common species was California bay (89 trees, 24% of population). The bays were in fair (46 trees) to poor (38 trees) condition with five trees in good condition. They varied in development from young (4" trunk diameter) to mature (22, 12" trunk diameter). Twenty-eight (28) California bays had multiple trunks (31%). The single stem trees had an average trunk diameter of 9". The bays were generally growing in dense stands with oaks in undeveloped natural areas (Photo 1).

Twelve (12) blue gum eucalyptus trees were assessed (3% of population). The blue gums were in poor (7 trees) to fair (5 trees) condition with no trees in good condition. They were the largest trees assessed with an average trunk diameter of 44". Blue gum #62 was the largest tree assessed with a trunk diameter of 62". Blue gums #7-12 had been harshly topped with poorly attached regrowth (Photo 3).

Eleven (11) Hollywood junipers were assessed (3% of population). The junipers were in fair condition (9 trees) with two trees in good condition and no trees in poor condition. The junipers had their typical chaotic, bushy form. They were planted in a narrow location high above the walkway providing minimal benefits to the landscape (Photo 4).

Photo 1 (upper left) – California bays and native oaks were the dominant species especially across the natural areas within the site.

Photo 2 (upper right) – Valley oak #250 was declining and had been over-pruned. Two of the six cables in the tree had broken.

Photo 3 (lower left) – Blue gums #7-12 had been topped with poorly attached regrowth.

Photo 4 (lower right) – The Hollywood junipers (#197 shown) were growing in raised planter beds next to covered sidewalks.

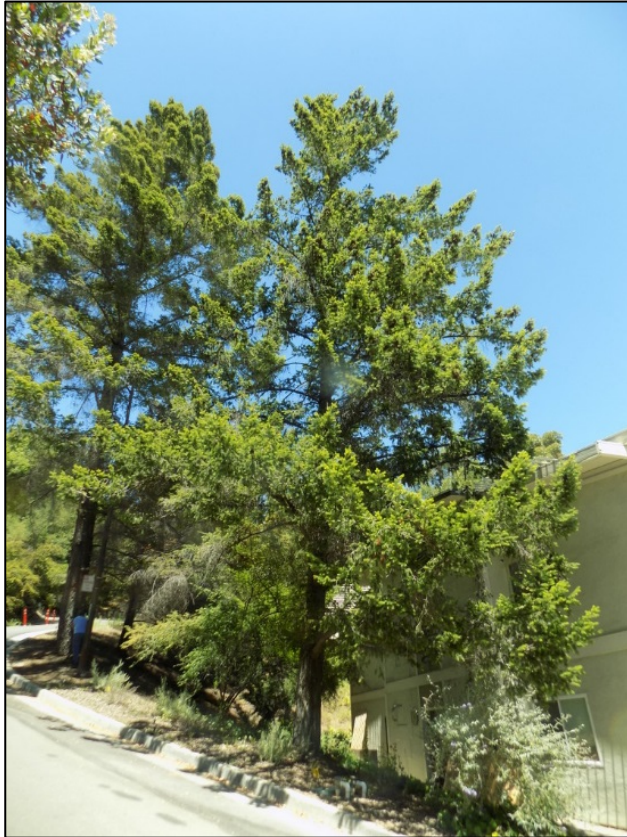
- Douglas firs #147-153 had an 18" average trunk diameter and were growing on the southern edge of the property (Photo 5).
- Four sawleaf zelkovas were growing in the central courtyard and were declining in health.
- Sugar gums #309 and 310 were mature trees in decline with large trunk wounds.
- White willow #288 was a large mature single-stemmed tree in good condition growing in the courtyard.
- Bailey acacia seed production was impressive along the northern property boundary (Photo 6).

Photo 5 – Douglas firs #147 and 148 were growing near the southern boundary of the site.

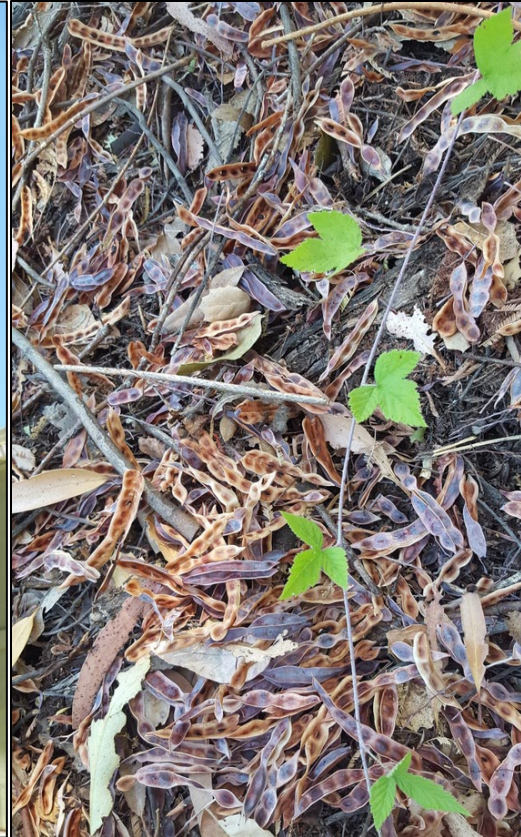
Photo 6 – Bailey acacias #366-370 were growing near the northern boundary of the property and produced an extreme amount of seed.
