**Tree Inventory, Assessment,
and
Protection Report**

**17020 Los Cerritos Drive
Los Gatos, CA 95032**

April 29, 2024

Monarch Consulting Arborists

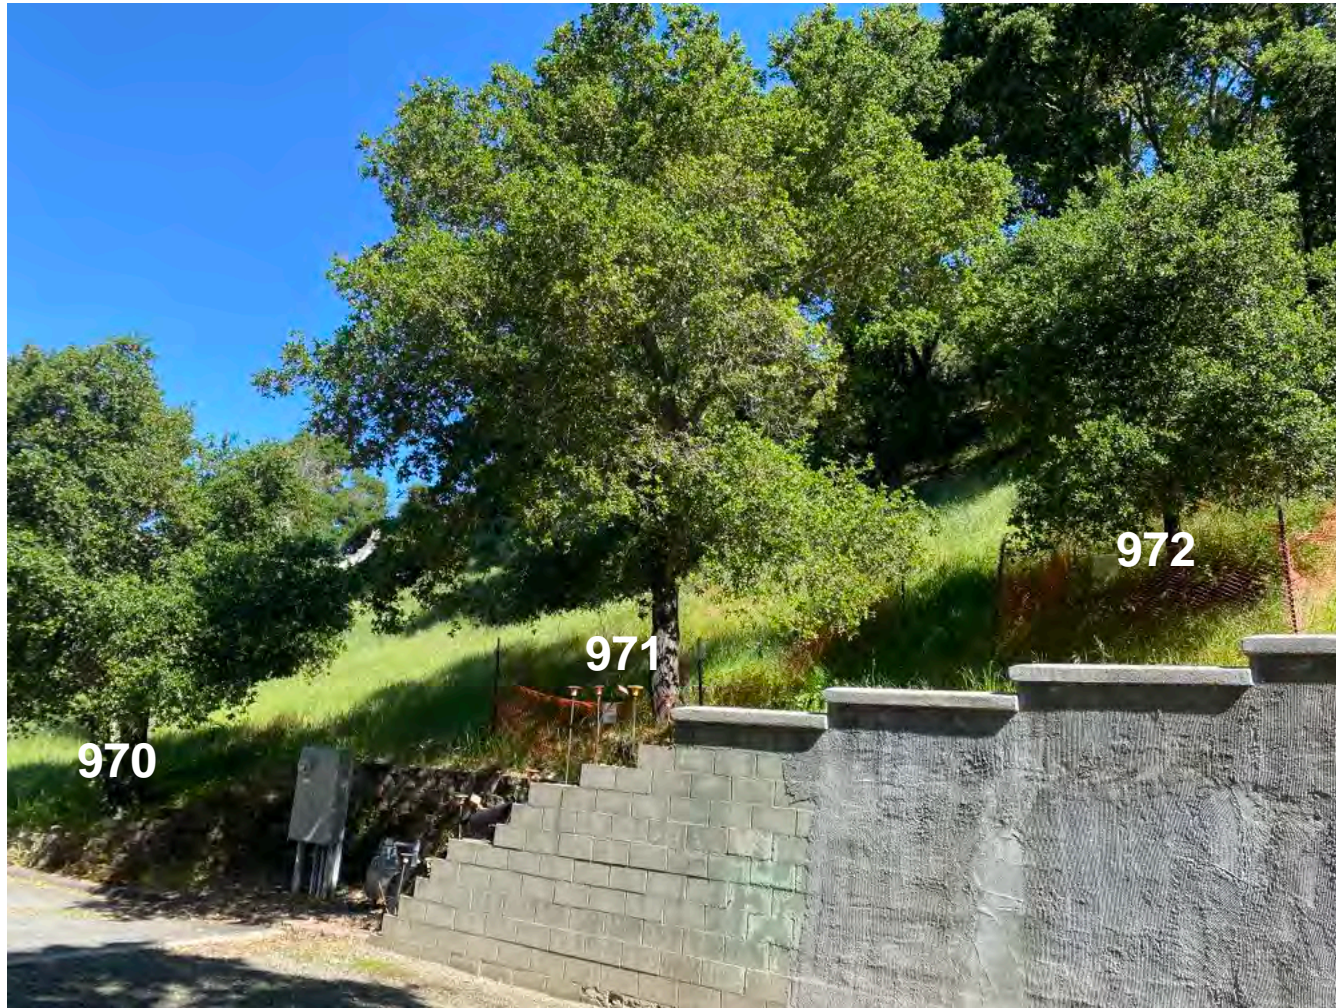
C1: Trees #970, #971, #972

Tree Species	I.D. #	Trunk Diameter (in.)	~ Canopy Diameter (ft.)	Condition	Expected Impact	Protection Status	Rounded Depreciated Value	Calculated Protection Radii (ft.)
coast live oak (<i>Quercus agrifolia</i>)	970	13, 11	15	Fair	Low	Large Protected	\$2,880.00	11
coast live oak (<i>Quercus agrifolia</i>)	971	15	20	Good	Low	Protected	\$3,130.00	10
coast live oak (<i>Quercus agrifolia</i>)	972	7	15	Good	Low	Protected	\$680.00	5
coast live oak (<i>Quercus agrifolia</i>)	973	32	30	Good	Low	Large Protected	\$14,300.00	21
coast live oak (<i>Quercus agrifolia</i>)	974	17	30	Good	Low	Protected	\$4,020.00	11
toyon (<i>Heteromeles arbutifolia</i>)	975	4	15	Fair	Low	Protected	\$290.00	3
coast live oak (<i>Quercus agrifolia</i>)	976	19	20	Fair	Low	Protected	\$3,590.00	13
coast live oak (<i>Quercus agrifolia</i>)	977	17	20	Fair	Low	Protected	\$2,870.00	11
Japanese maple (<i>Acer palmatum</i>)	978	5	10	Good	Low	Protected	\$590.00	3

1. Place tree numbers on all the plans including the Grading and Drainage plans..
2. Place tree protection fence around the four groups of trees as indicated in Appendix A group 1 #971 and #972, group 2 973, #974, 975, group 3 #982, #983, #984, and group 4 #980 and #981.

3. Protect the trunks of trees #970, #976, and #977 as indicated in Appendix D2.
4. All tree maintenance and care shall be performed by a qualified arborist with a C-61/D-49 California Contractors License. Tree maintenance and care shall be specified in writing according to American National Standard for Tree Care Operations: *Tree, Shrub and Other Woody Plant Management: Standard Practices* parts 1 through 10 and adhere to ANSI Z133.1 safety standards and local regulations. All maintenance is to be performed according to ISA Best Management Practices.

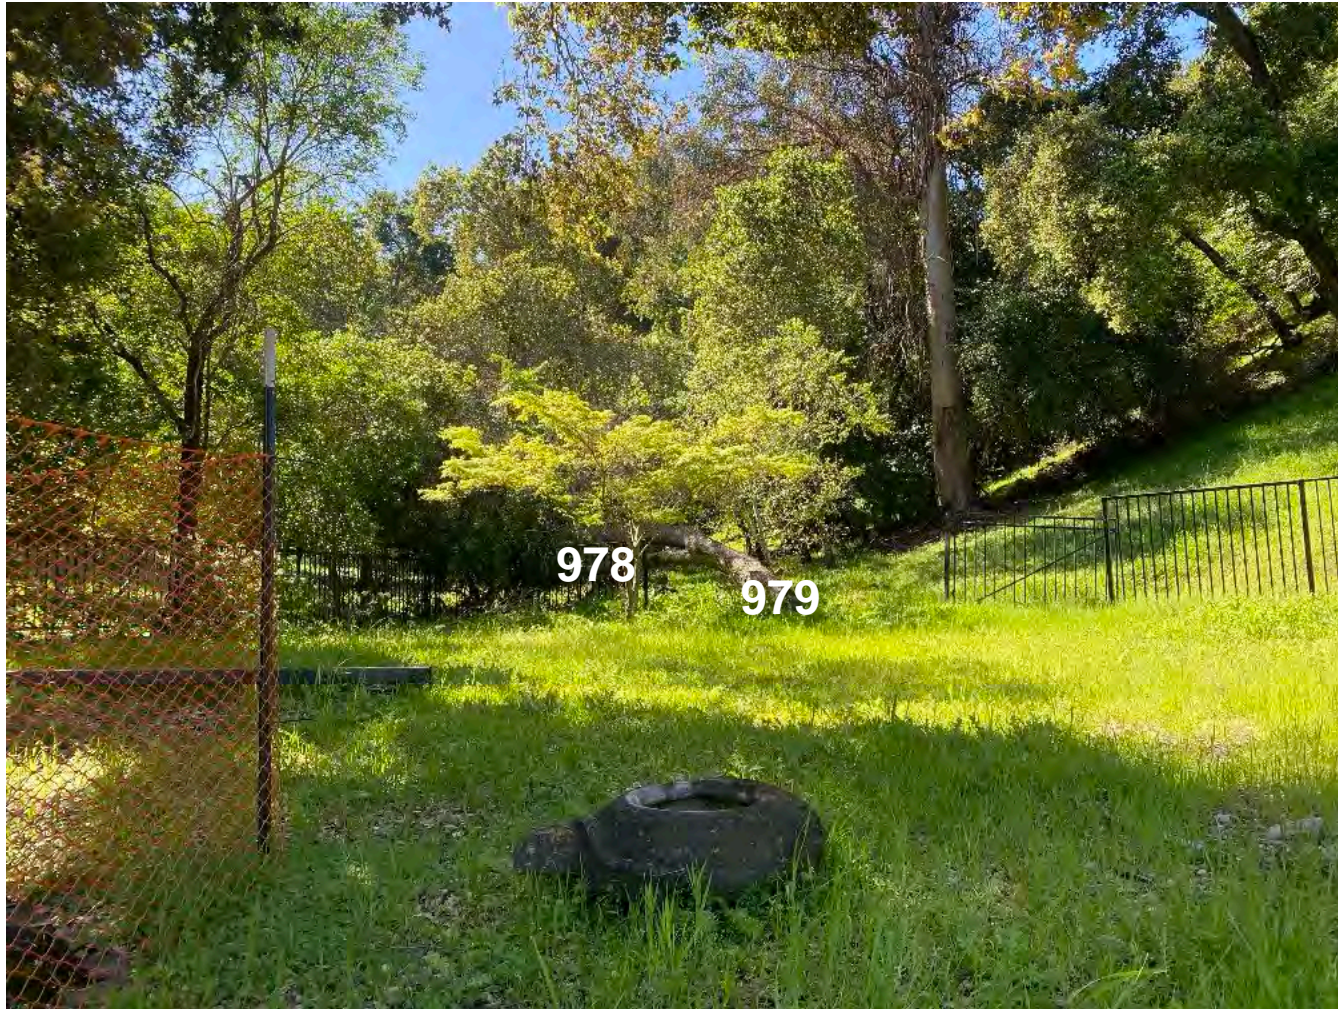
C4: Trees #978 and #979

Nine trees are in good condition, five fair, and one coast live oak is in very poor shape (#979 has failed and destroyed the fence) (Chart 2).

coast live oak (<i>Quercus agrifolia</i>)	979	18	15	Very poor	Low	Protected	\$970.00	12
Japanese maple (<i>Acer palmatum</i> 'Bloodgood')	980	Multi 4	15	Good	Low	Protected	\$1,110.00	6
Japanese maple (<i>Acer palmatum</i>)	981	Multi 4	15	Good	Low	Protected	\$1,890.00	6

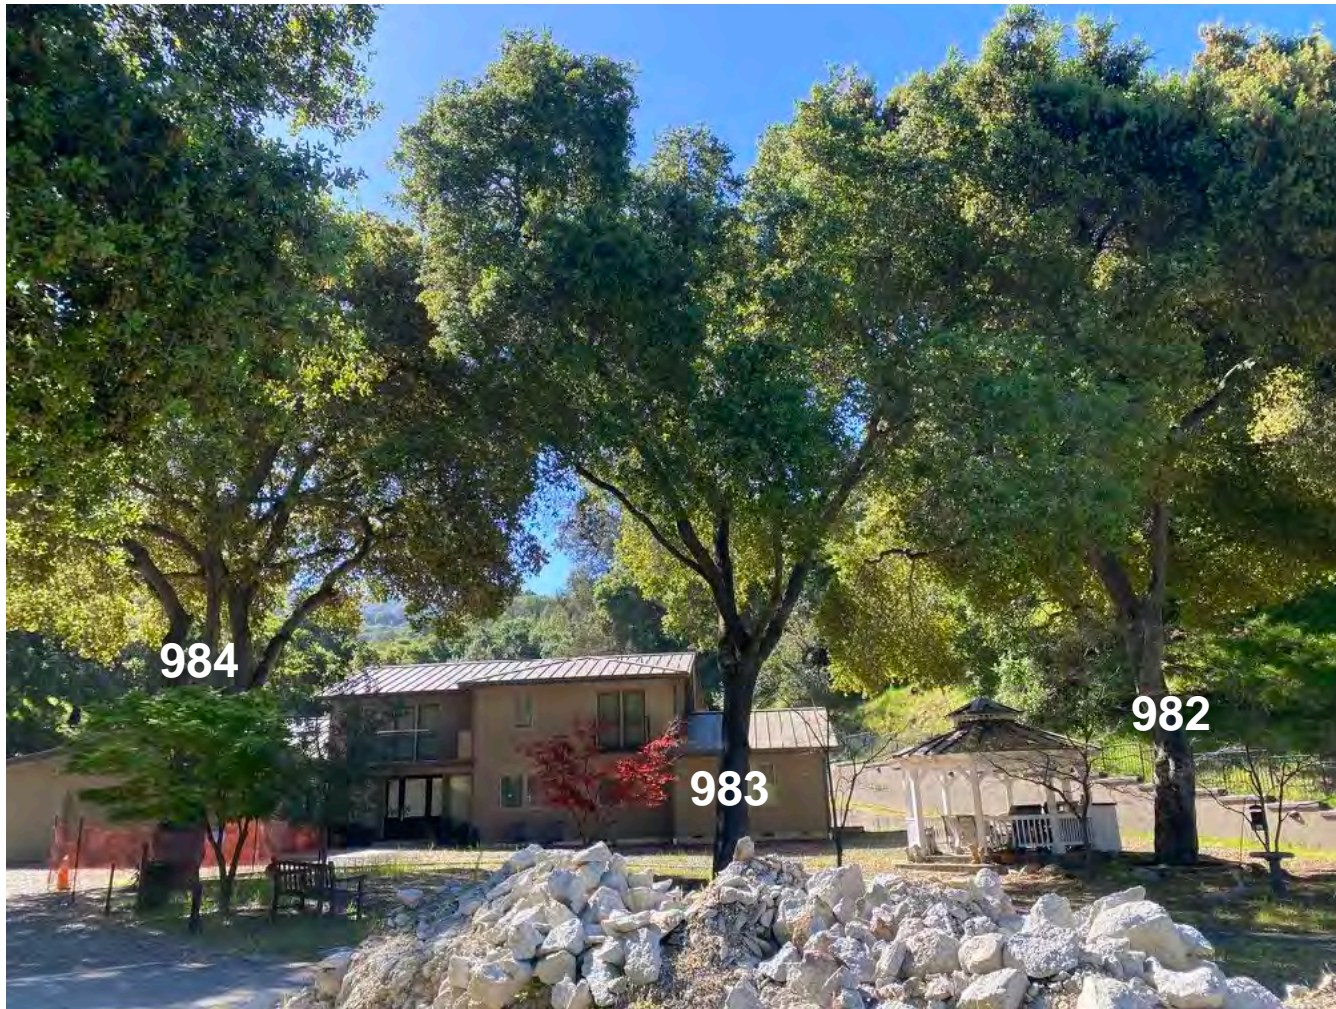
C6: Trees #982, #983, and #984

Tree Species	I.D. #	Trunk Diameter (in.)	~ Canopy Diameter (ft.)	Condition	Expected Impact	Protection Status	Rounded Depreciated Value	Calculated Protection Radii (ft.)
coast live oak (<i>Quercus agrifolia</i>)	982	40	40	Fair	Low	Large Protected	\$15,900.00	27
coast live oak (<i>Quercus agrifolia</i>)	983	36	40	Good	Low	Large Protected	\$18,000.00	24
coast live oak (<i>Quercus agrifolia</i>)	984	40	40	Good	Low	Large Protected	\$22,300.00	27
