Arborist Report

North 40 Phase II Los Gatos, CA

August 2023

Updated September 27, 2024

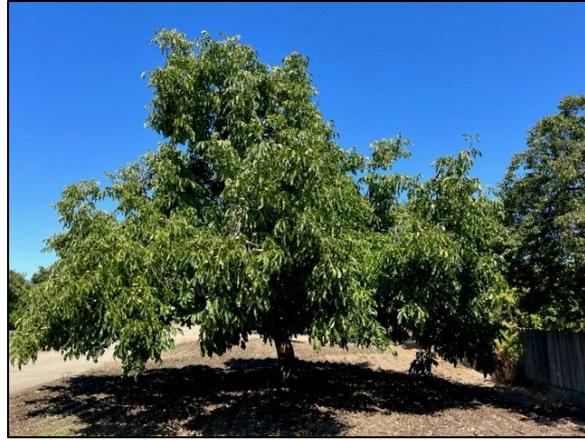
Photo 1. English walnut #345 had a typical orchard-pruned shape.

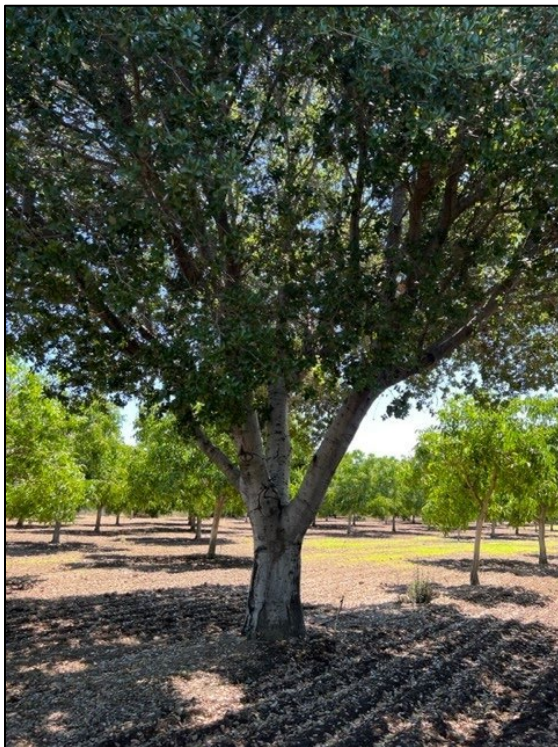
Photo 2. Coast live oak #380 was growing on the northeast side of the house in the orchard had good structure and form.

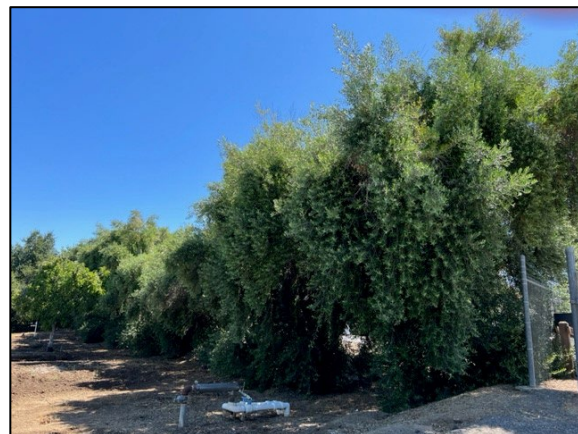
Photo 3. Olives #311 – 317 were growing behind the fence and sidewalk along Los Gatos Blvd.

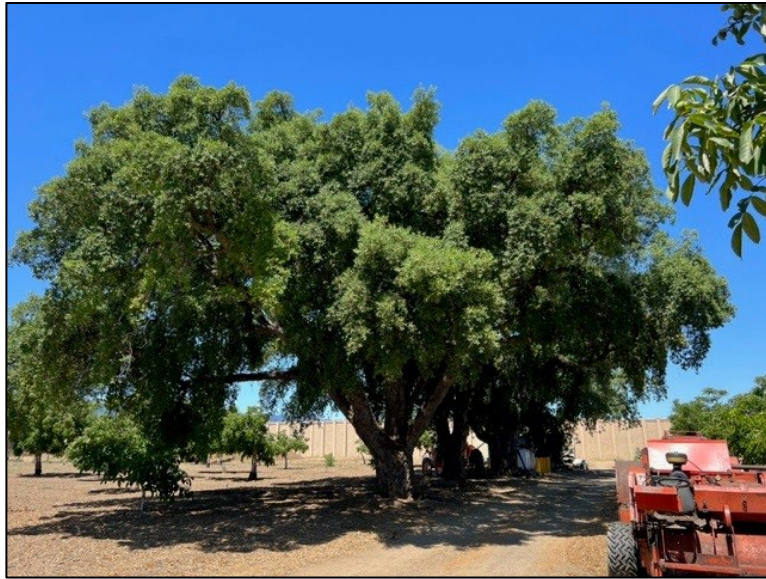
Photo 4. Cork oaks #394 – 398 were growing in a row on the west side of the property.

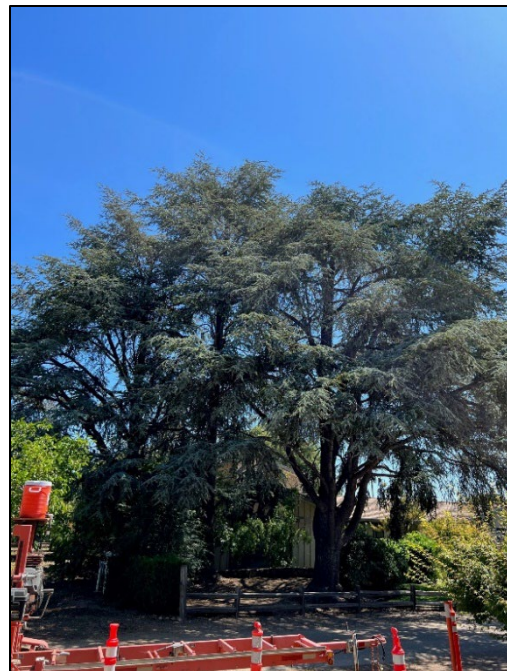
Photo 5. Atlas cedars #370 – 372 were in fair condition in front of the primary residence.

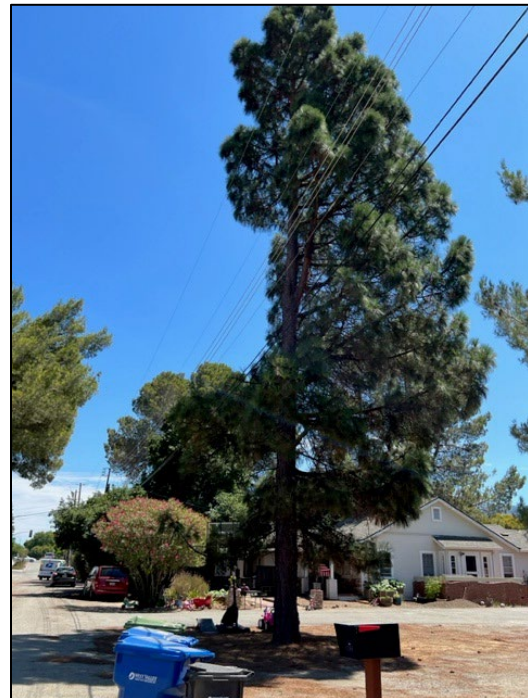
Photo 6. Canary Island pine #264 was one-side to the south due to power line pruning.

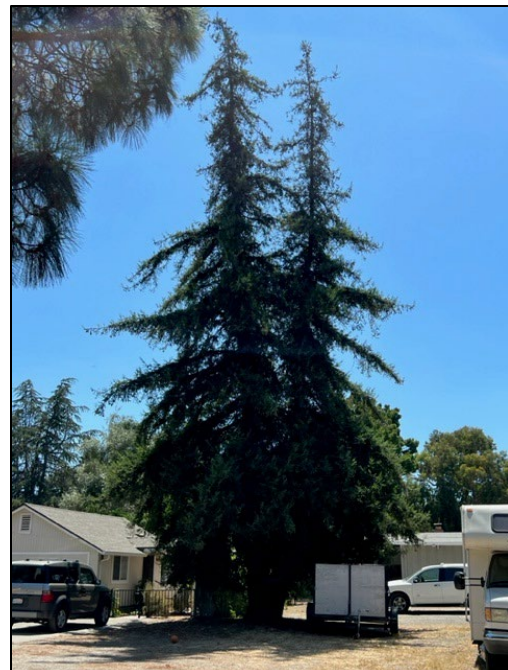
Photo 7. Coast redwood #270 had a codominant trunk at 3 feet and was in fair condition.

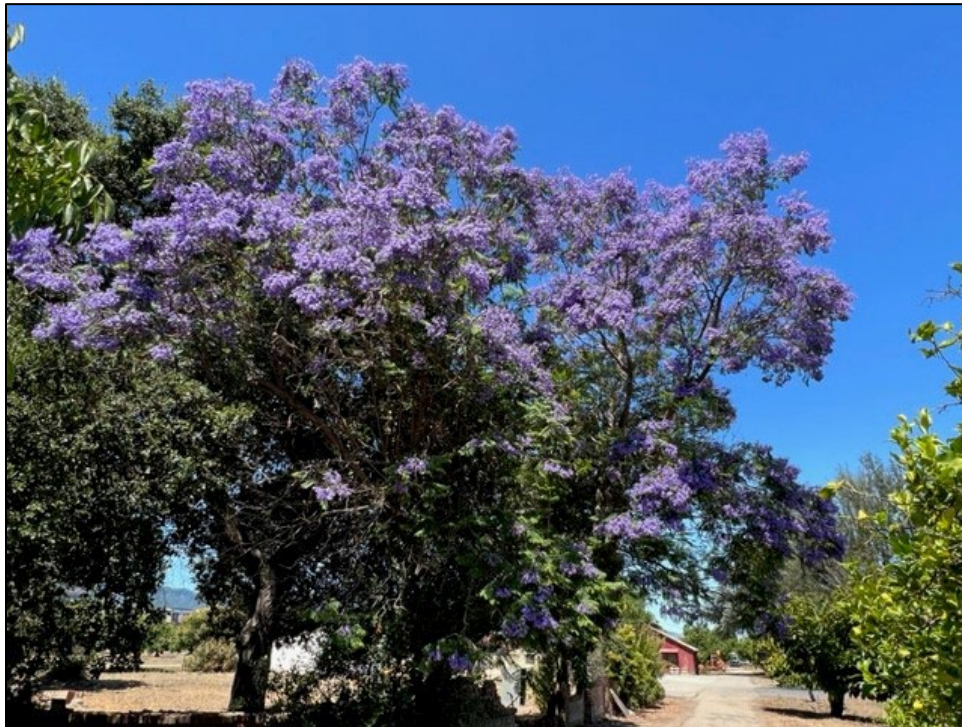
- Jacaranda #338 was in full flower with a codominant trunk at 3 feet with a full crown of epicormic sprouts due to having been previously topped (Photo 8). The tree was in fair condition and leaned heavily to the north. Jacaranda #382 had been previously topped and was in poor condition.

Photo 8. Jacaranda #338 was in full bloom and had poor structure due to being previously topped.

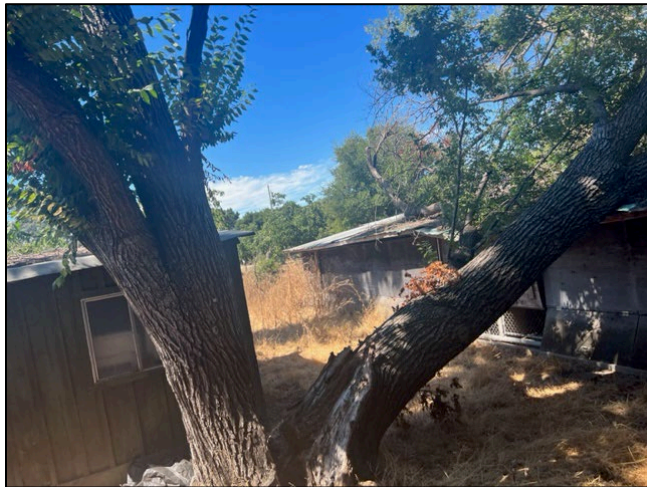
- Siberian elm #277 was in the back of 16270 Burton Road with a split codominant main stem and half of the tree was resting on the dog kennel (Photo 9). This tree was in poor condition.

Photo 9. Siberian elm #277 was storm damaged and the main trunk was split at the base.

- **Structural integrity**
Trees with significant amounts of wood decay and other structural defects that cannot be corrected are likely to fail. Such trees should not be preserved in areas where damage to people or property is likely. Siberian elm #277 was split at the base and half the tree was on the roof of an outbuilding. This tree is not structurally sound.

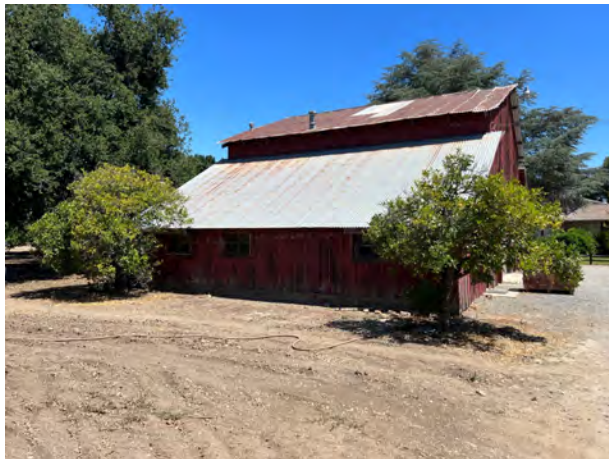
(22) Limes #352 & 353

- Limes #352 and 353 were located on the east side of the barn. They had small crowns with multiple attachments at the base. Both trees were in poor condition.

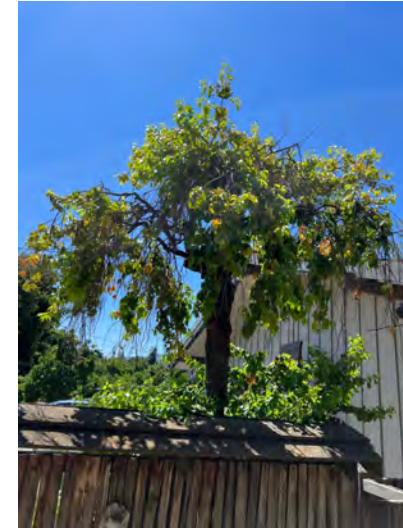
(33) Hollyleaf Cherry #386

- Hollyleaf cherry #386 was growing beside the primary residence with poor structure and form. It was previously topped due to site constraints and was in poor condition.

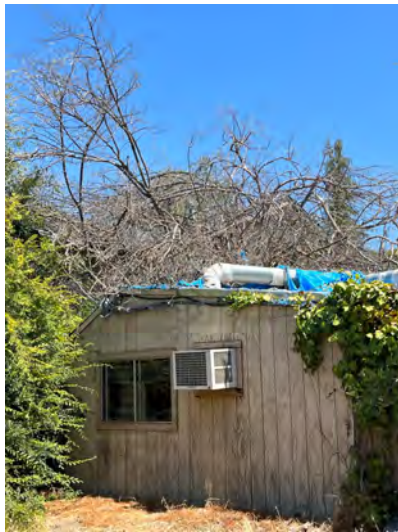
(64) Dead Mulberry #274

- Mulberry #274 was dead in the back of 16270 Burton Road, surrounded by pavement.
- Persimmon #342 had a 12-inch diameter trunk with good form and high vigor. The crown had an umbrella shape, and the tree was in good condition.
