**Tree Inventory, Assessment,  
and  
Protection Report**

**400 Surmont Drive  
Los Gatos, CA 95032**

**Town of Los Gatos**

**September 27, 2019  
Revised February 11, 2022**

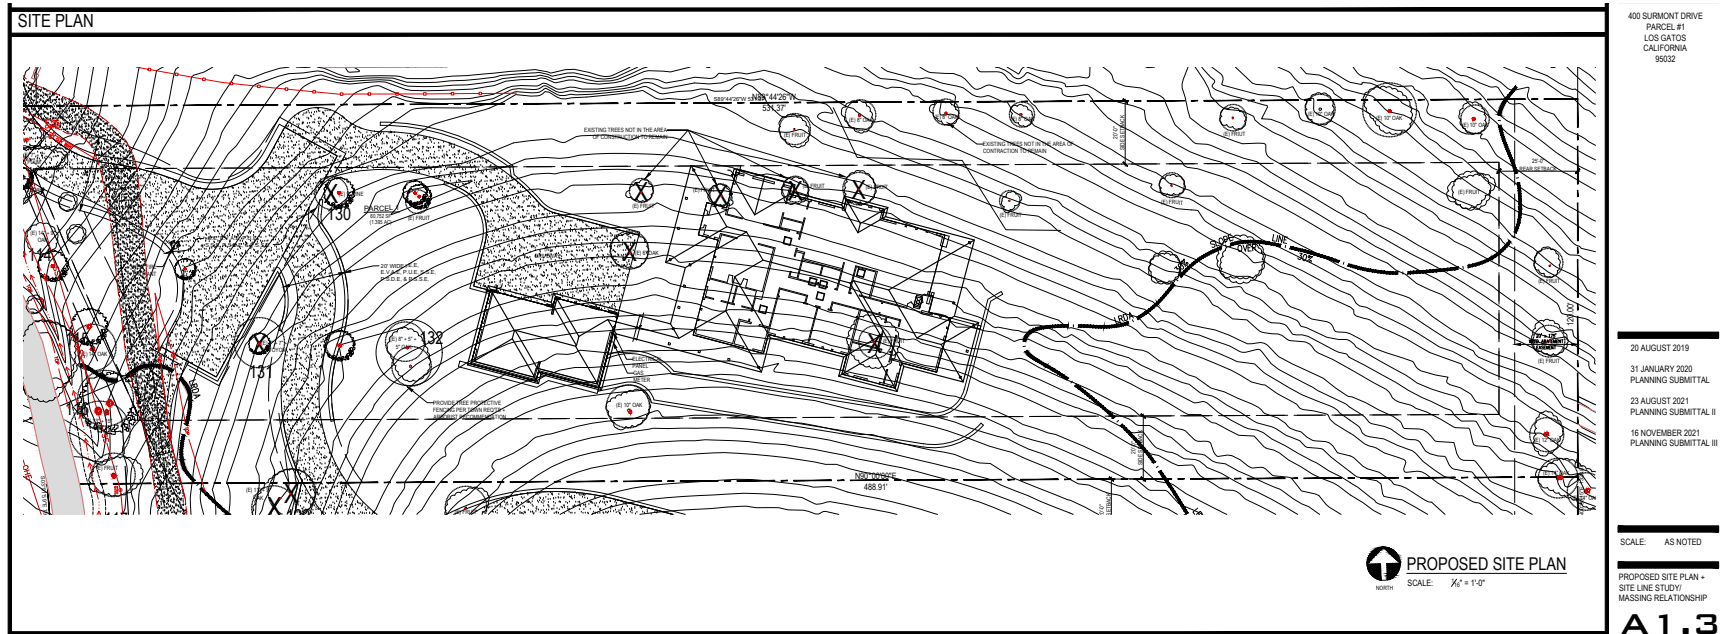
## A1: Site Plan Parcel 1

Site plan not to scale. Trees with an 'X' next to them are highly impacted. The blue dash represents the tree protection fence.
