**Tree Inventory, Assessment,  
and  
Protection Report**

**17121 Crescent Drive, Los Gatos  
Los Gatos, CA 95032**

**Town of Los Gatos**

**October 14, 2021**

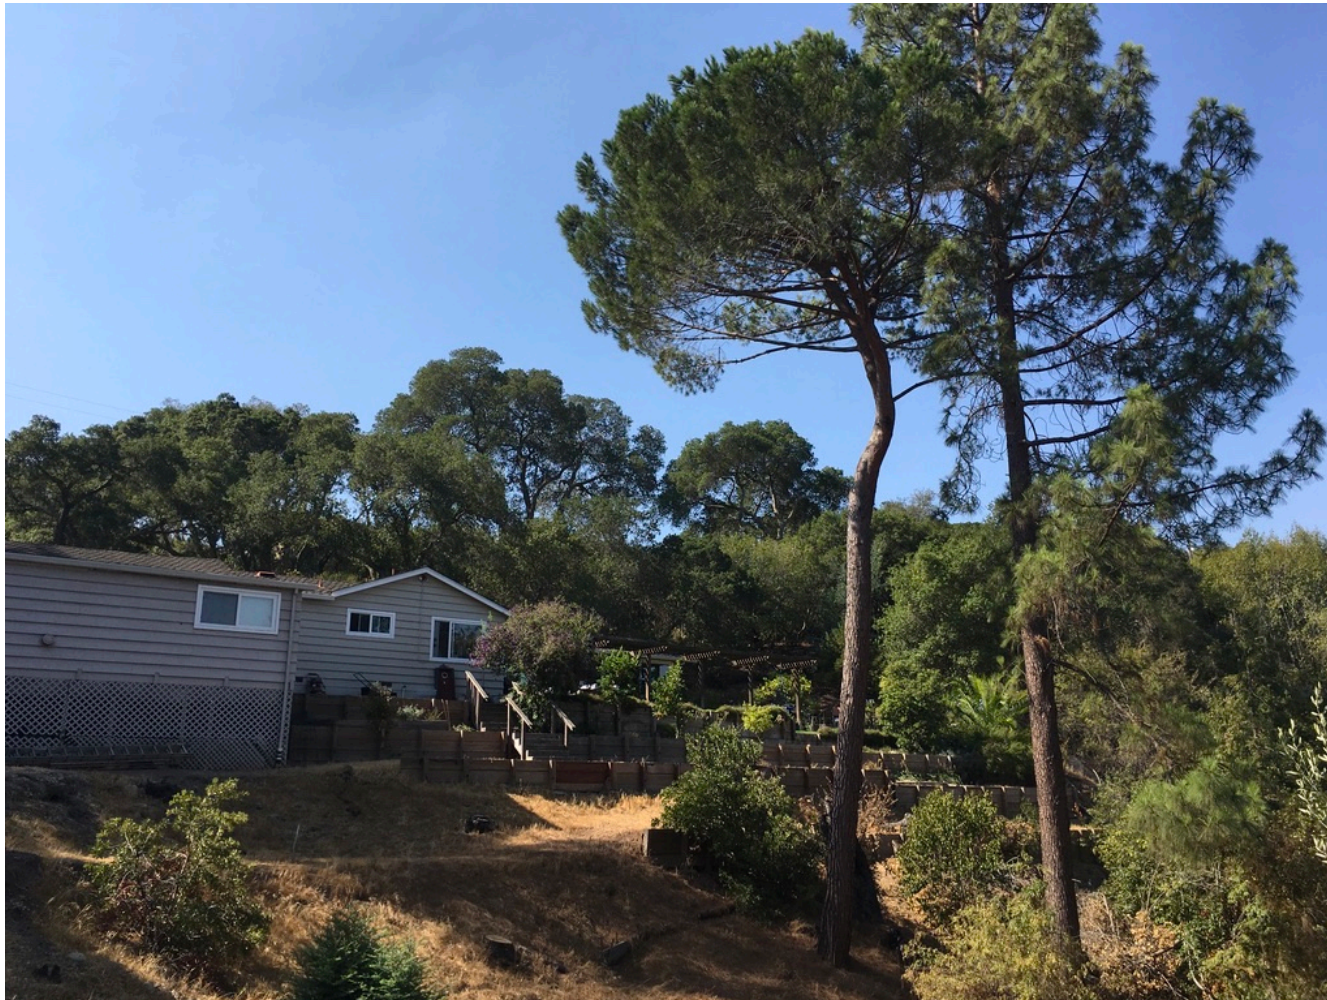
### C1: Pines #718 and #719

| Tree Species | I.D. Number | Trunk Diameter (in.) | ~ Canopy Diameter (ft.) | Health | Structure | Form | Status |
|---|---|---|---|---|---|---|---|
| Canary Island pine ( <i>Pinus canariensis</i> ) | 718 | 23 | 45 | Fair | Fair | Good | Protected |
| stone pine ( <i>Pinus pinea</i> ) | 719 | 24 | 55 | Fair | Fair | Good | Protected |

There is one tree in good condition which is the Brazilian pepper and the remaining trees are in fair shape. The redwoods are drought stressed with sparse crowns and multiple tops and the coast live oaks have codominant stems. The pines have grown naturally and are somewhat stressed.

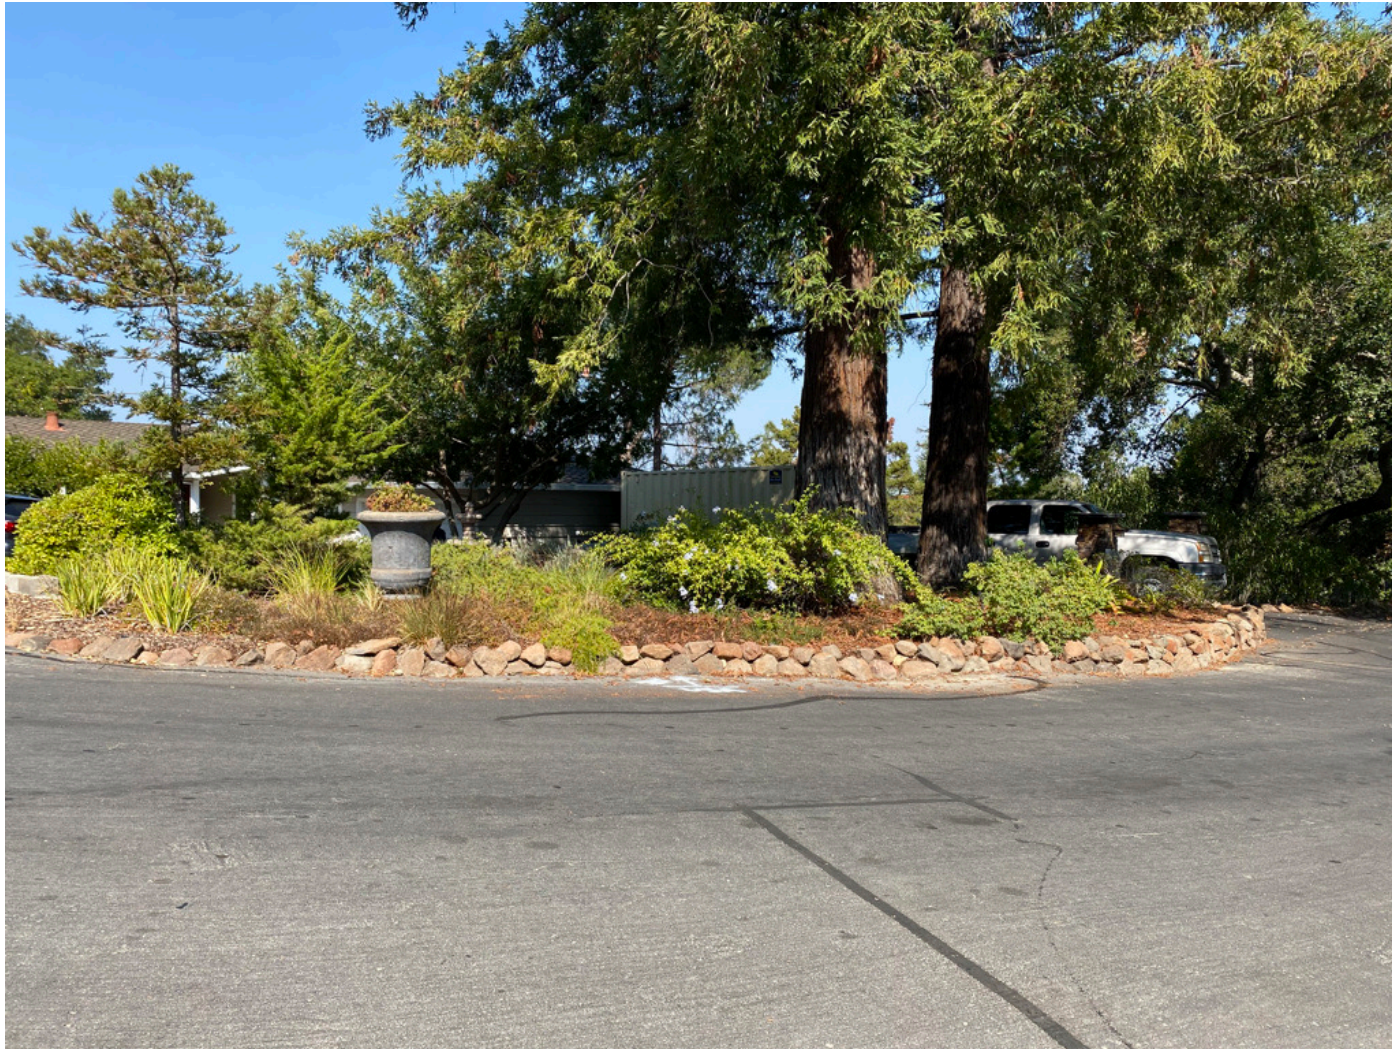
## C2: Redwoods #714 and #715

| Tree Species | I.D. Number | Trunk Diameter (in.) | ~ Canopy Diameter (ft.) | Health | Structure | Form | Status |
|---|---|---|---|---|---|---|---|
| coast redwood ( <i>Sequoia sempervirens</i> ) | 714 | 34 | 35 | Poor | Fair | Good | Protected |
| coast redwood ( <i>Sequoia sempervirens</i> ) | 715 | 42 | 35 | Poor | Fair | Good | Protected |

Tree protection for the coast redwoods and Brazilian pepper should consist of fence around the existing planting island where the trees originate. Supplemental watering will be required in this planting bed to ensure the survival of the already declining coast redwoods. The coast live oaks are close to proposed filling and draining and offsets of eighteen feet under the trees should be established.

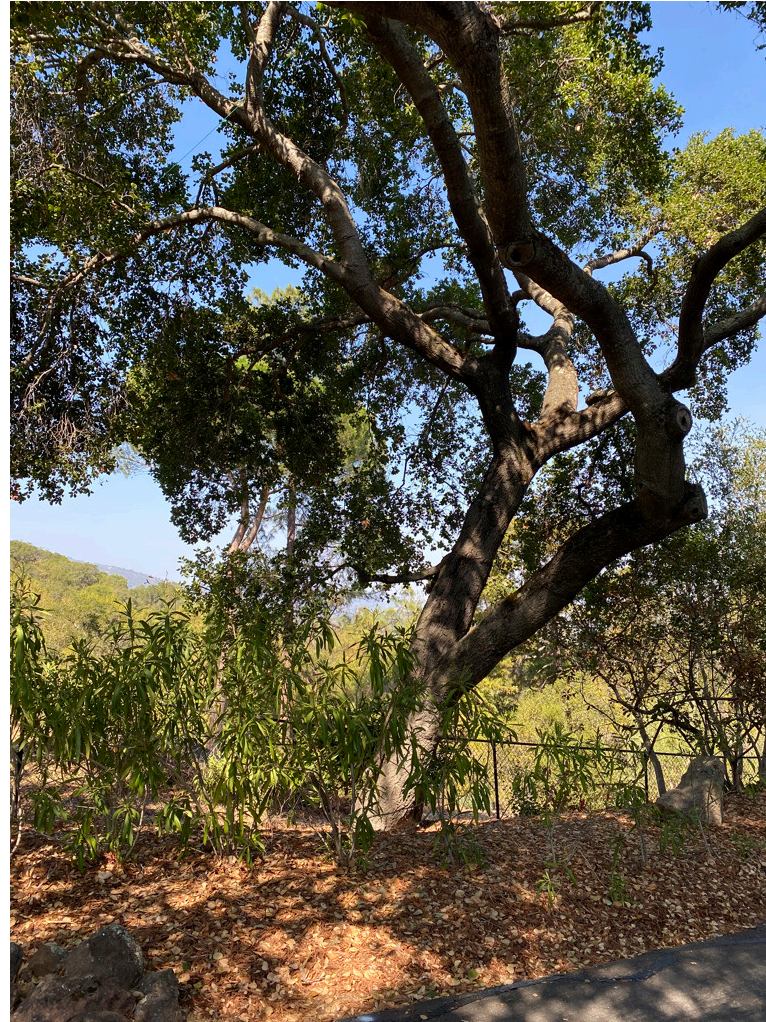
### **C3: Coast live oak #717**

| Tree Species | I.D. Number | Trunk Diameter (in.) | ~ Canopy Diameter (ft.) | Health | Structure | Form | Status |
|---|---|---|---|---|---|---|---|
| coast live oak ( <i>Quercus agrifolia</i> ) | 717 | 17, 20 | 35 | Good | Fair | Good | Large Protected |

No trees are expected to be highly impacted or removed. Four trees will be moderately impacted by the proposed plans which are the two coast redwoods in front and the two coast live oaks along the road with drainage and soil filling nearby. The driveway will remain in a similar location with half of the roundabout abandoned. The new driveway is located in the same footprint of the existing. If there is significant grading, compaction, or sub base excavation it will likely destroy roots of the redwoods under the existing asphalt. The soil filling near the coast live oaks #717 and #720 will need to be at least 18 feet from the trees.

2. Place tree protection around the coast redwoods and Brazilian pepper consisting of fence around the existing planting island where the trees originate. The coast live oaks are close to proposed filling and draining and offsets of eighteen feet under the trees should be established.
