**Tree Inventory, Assessment,  
and  
Protection Report**

**16220 Harwood Road, Los Gatos  
Los Gatos, CA 95032**

**Lot B**

**March 10, 2023**

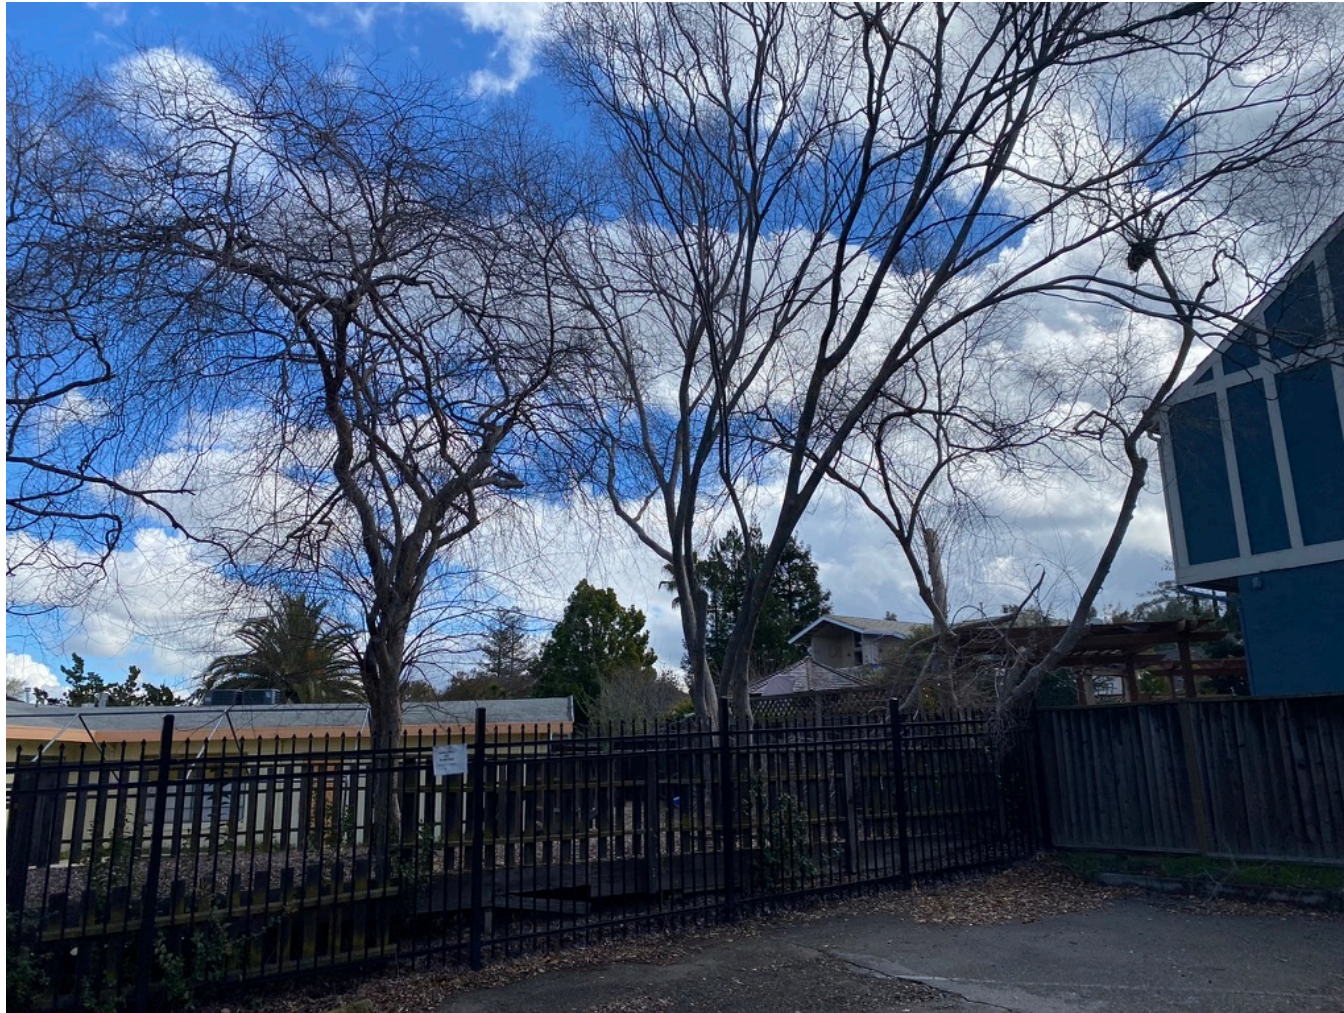
### C1: Chinese Elms

Eight trees will be highly impacted and caused to be removed, although the plans only call out seven. The eighth tree is Chinese elm #293 at the edge of the proposed driveway. Not sure how or why the others are to be removed but this one indicated as a retain. The tree will not survive the construction around it. Two additional trees could be moderately affected and include Chinese elms #291 and #295. Tree #272 is in poor condition but not expected to be affected, #295 is in poor conditions and expected to be moderately impacted, and #275 is in very poor shape and not expected to be impacted, all three of these should be considered for removal along with the eight highly impacted.

| Tree Species | I.D. # | Trunk Diameter (in.) | ~ Canopy Diameter (ft.) | Condition | Expected Impact | Protection Status | Rounded Depreciated Value | Tree Protection Radii (ft.) |
|---|---|---|---|---|---|---|---|---|
| Chinese elm ( <i>Ulmus parvifolia</i> ) | 293 | 12, 7, 6 | 30 | Fair | High | Protected | \$5,900.00 | 10 |

1. Place tree protection fence around the perimeter of the site at the appropriate radius as indicated in Appendix B.
2. Consider removing #293 or reconfiguring the driveway.

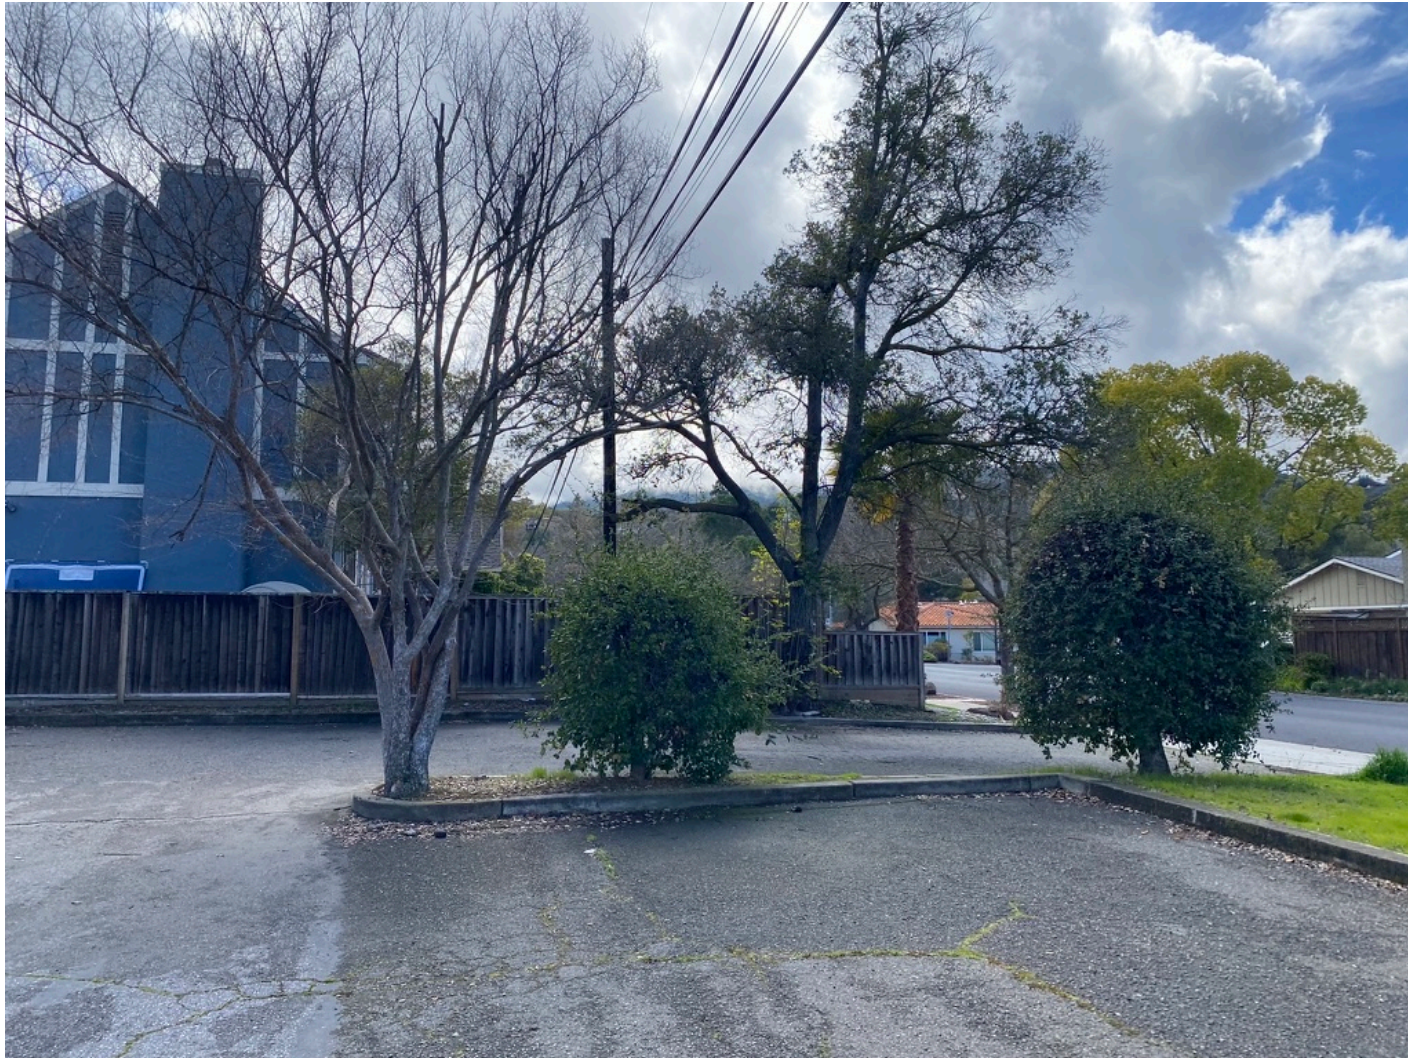
## C2: Chinese Elms and Coast Live Oaks

| Tree Species | I.D. # | Trunk Diameter (in.) | ~ Canopy Diameter (ft.) | Condition | Expected Impact | Protection Status | Rounded Depreciated Value | Tree Protection Radii (ft.) |
|---|---|---|---|---|---|---|---|---|
| coast live oak ( <i>Quercus agrifolia</i> ) | 294 | 16 | 35 | Very poor | High | Protected | \$1,530.00 | 11 |
| coast live oak ( <i>Quercus agrifolia</i> ) | 296 | 2, 2 | 6 | Very poor | High | Protected | \$50.00 | 2 |
| coast live oak ( <i>Quercus agrifolia</i> ) | 297 | 6 | 10 | Very poor | High | Protected | \$210.00 | 4 |
