# ARBORIST REPORT

TREE PROTECTION - BUILDING PROJECT

JULY 18, 2024

PROJECT ADDRESS:  
176 LOMA ALTA AVE • LOS GATOS • 95030

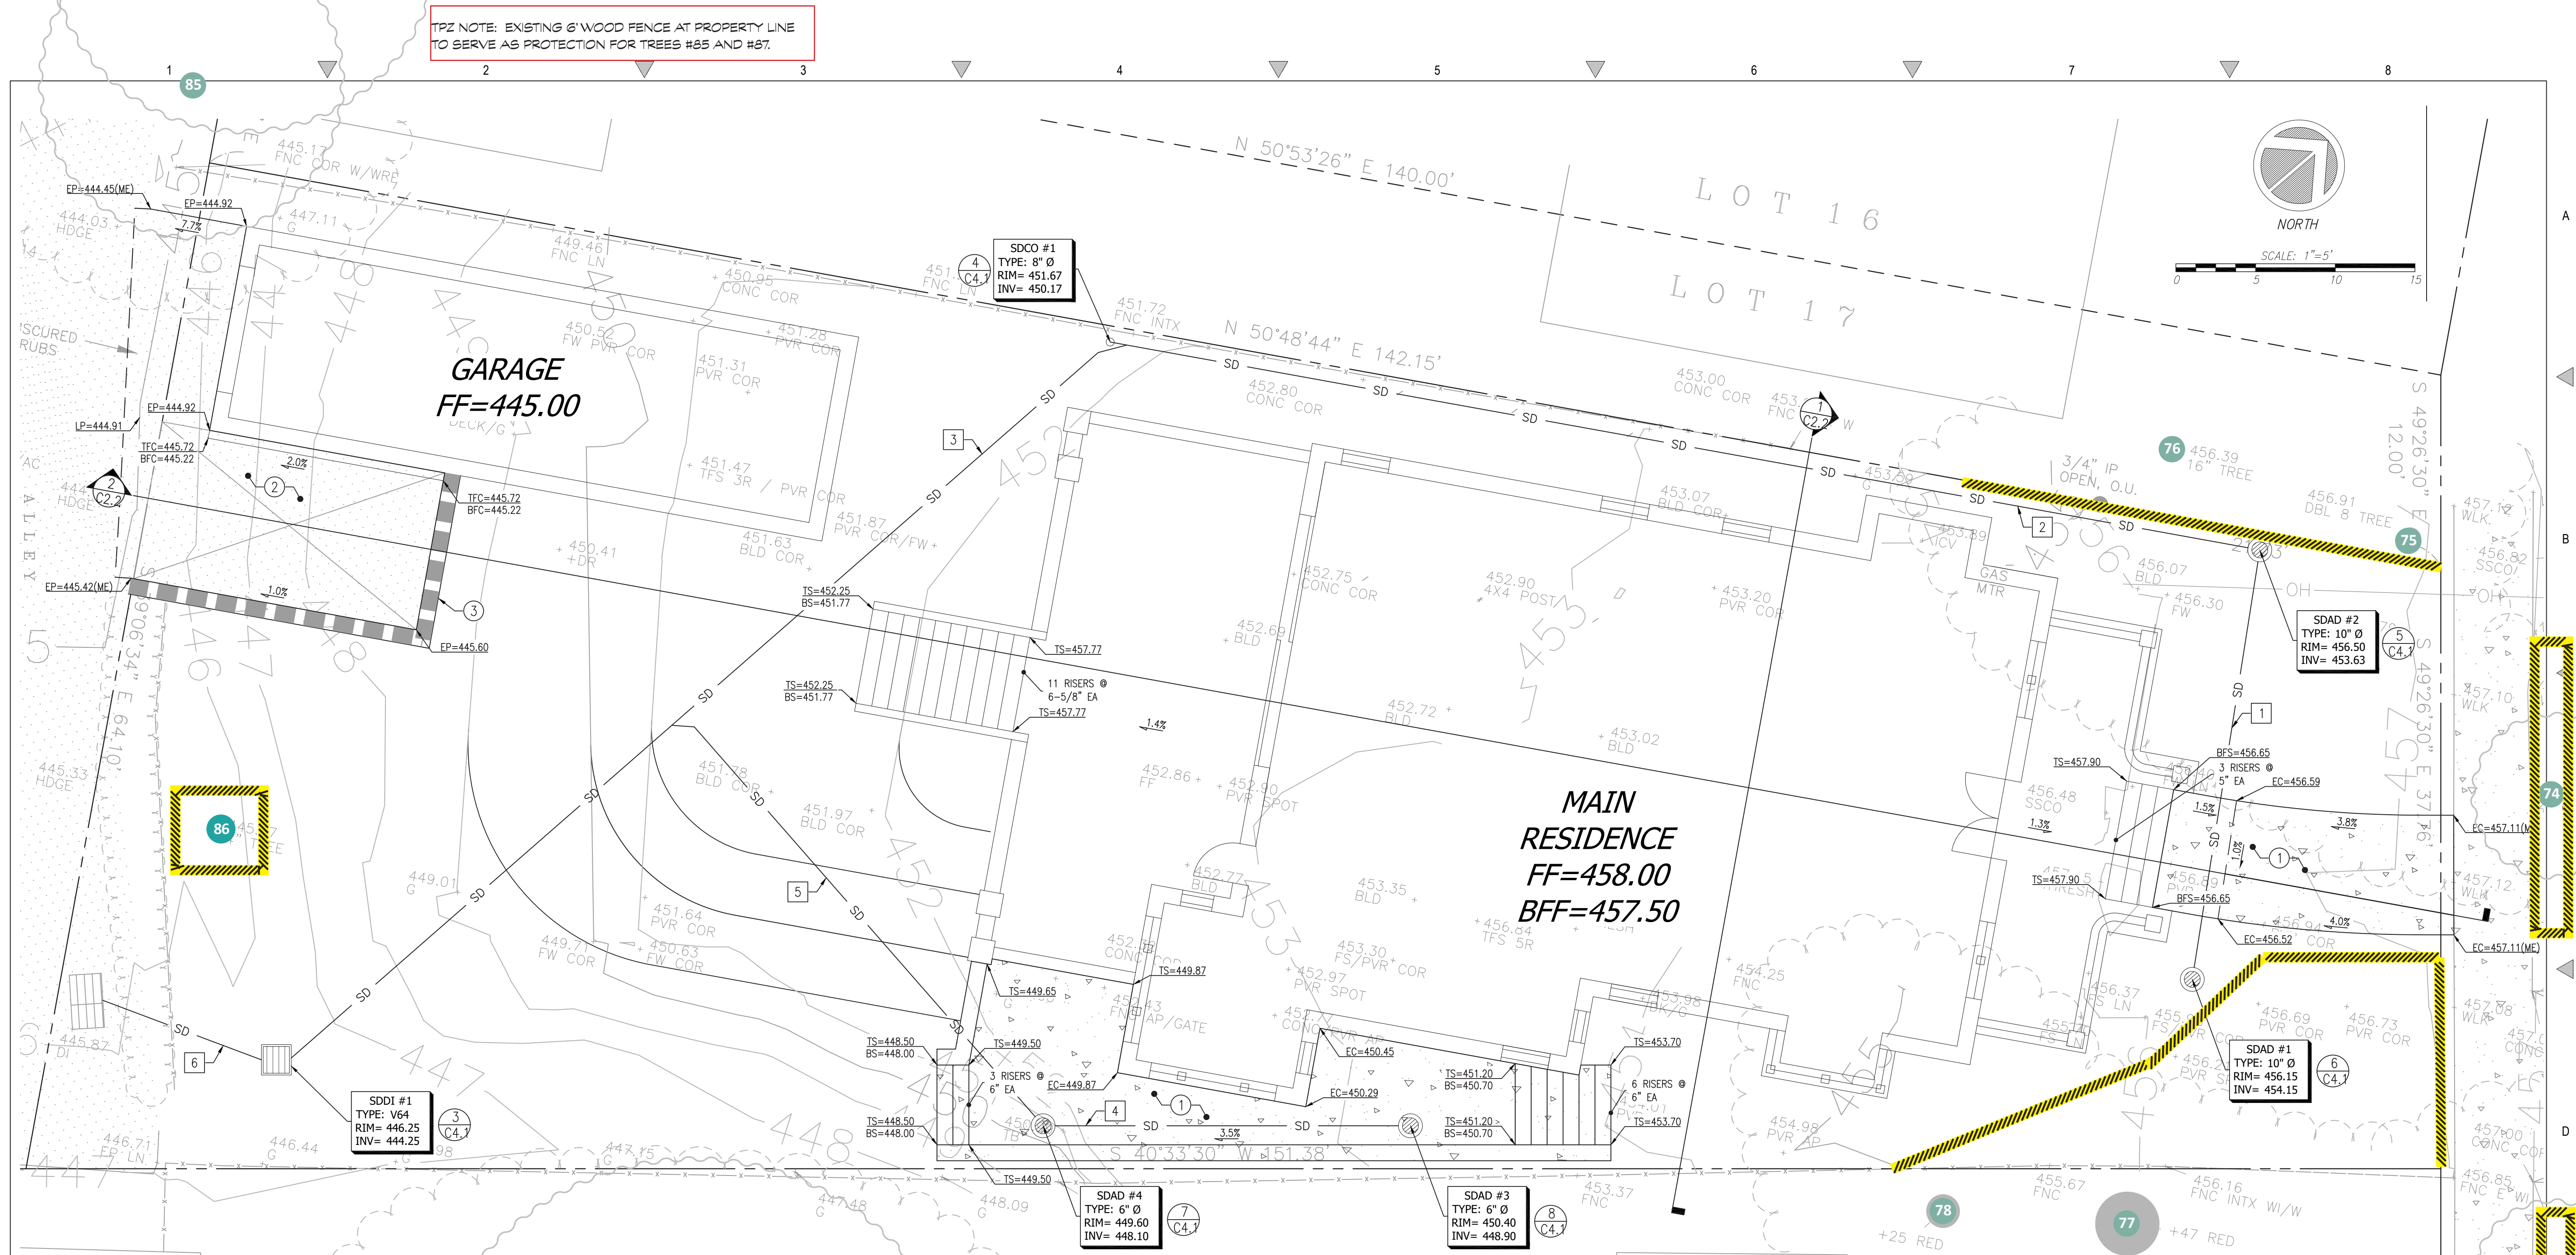
# TREE PROTECTION ZONE MAP

TPZ NOTE: EXISTING 6" WOOD FENCE AT PROPERTY LINE TO SERVE AS PROTECTION FOR TREES #85 AND #87.

TPZ NOTE: EXISTING 6" WOOD FENCE AT PROPERTY LINE TO SERVE AS PROTECTION FOR TREE #88.

**Please see attached "TPZ Map" for recommended fencing locations.** Recommended protection for trees is as follows:

- **Tree #74 (15.5" southern magnolia Street tree):** Establish standard TPZ fencing radius to 15 feet or the greatest extent possible as limited by the planting strip. Place fence posts into the ground along the existing hardscape.

- **Trees #75 and #76 (neighboring cherry laurel and elm):** These neighboring trees may be protected as a group within the same perimeter. Establish standard TPZ fencing along the property line to 20 feet, or to the greatest extent possible as limited by the work.

- **Trees #77 and #78 (neighboring redwoods):** Establish standard TPZ fencing with a radius of 25 feet, or to the greatest extent possible as limited by the proposed work. TPZ fencing may need to be adjusted during the demolition of the driveway. Restore TPZ fencing to original location promptly upon completion.

- **Trees #85 and #87 (neighboring redwood and olive):** These neighboring trees would be protected adequately by the existing wooden fence at the property line. Due to the location of the work, an additional chain link fence at this location would not be practical.

- **Tree #86 (4" purple-leaf plum, *Prunus cerasifera*):** Establish standard TPZ fencing with a radius of 5 feet.
- **Tree #89 (8.5" Chinese pistache Street tree):** Establish standard TPZ fencing radius to 10 feet or the greatest extent possible as limited by the planting strip. Place fence posts into the ground along the existing hardscape.
