**Tree Inventory, Assessment,
and
Protection Report**

**16940 Roberts Road
Los Gatos, CA 95032**

Town of Los Gatos

October 10, 2019

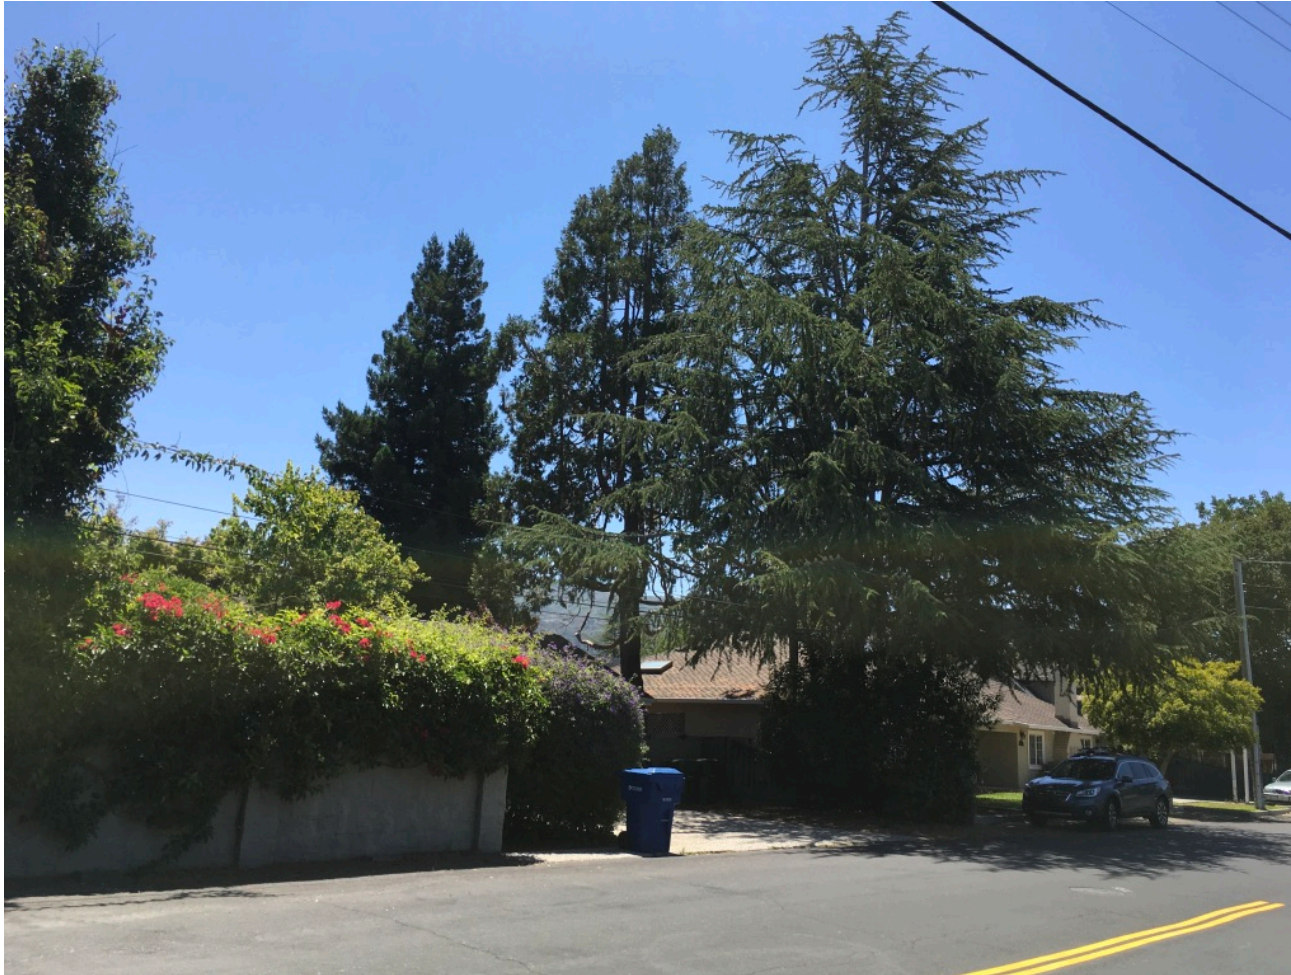
C1: Cedars #378, #389 on adjacent site

Both the construction and permanent driveway near Unit 1 is close to the property boundary and adjacent to #378 and #379. For the construction driveway the contractor could place steel road plate over the soil surface on top of 6 inches of wood chips or use railroad ties as a bridge, and then place any erosion control material on top of that to avoid unnecessary compaction.

The first priority for the driveway construction is to adopt a no dig policy and incorporate a design plan that will minimize soil compaction and root disturbances under the trees. Use the thinnest material possible to achieve structural compliance and use porous material that allows for water infiltration under the surface if possible. Adjust the finished grade to be above the natural grade without digging for a sub-grade treatment. In this instance the pavement will be higher up and edge treatments or curbing also need to be constructed above grade. Use paving material that does not rely on the strength of a compacted sub-base for strength. This may be accomplished by reinforcing the surface layer material like monolithic concrete slabs or reinforced concrete. Place geotextile fabric at the bottom of the sub-base to reduce displacement into the parent soil along with a reduction in compaction requirements. Use biaxial Tensar BX-1100 or equivalent to manufacturer specifications on grade.

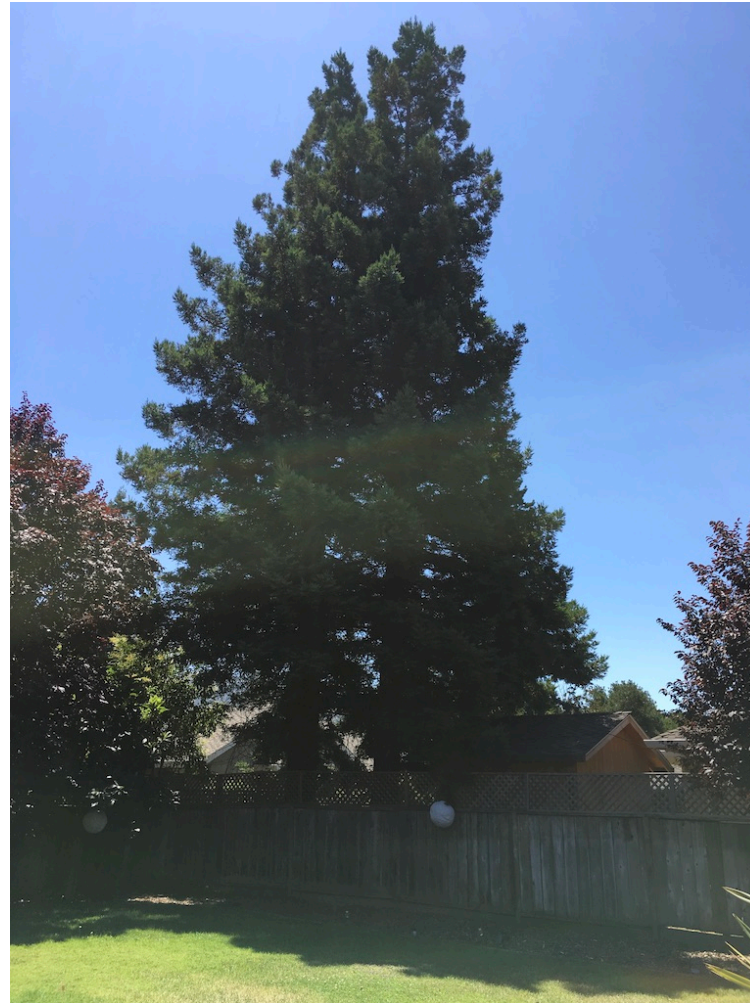
C2: Coast redwoods #391 and #392 on the adjacent site

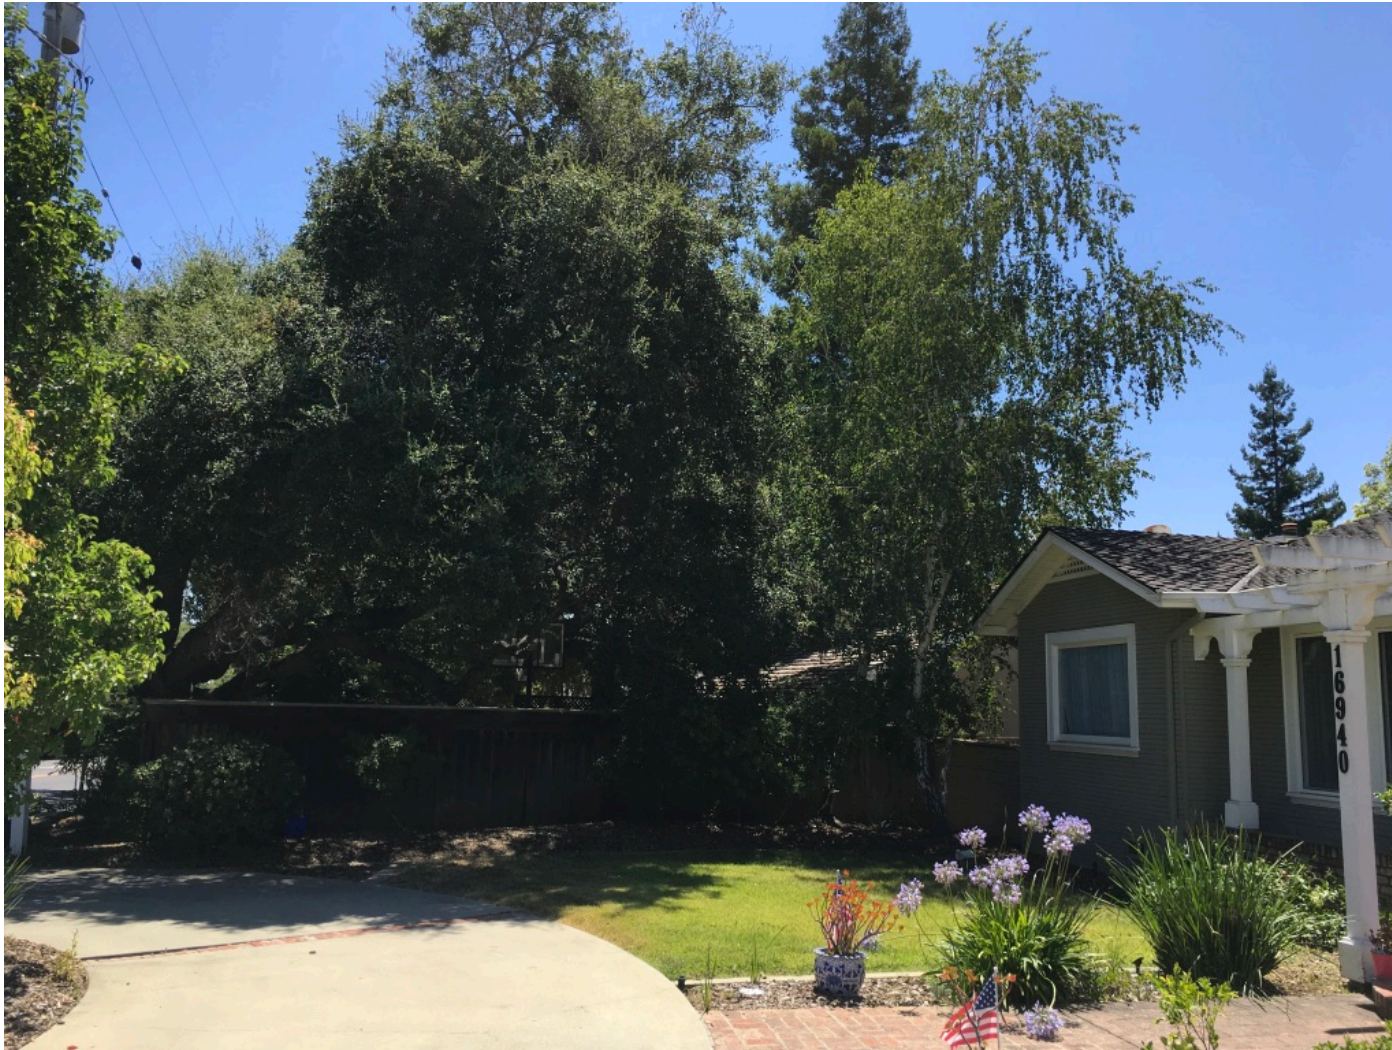
C3: Coast live oak #395 on the adjacent site and birch #396 and #397

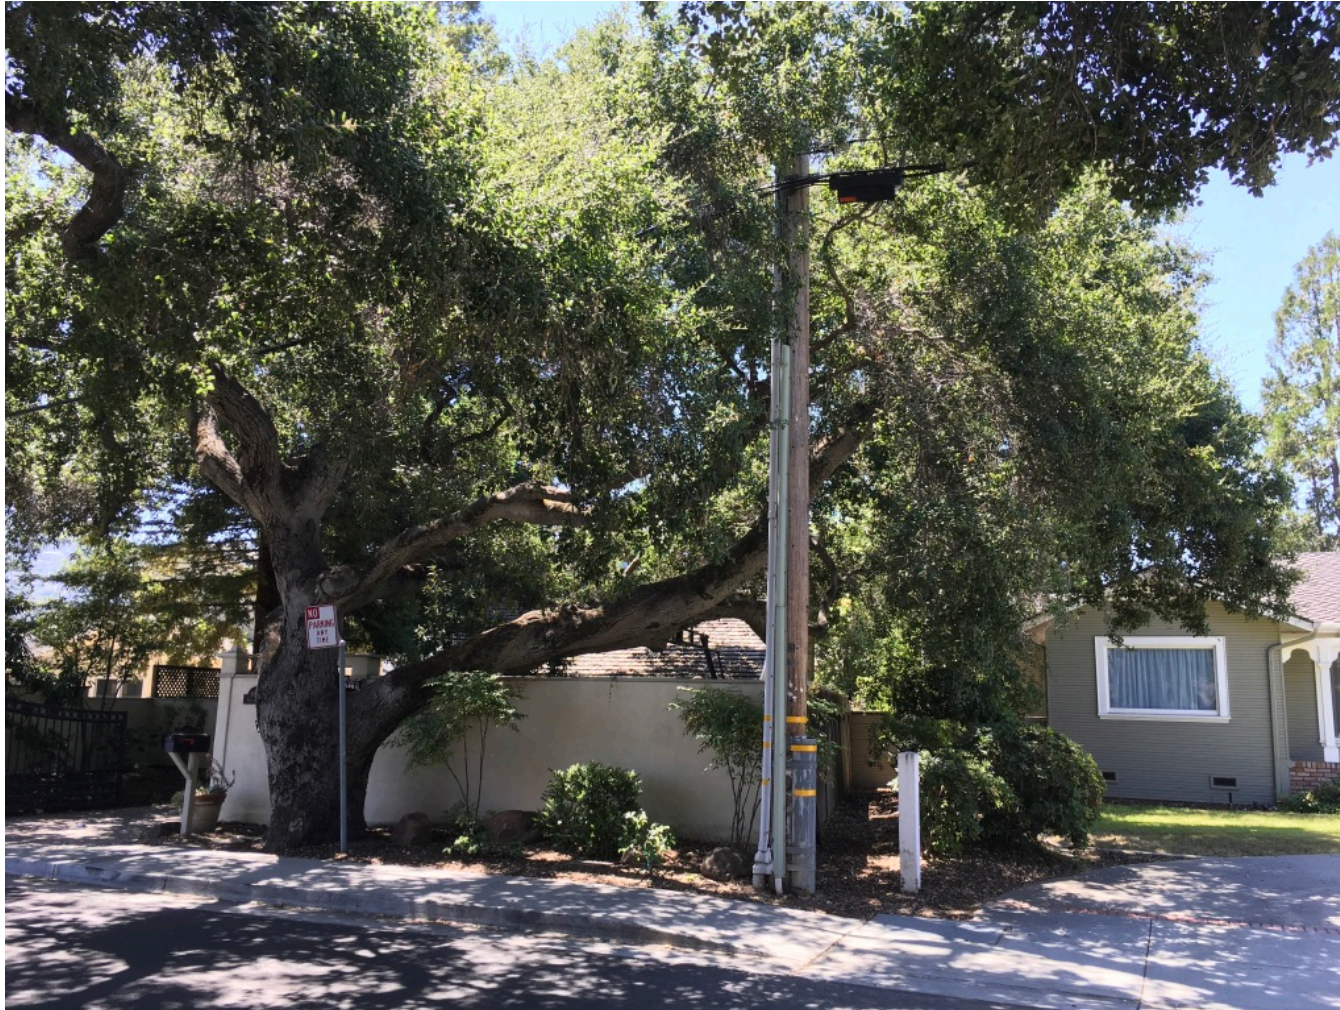
C4: Coast live oak #395 on adjacent site

Tree protection for this project will focus on avoiding soil impacts in the property setback. It may be necessary to prune the coast live oak 395.

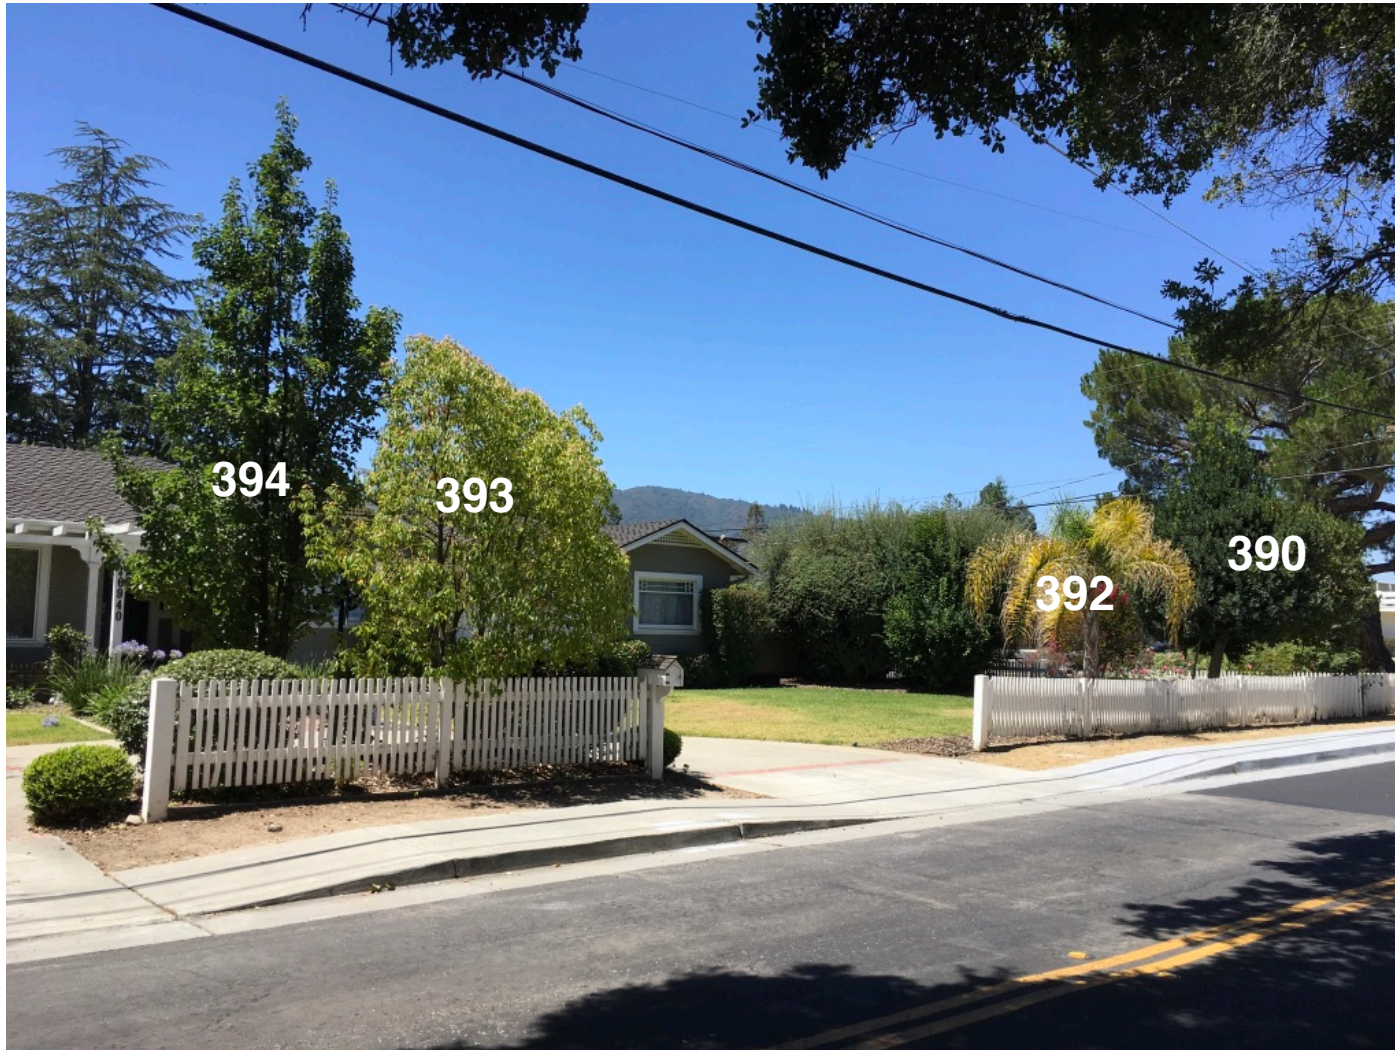
C5: Trees #390, #392, #393, and #394

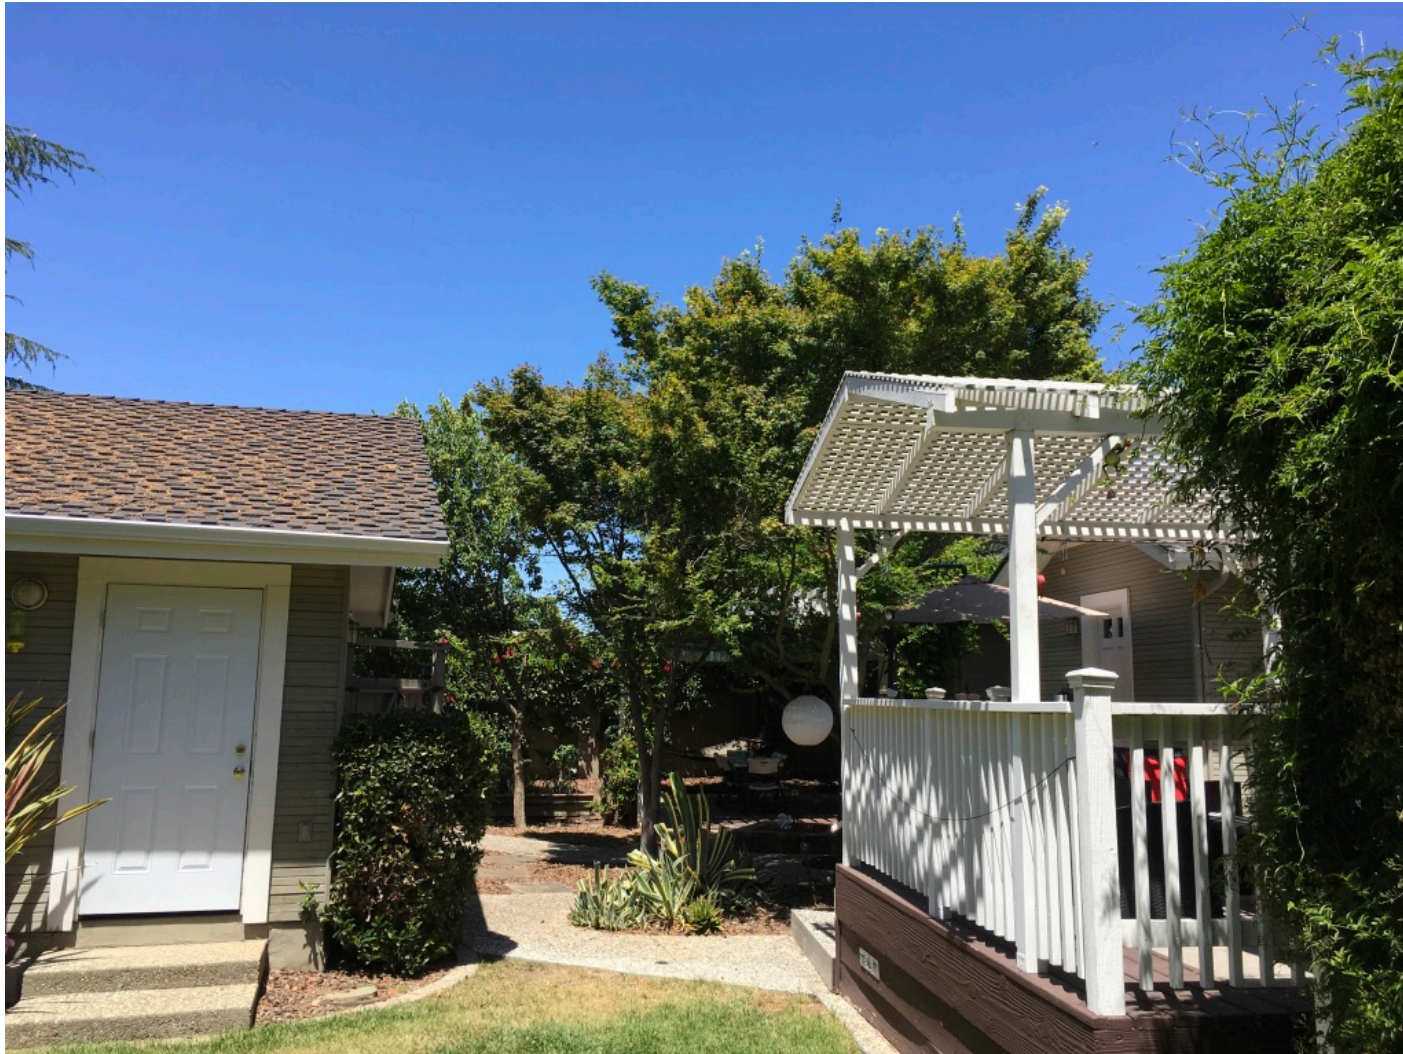
C6: Japanese maples #387 and #388
