**Tree Inventory, Assessment,
and
Protection**

**15925 Quail Hill Road
Los Gatos, CA 95032**

Town of Los Gatos

April 18, 2019

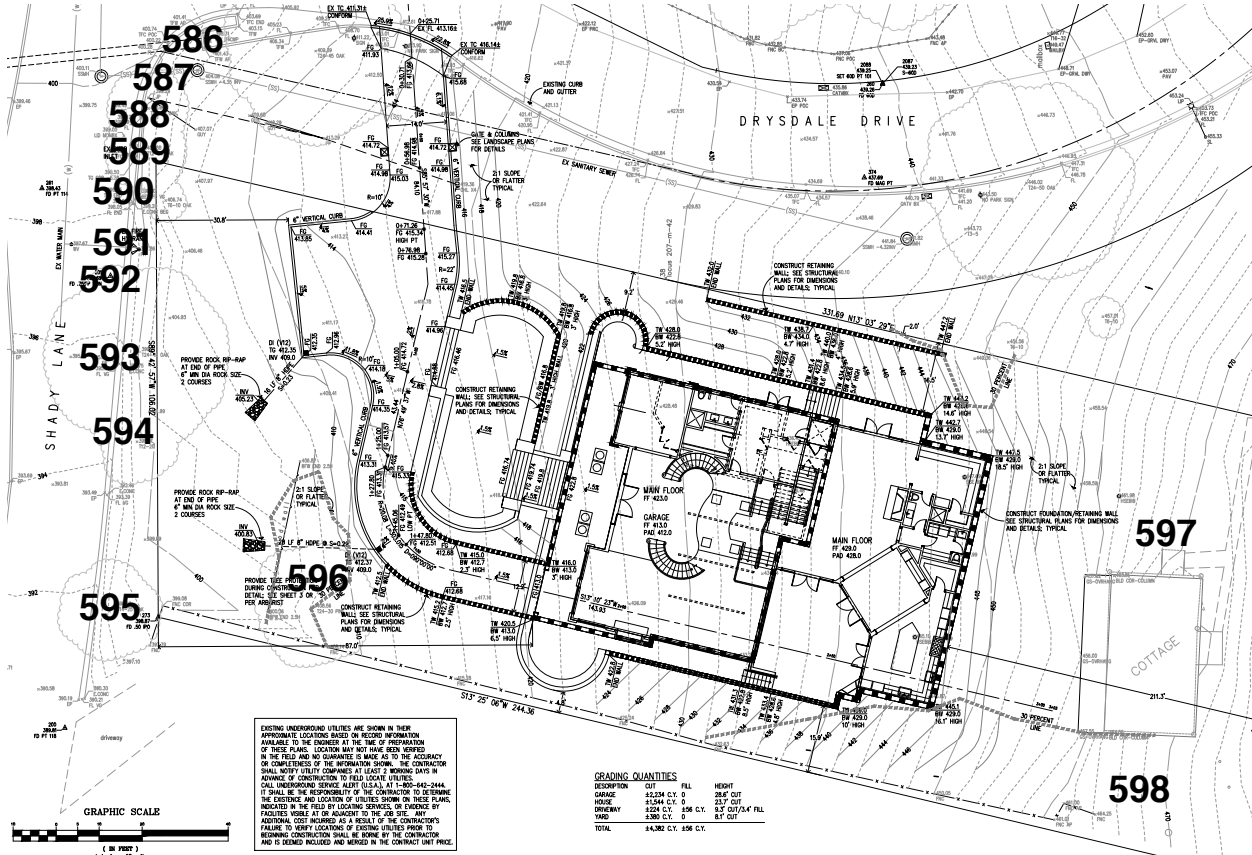
Appendix A: Tree Inventory Map and Site Plan

Snapshot not to scale from Hanna Brunetti Grading and Drainage Plan February 13, 2019 sheet 5 of 6. Tree number locations are approximations

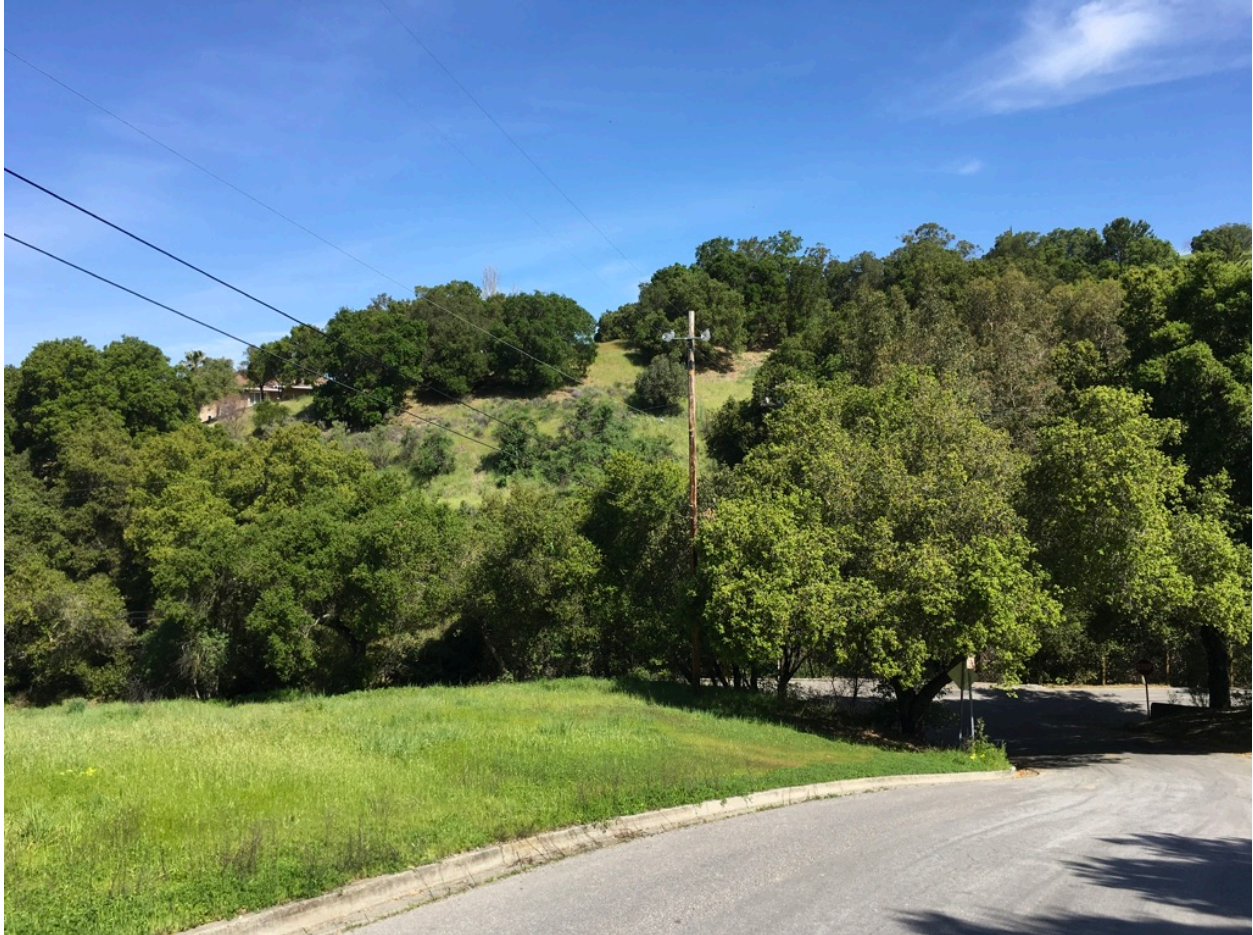
C1: Stand of trees along the lower lot (#586 through #595)

1. Place tree trunk locations on the topographic survey along with on all the plans
2. Place tree numbers and protection schemes on all the plans.
3. Place tree protection fence 30 feet to the south of trees #586 through #595.

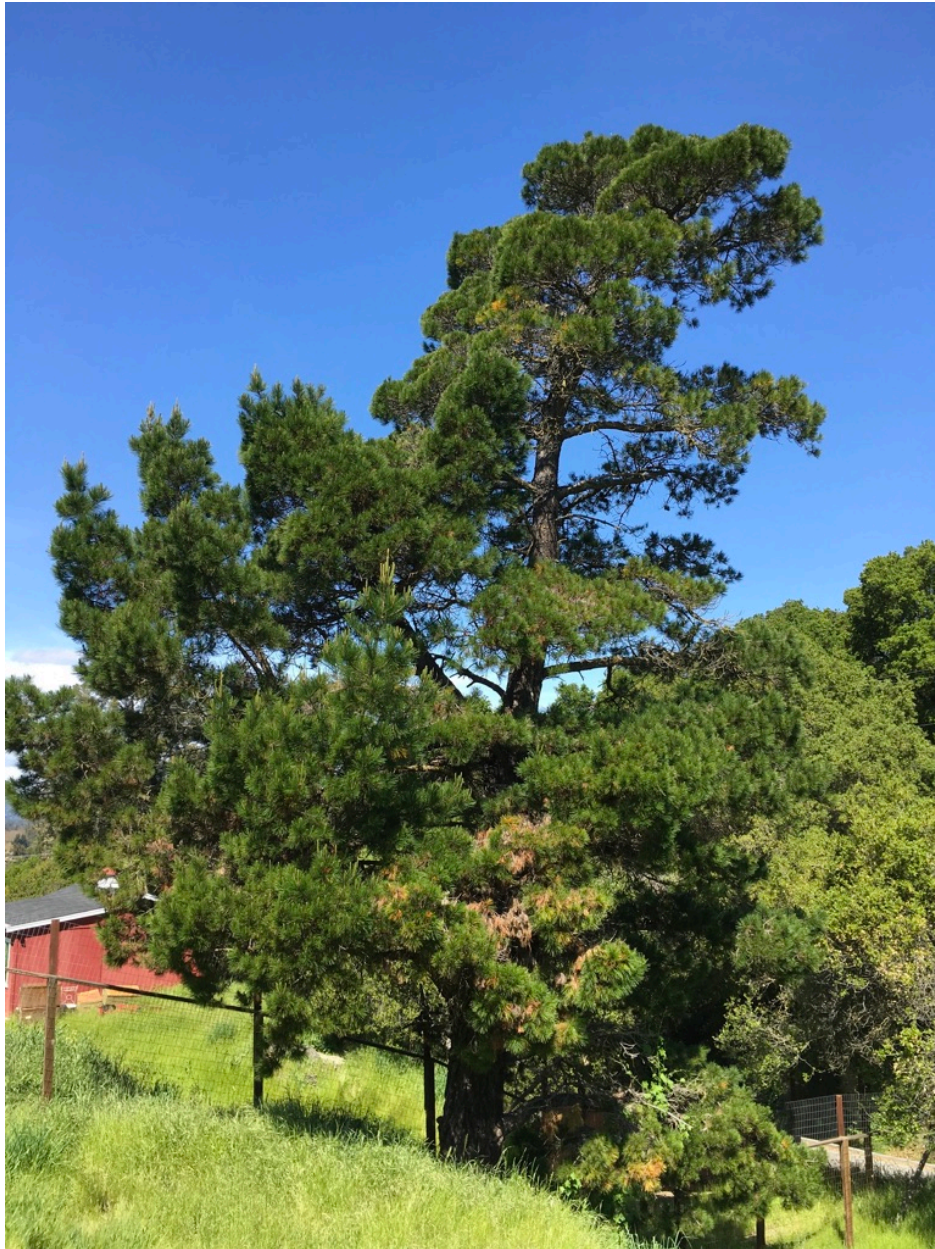
Only one tree is expected to be highly impacted by the proposed plans which is Monterey pine #596. All the remaining trees are located on the lower slope away from the proposed project with the exception of the two trees near the cottage (#597 and #598). There are some smaller trees down the slope near the existing house but were not included in this assessment and are not located on the plans. The demolition of the existing structures should not affect these trees.

C2: Monterey pine #596 likely to be removed

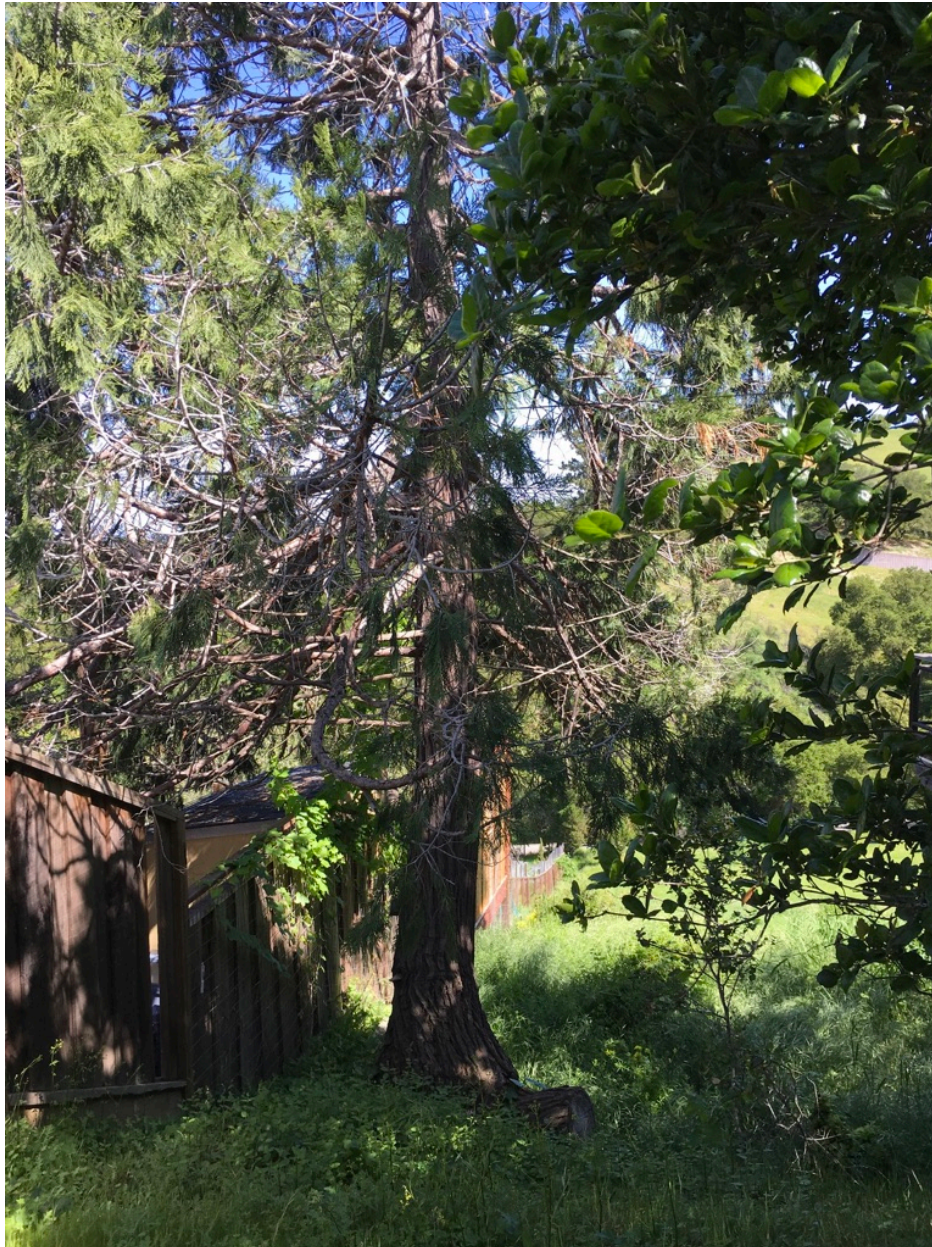
C3: Incense cedar #598 near cottage

4. Place tree protection fence around trees #597 and #598 at a radius of 16 feet where possible during demolition.
5. Consider removing tree #593 for public safety.
