Assessment of Five (5) Regulated-Size Trees #51 Through #55 At and Adjacent to 16336 Shady View Lane Los Gatos, California

Prepared for:
Mr. Azhar Khan, Assistant Planner
Town of Los Gatos Community Development Department

Field Visit:
Walter Levison, Contract Town Arborist (CTA)
1/29/2019

Report by (CTA) 1/31/2019

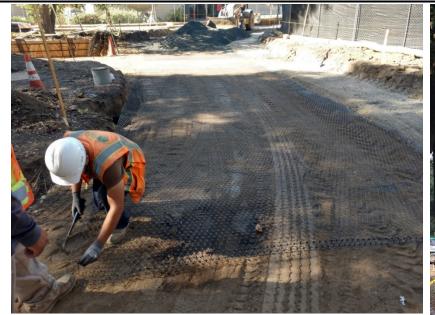
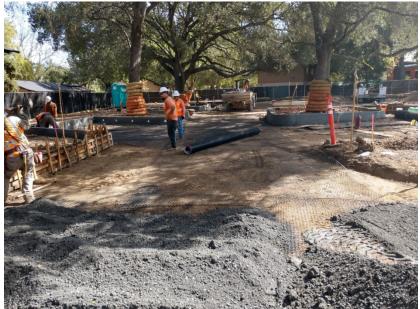
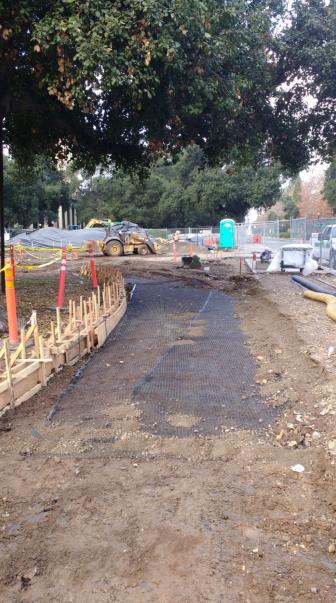
The photo at far right is a sidewalk project at Stanford where the walkway passes beneath the canopy dripline of a very large and valuable oak specimen that is a key historic element of the landscape.

Baserock is laid directly over the geogrid after it is pinned in place with steel pins (photo at right shows baserock piled over the geogrid).

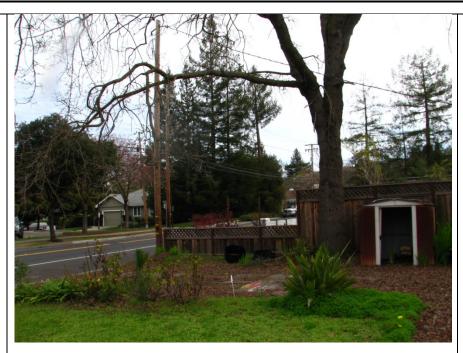
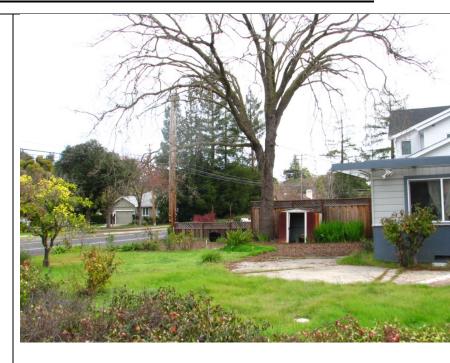
53

The limb extending left at 15 feet elevation may need to be removed to clear construction. It is placed directly over the existing and proposed driveway footprint, and extends generally westward, hanging down to just a few feet above grade once it reaches the grass area in this image.

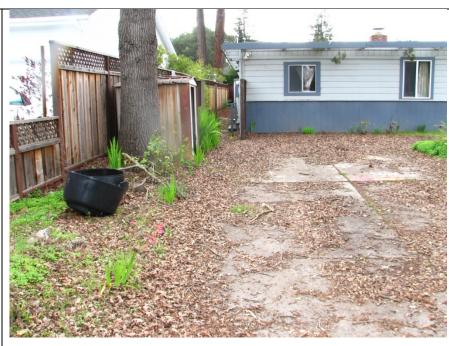
53

This older driveway area is the oak #53 "Critical Root Zone" (west side of root zone) which will be required to be preserved and protected during construction.

There are two separate proposed storm drain pipes that will have to be realigned to outside this area (preferably to 25 feet offset of the trunk), and one proposed new joint trench that will also need to be realigned to 25 feet or so from trunk.

To preserve the root zone under this older driveway, an underlayment of Tensar TriAx triaxial geogrid will need to be pinned down over the old baserock or old soil as a lateral load dispersal membrane, prior to building up baserock and pavers, etc. over the rock. This will allow us to avoid any subbase overexcavation or subbase recompaction that would otherwise be required and which normally destroy trees' root systems in the process. See digital images of TriAx installations at Stanford for a Walter Levison project, above in this report.

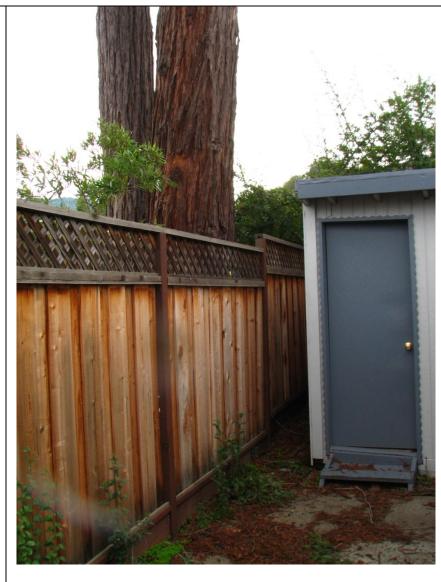
The critical root zone (CRZ) of this very large neighbor owned redwood valued at over \$60,000, extends at least 20 feet westward beyond the property boundary fence, and into the proposed "future pool" area shown on the applicant's plans.

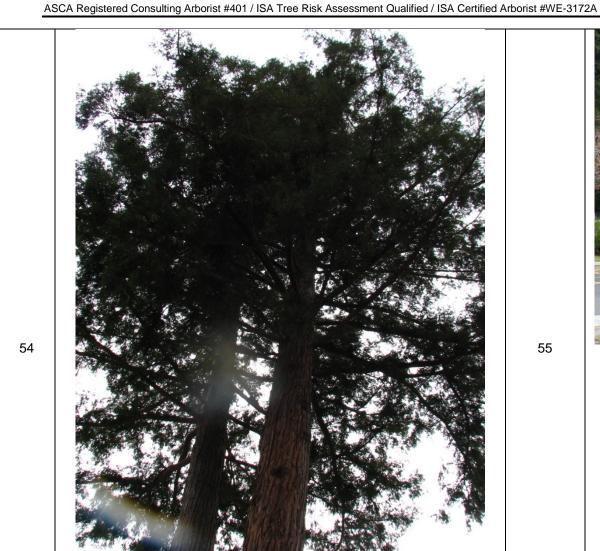
The tree extends 120 feet vertical, with 50 feet or more of canopy spread. The proposed pool area will need to be redesigned in order to avoid destroying the tree's western root system, assuming that the roots extend under the existing residence to be demolished on 16336 Shady View (which is very likely).
