**Tree Inventory, Assessment,
and
Protection**

**56 Central Avenue
Los Gatos, CA 95032**

October 11, 2018

Monarch Consulting Arborists LLC

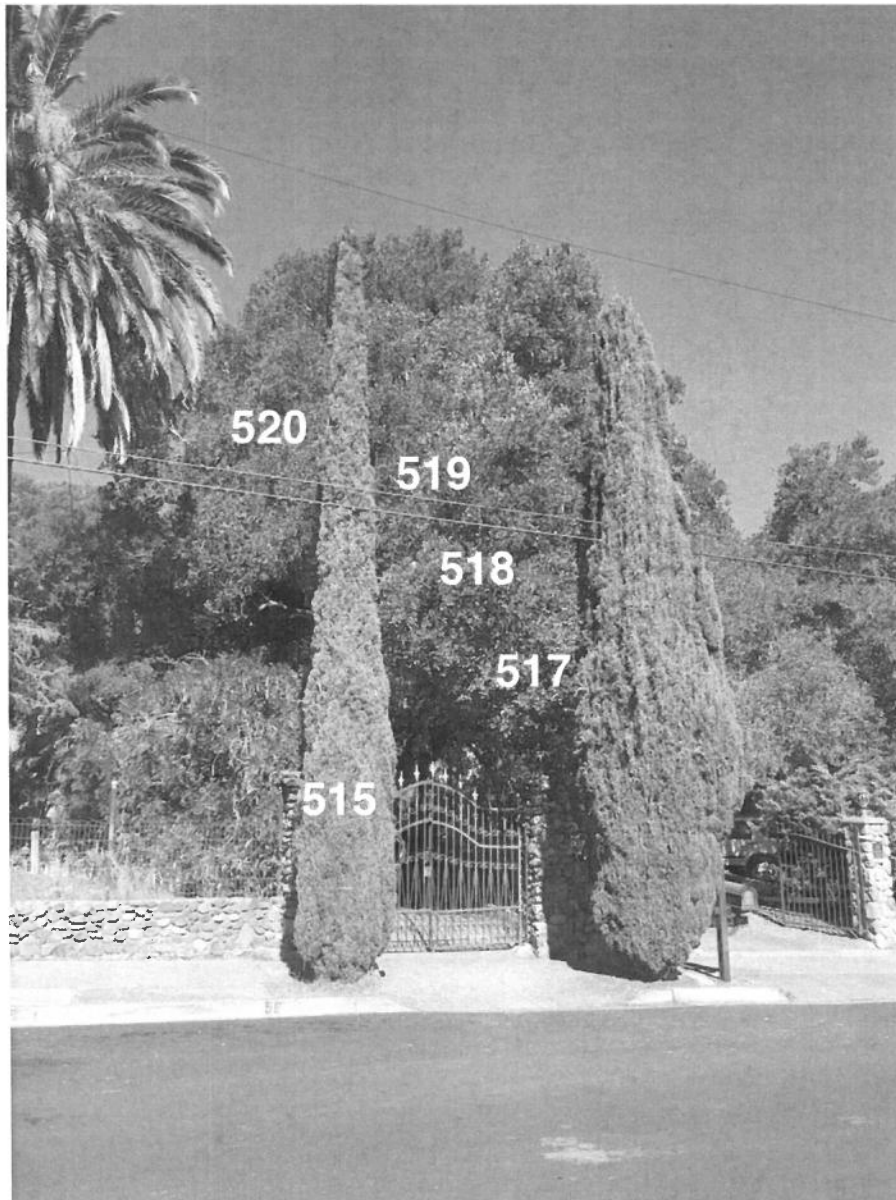
C1: Cypress 515 and 516, Oaks 517 through 520

Coast live oaks 517, 518, 519, 533, 534 are not located on the plans and are growing along the property boundary adjacent to the existing cottage (Appendix A). Trees 517, 518, 519 are at the driveway entrance while 533 and 534 are next to the structure growing along the northeast boundary. It is likely these trees originate on the adjacent site along with blue oak 528 and coast live oak 529.

2. Locate and include trees 517, 518, 519, 533, 534 missing from the plans growing along the northeast boundary.
3. Contact a wildlife biologist to inspect the date palm and verify any protection required as per the Migratory Bird Treaty Act and State Regulations regarding birds of prey.

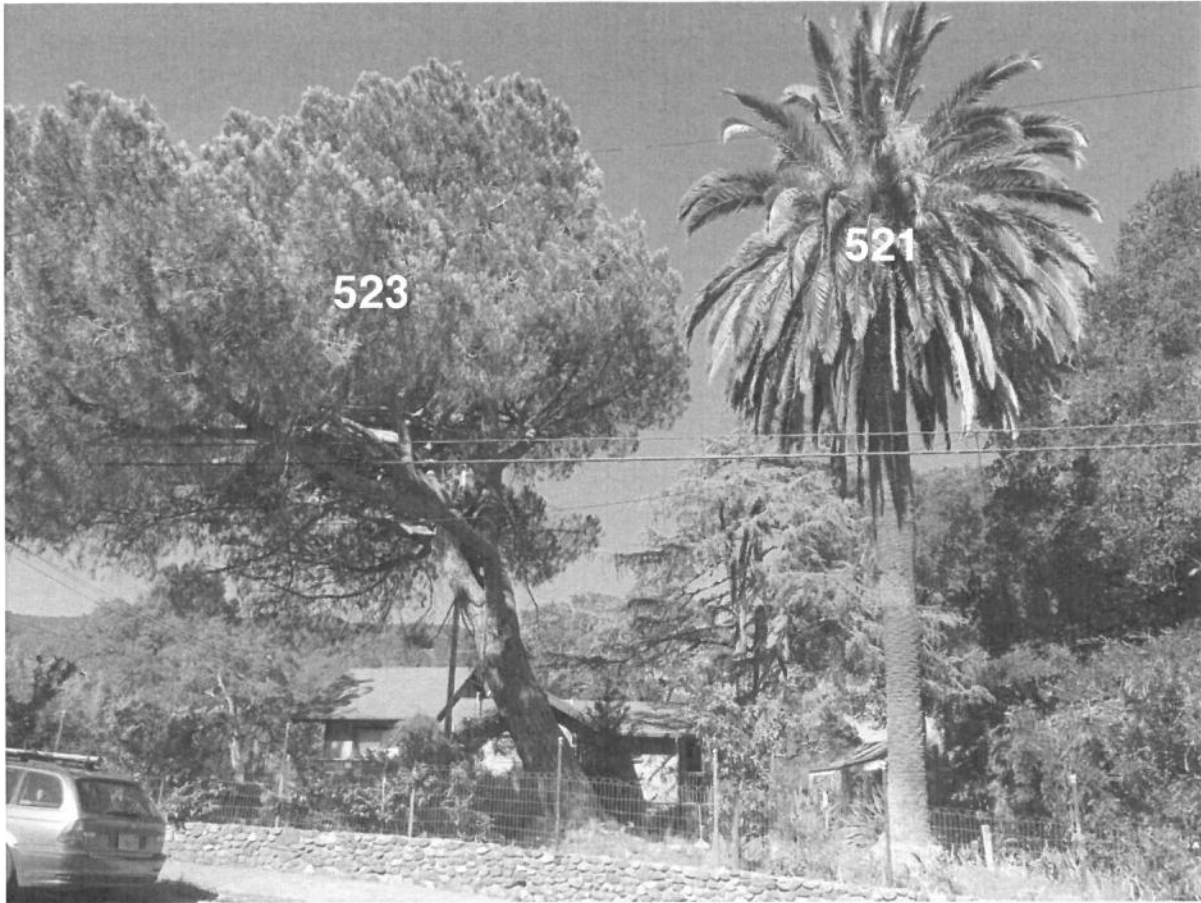
C2: Palm 521 and stone pine 523

Several trees are indicated to be removed including date palm 521, deodar cedar 524, coast live oaks 525 and 526, and blue oak 527. All these trees are within the footprint of the proposed structures. Stone pine 523 is listed to remain on the site plan but removed on the civil drawings, it will be highly impacted by grading and any destruction to the soil environment or roots behind the lean will compromise the tree.

Palm tree 521 currently has nesting owls (*Strix sp.*)⁴ in a cavity under the lowest fronds.
