**Tree Inventory, Assessment,
and
Protection Report**

**114 Wilder Avenue
Los Gatos, CA 95032**

July 11, 2022

Monarch Consulting Arborists

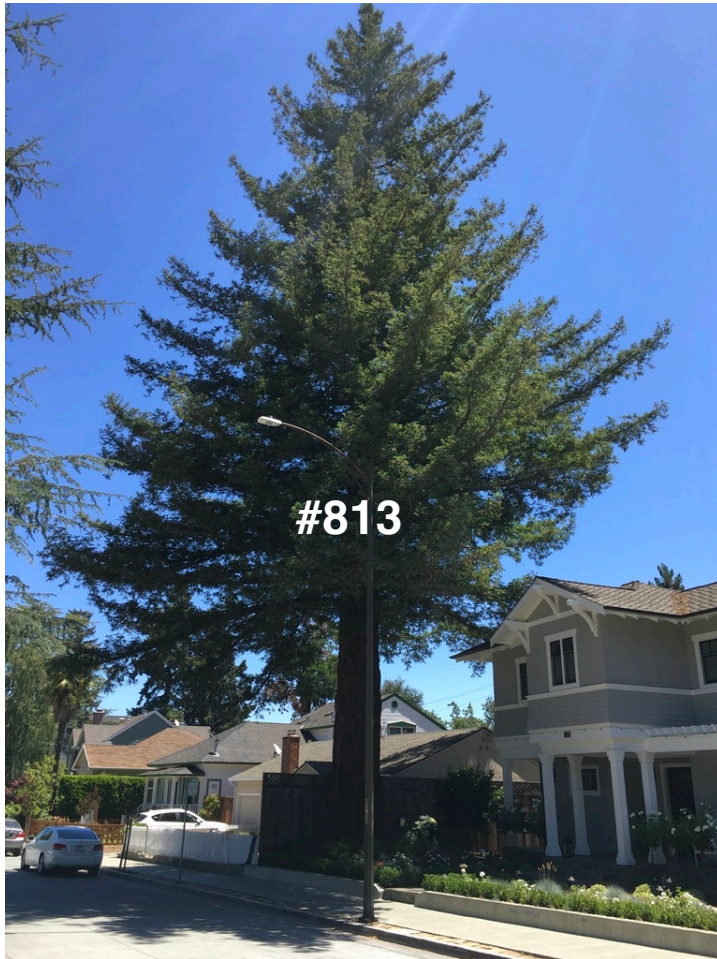
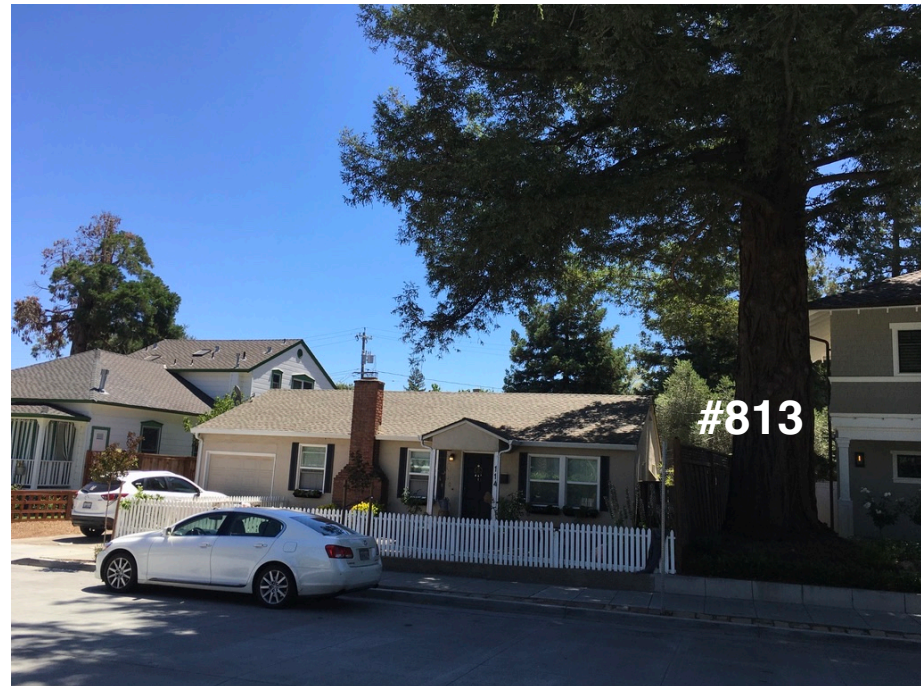
C1:Coast redwood #813

It is not possible or practical to obtain a radius of 48 feet (8 times the trunk diameter distance). The proposed resident is close to the tree and any over-excavation could be problematic. The existing resident is also close to the tree and would act as a “place holder” to some extent because it is unlikely there are significant roots under the structure.

The coast redwood #813 will be moderate to highly impacted depending on limits of excavation and construction techniques, the olive #812 will be highly impacted and need to be removed, and the remaining three coast redwoods #811, #810 and #809 will not be affected.

Coast redwood #813 will potentially require exploratory trenching along the proposed foundation or excavation limits on the side where the tree originates to remove roots if necessary. Due to the size of the tree and the close proximity it is not possible to obtain the typical tree protection zones of eight times the trunk diameter distance or more in radius. The ANSI A300 Part 5, 2019 Standard Practices (*Management of Trees and Shrubs During Site Planning, Site Development, and Construction*) states the following:

In accordance with the ANSI Standard, mitigation for this project could include exploratory trenching around the building/limits of excavation perimeter adjacent to #813, selective root removal may be required if necessary.

2. Place tree protection around between #811, #810, and #809 at a distance of 16 feet or maintain the existing privacy fence.
3. Coast redwood #813 will require exploratory trenching along the proposed foundation or excavation limits on the side where the tree originates to selectively remove roots if necessary. Use shoring techniques to avoid over-excavation as best as possible. Temporarily fence can be placed in the setback from the sidewalk along the edge of the property.

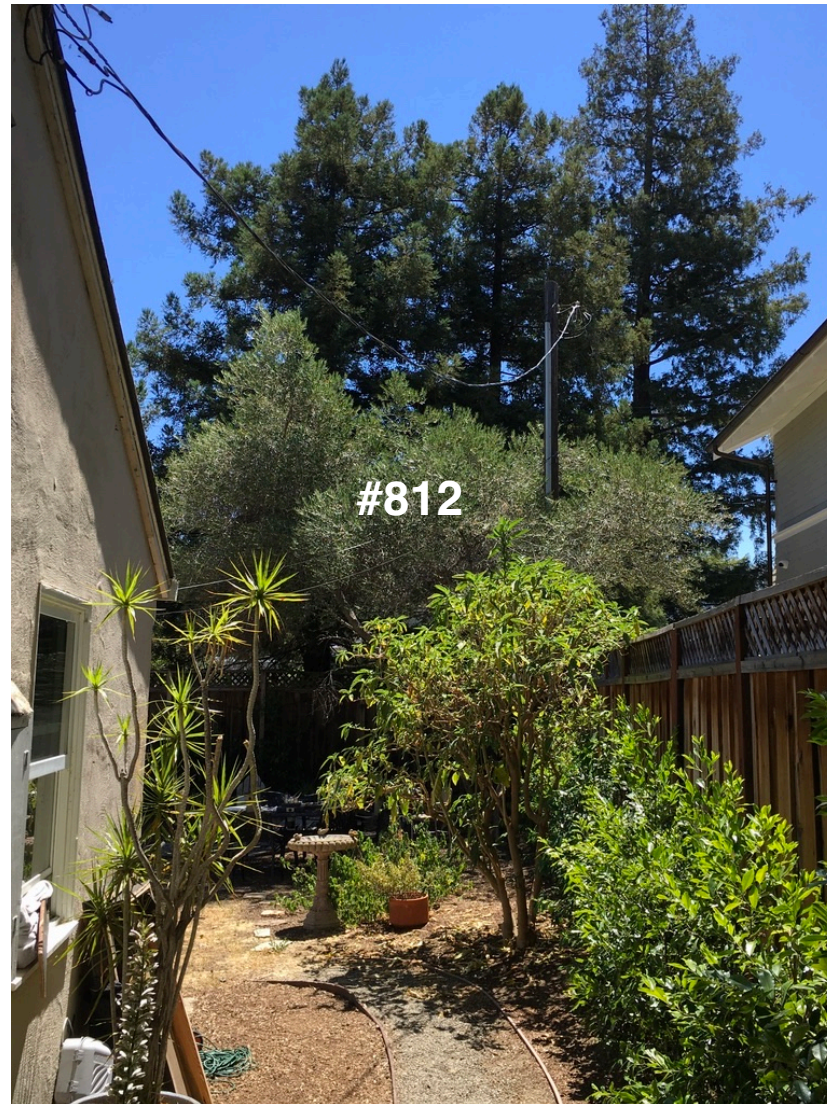
C2: Olive #812

The olive #812 will need to be removed but the tree is Exempt. The remaining coast redwoods in the back of the site #811, #810, and #809 along the alleyway will not likely be affected but neither the redwoods or the olive are not located on the plans.

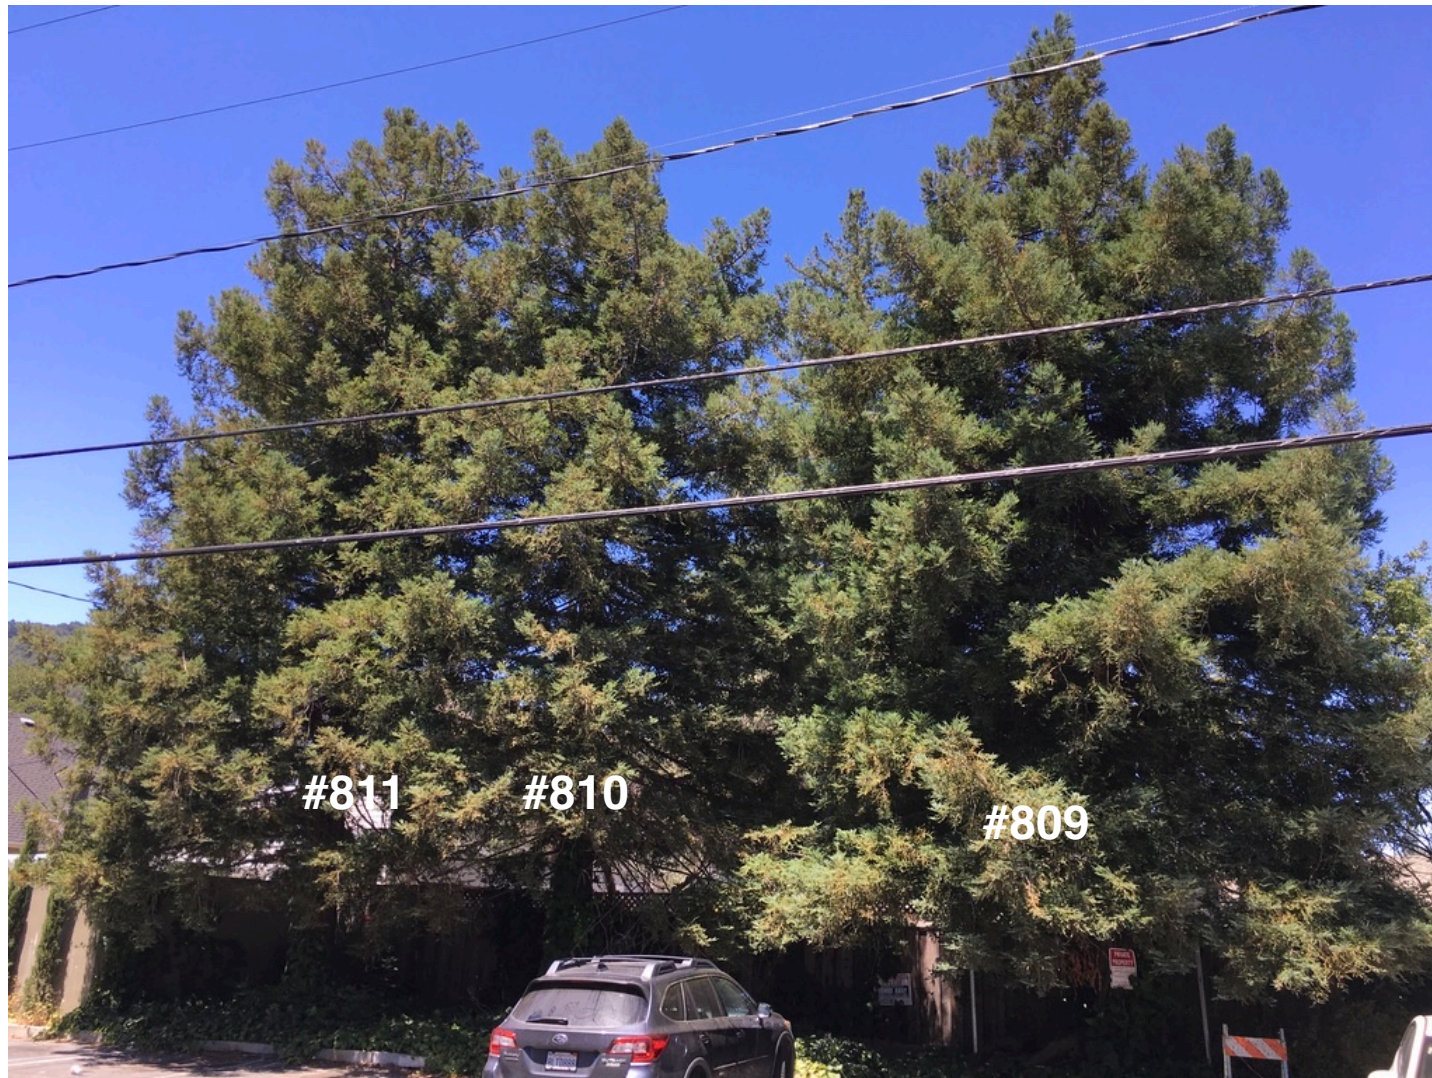
C3: Coast redwoods #811, #810, and #809

All the trees are in good overall condition with normal foliar color, size and density. The coast redwoods have single trunks and no descendable leans. The olive is multi-trunk but the growth habit of the tree is normal while somewhat suppressed under the coast redwoods in back.

Tree protection will include fence at sixteen feet for the coast redwoods in the back of the site (#811, #810, and #809) or maintaining the existing fence would likely be adequate. The olive will be removed so no protection is necessary.
