3/7/2025

Re: Tree protection for proposed renovation at 31 University Ave, Los Gatos, CA 95030

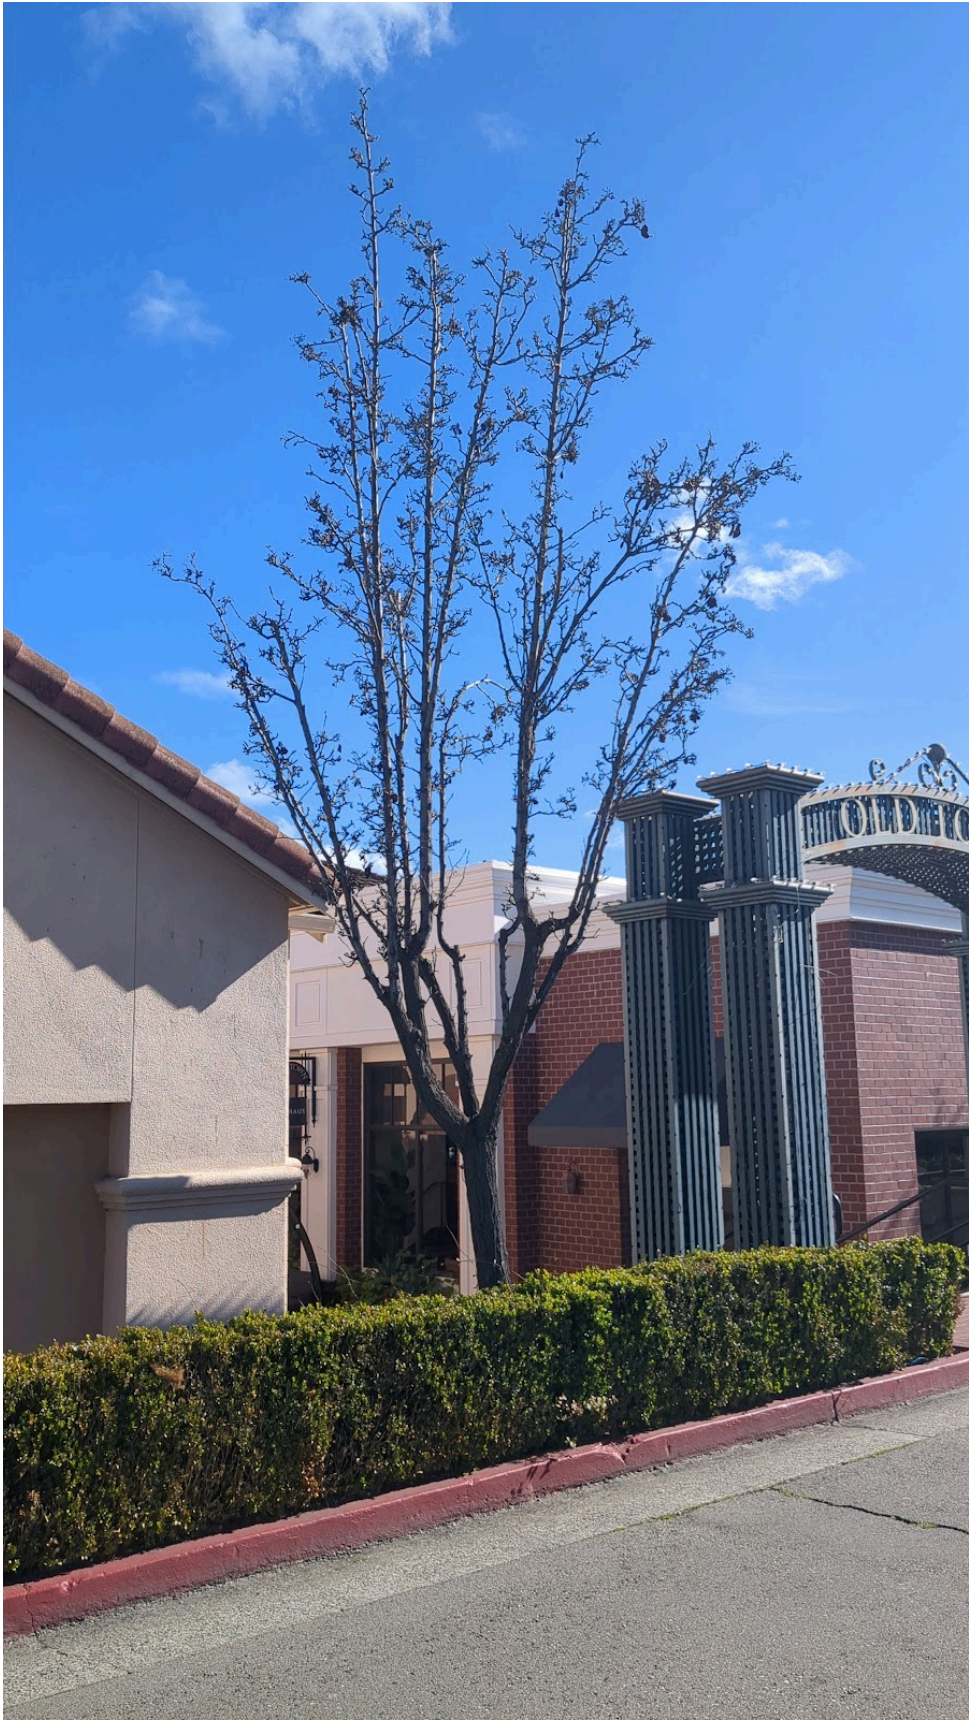
*Image 1: Callery pear #1*

Health - most trees present are in moderate to good health. Only trees #2, 3, 5, and 10 are in poor health.

Structure - most trees present exhibit good to moderate branching structure. Only trees #2 and 3 exhibit poor structure.

Form - Form refers to the tree's shape in relation to aesthetics, maintenance issues, conflicts with nearby objects, and similar items besides the tree's structure. Most trees present exhibit good to moderate form. Only trees #2, 3, and 10 exhibit poor form.

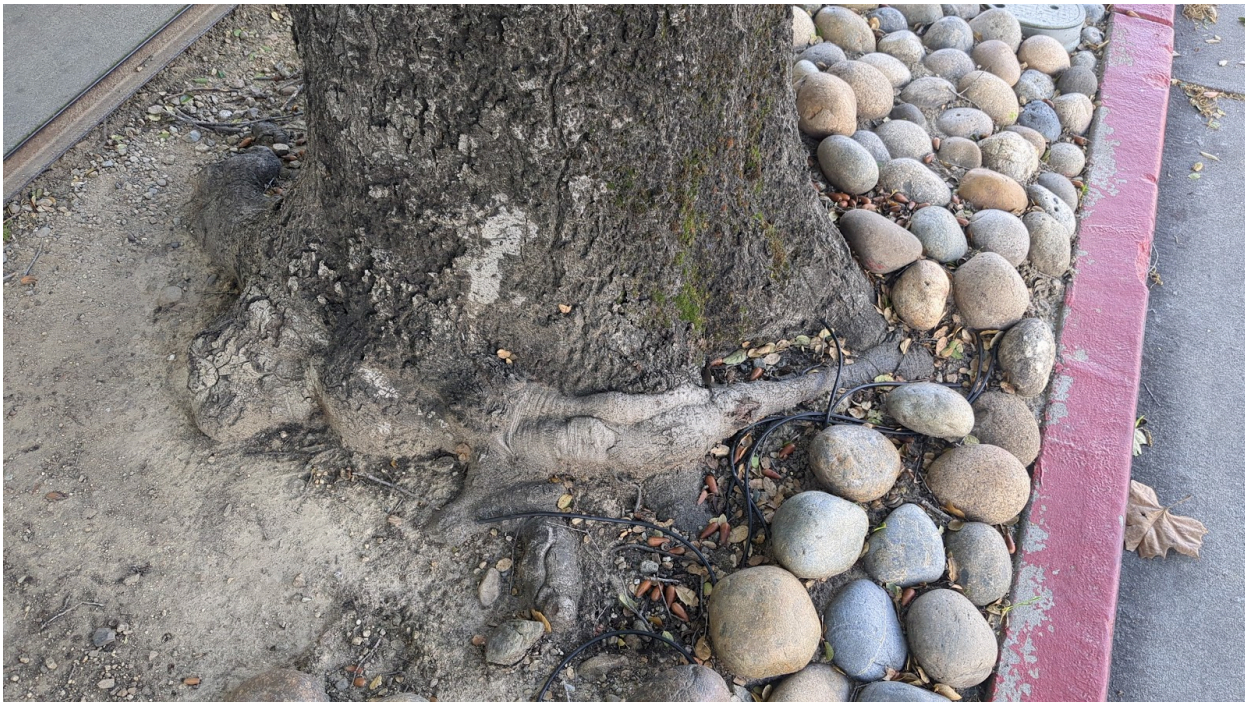
*Image 6b: girdling root on coast live oak #6*

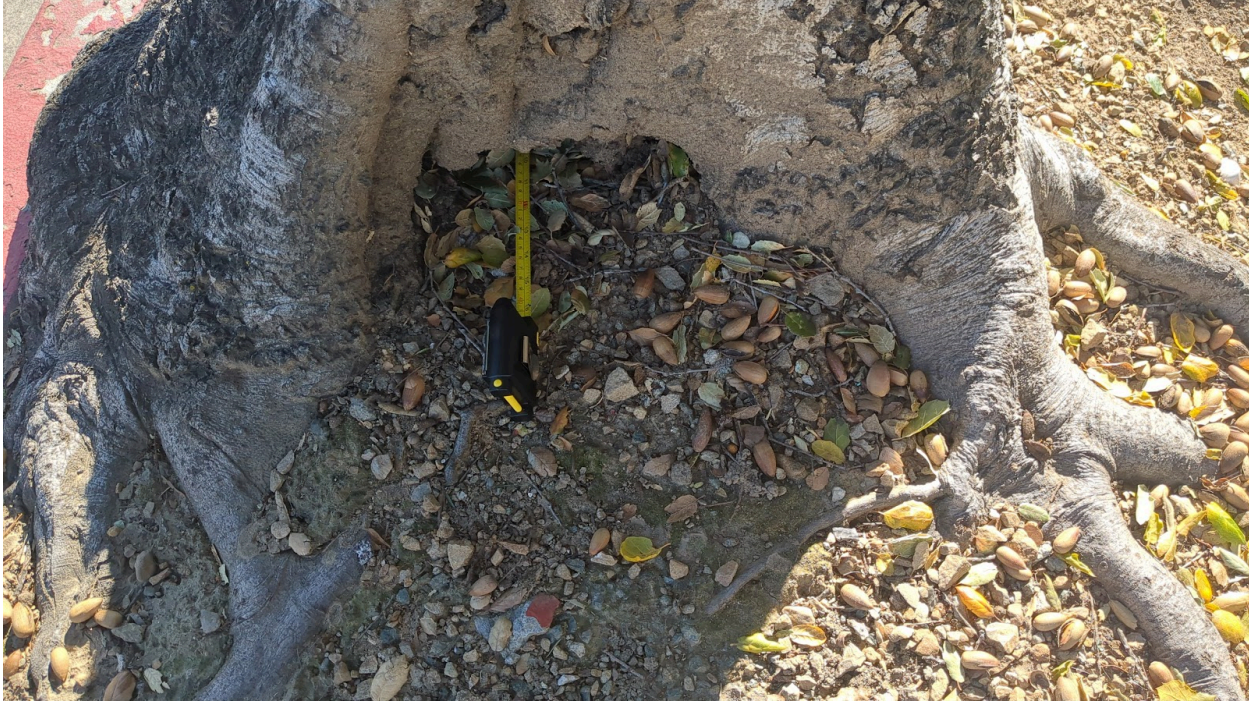
*Image 9b: decay cavity at base of coast live oak #9*

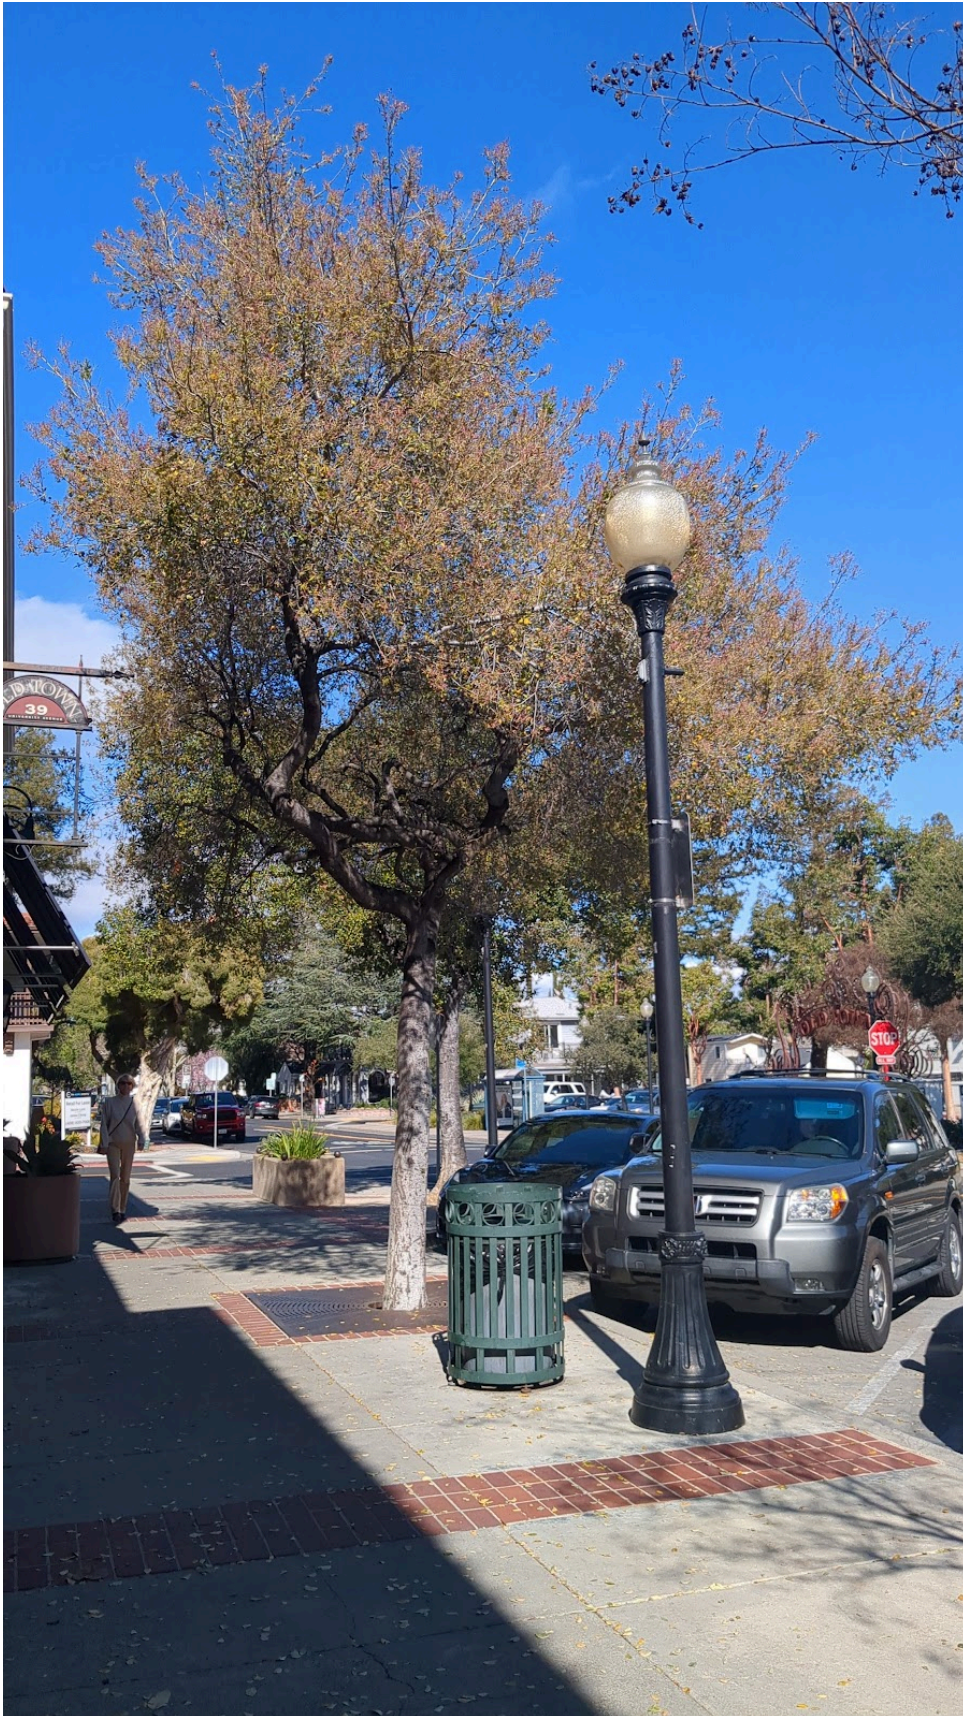
*Image 10: Coast live oak #10*

The sidewalk replacement along university has the potential to impact the TPZ<sup>1</sup> and CRZ<sup>2</sup> of tree #10, which has a 40% suitability for preservation due to its poor health and structure. Also, trees #11 and 12 will be removed due to the elimination of their tree wells and a new tree planted in the new well that is created between the two.

Tree #10 - the removal of the sidewalk may impact the health of this tree. This tree should be monitored, and removal and replacement should be considered.

1. Consider the relocation of two streetlights at least 10 ft from trees #10 and from the newly planted tree, to prevent damage to the streetlights, and prevent the need for improper pruning of the trees.
2. Consider the removal of tree #10, since so much concrete work will take place underneath it, and the damage may lead to the decline of the tree that had a 40% suitability for preservation.

5. Remove tree protection measures, upon approval from the Project Arborist and City Arborist.
6. If retained, provide supplemental irrigation for tree #10 to aid in root regrowth for at least three years.
  - a. Irrigate at a very slow trickle for several hours to ensure infiltration. Once per month is usually sufficient.
  - b. COAST LIVE OAKS/DEODAR CEDARS Irrigation should only take place in the normal rainy season for this area (October - April), and only if rainfall is below average.
  - c. All other species should be irrigated year-round.
  - d. Irrigation should be paused during the rainy season if rainfall is average or above.

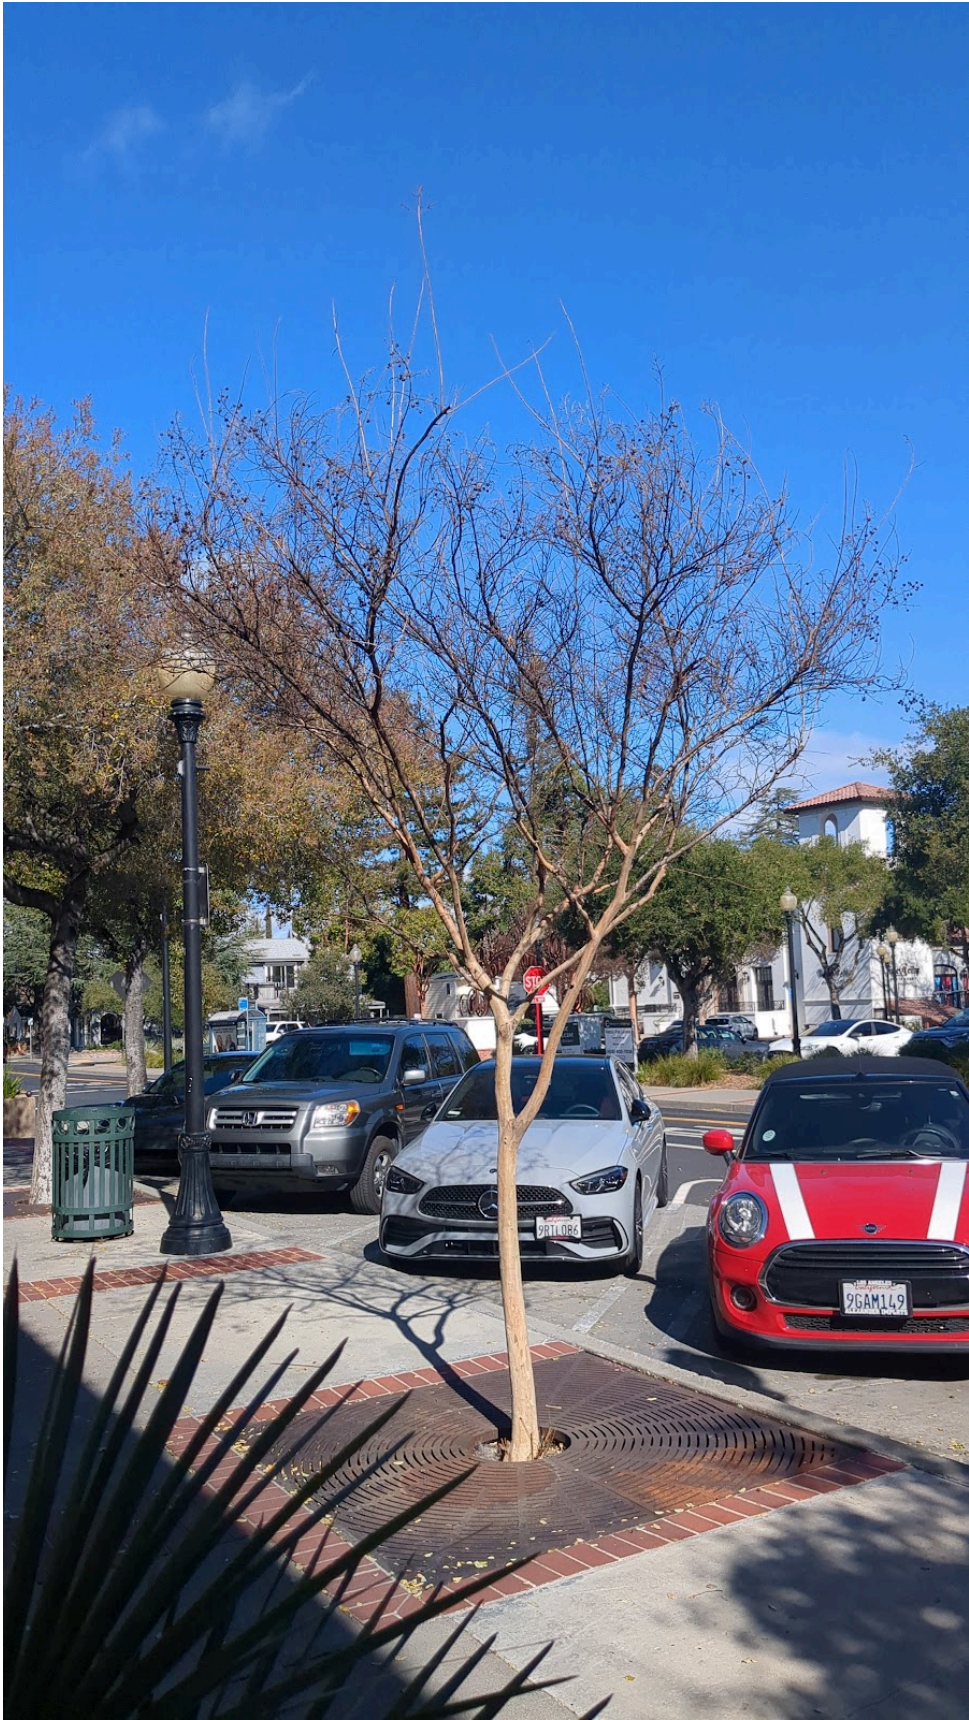
Image 11: Crape myrtle #11

**HARDSCAPE** - the sidewalk along University Ave will be removed and replaced, and the location of the two tree wells #11 and 12 will be willed in and replaced with a tree well in between the two.

Trees #11 and 12 - these trees will be removed for construction to be replaced with a new tree

1. Remove trees #11 and 12, upon receipt of a permit from the Town of Los Gatos. The reason for removal is as follows:
