**Tree Inventory, Assessment,
and
Protection**

**15365 Santella Court
Los Gatos, CA 95032**

Town of Los Gatos

November 29, 2018

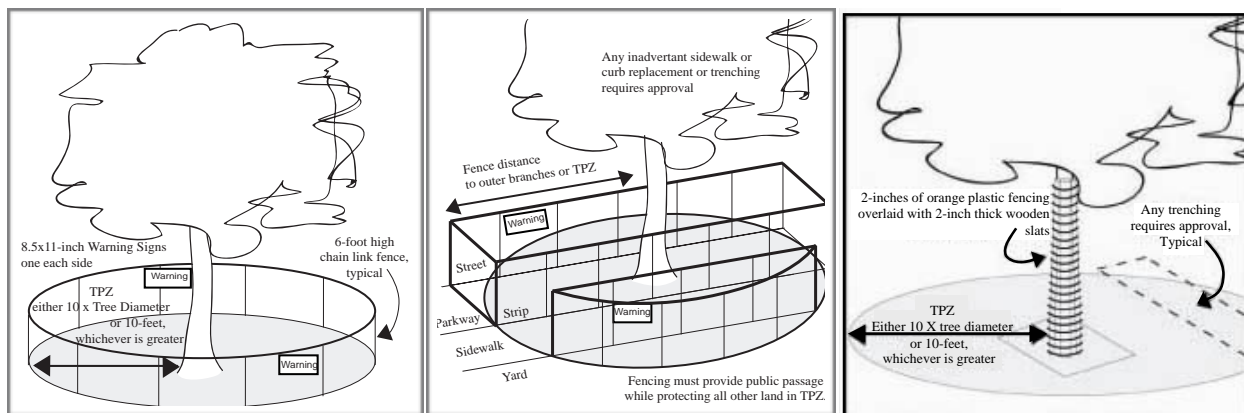
Figure 1: Type I Tree protection with fence placed at a radius of ten times the trunk diameter. Image City of Palo Alto 2006.

Figure 2: Type II Tree protection with fence placed along the sidewalk and curb to enclose the tree. Image City of Palo Alto 2006.

Figure 3: Type III Tree protection with trunk protected by a barrier to prevent mechanical damage. Image City of Palo Alto 2006.

Tree protection for this project would consist of a modified Type I scheme with the retained trees all located around the perimeter of the site. The tree protection fence should be placed no closer than six times the trunk diameter distances in feet and preferably twelve.

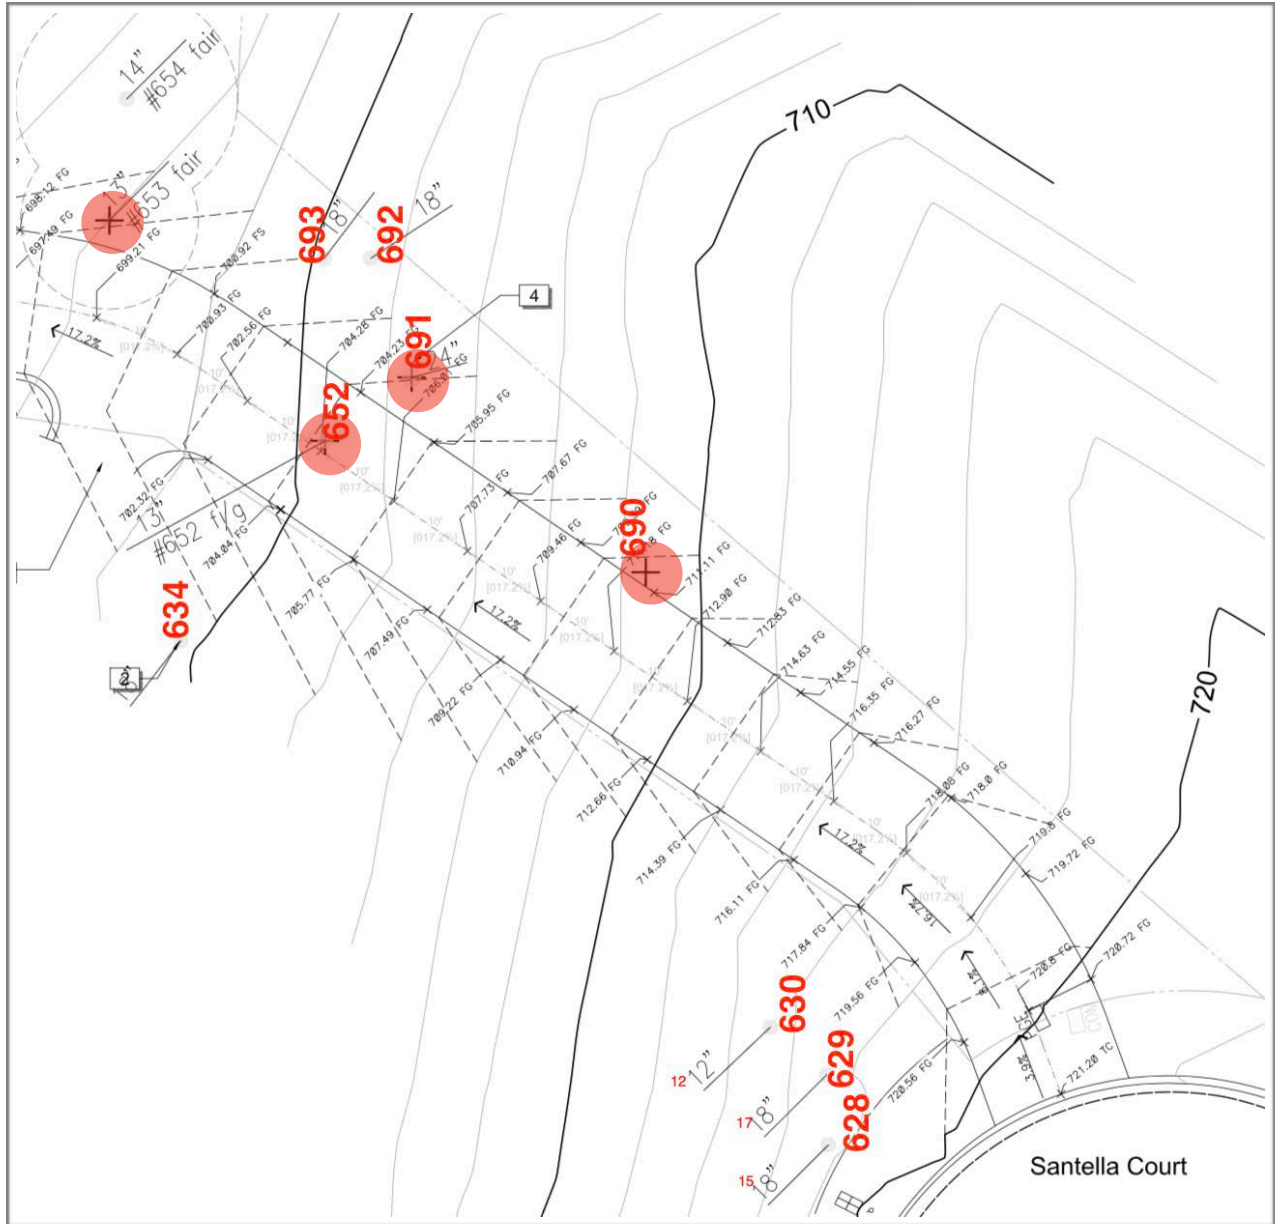
A1: Driveway entrance

Sheet taken from L1 (Red circles indicate removals/highly impacted)

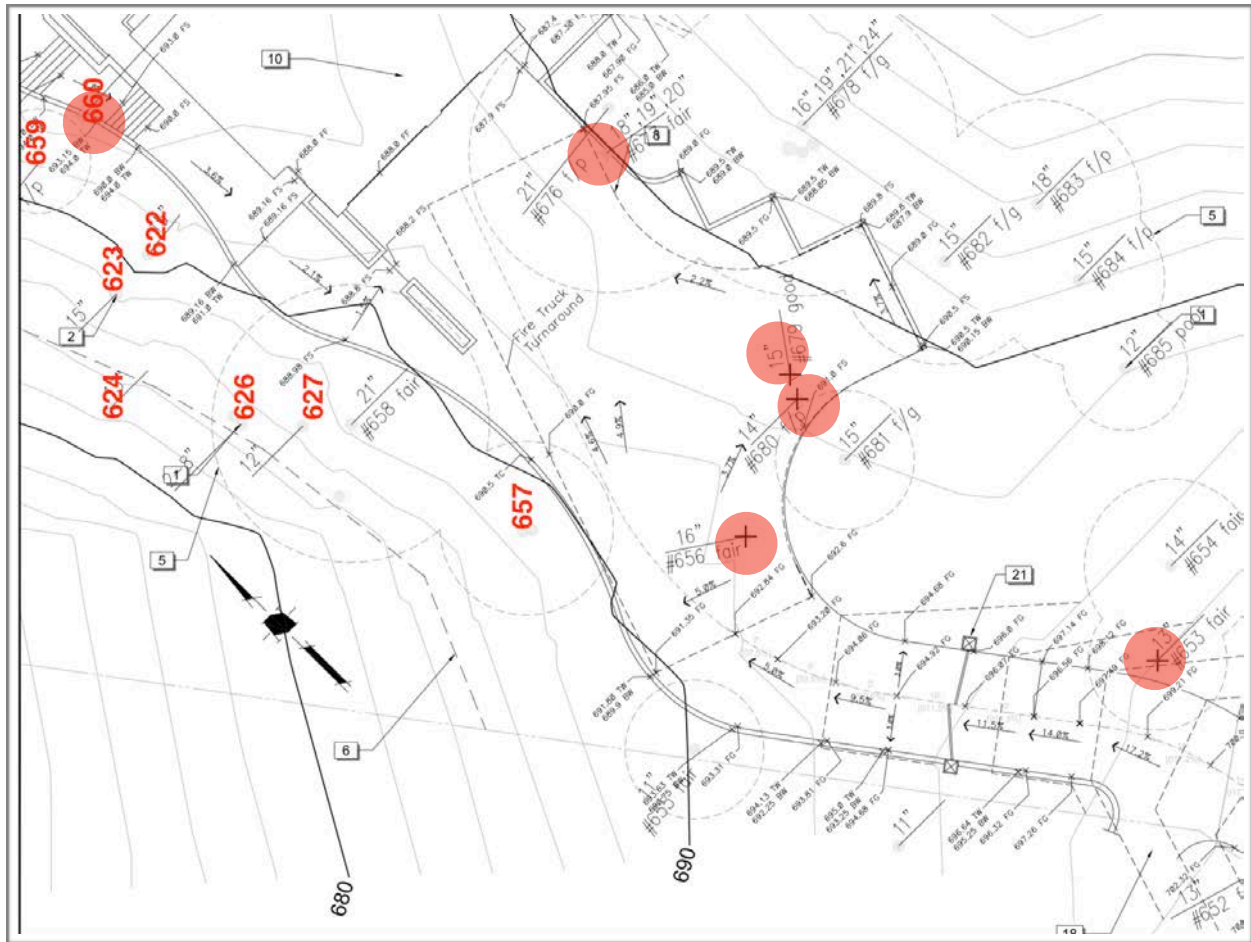
A2: Driveway and Hammerhead

Sheet taken from L1 (Red circles indicate removals/highly impacted)

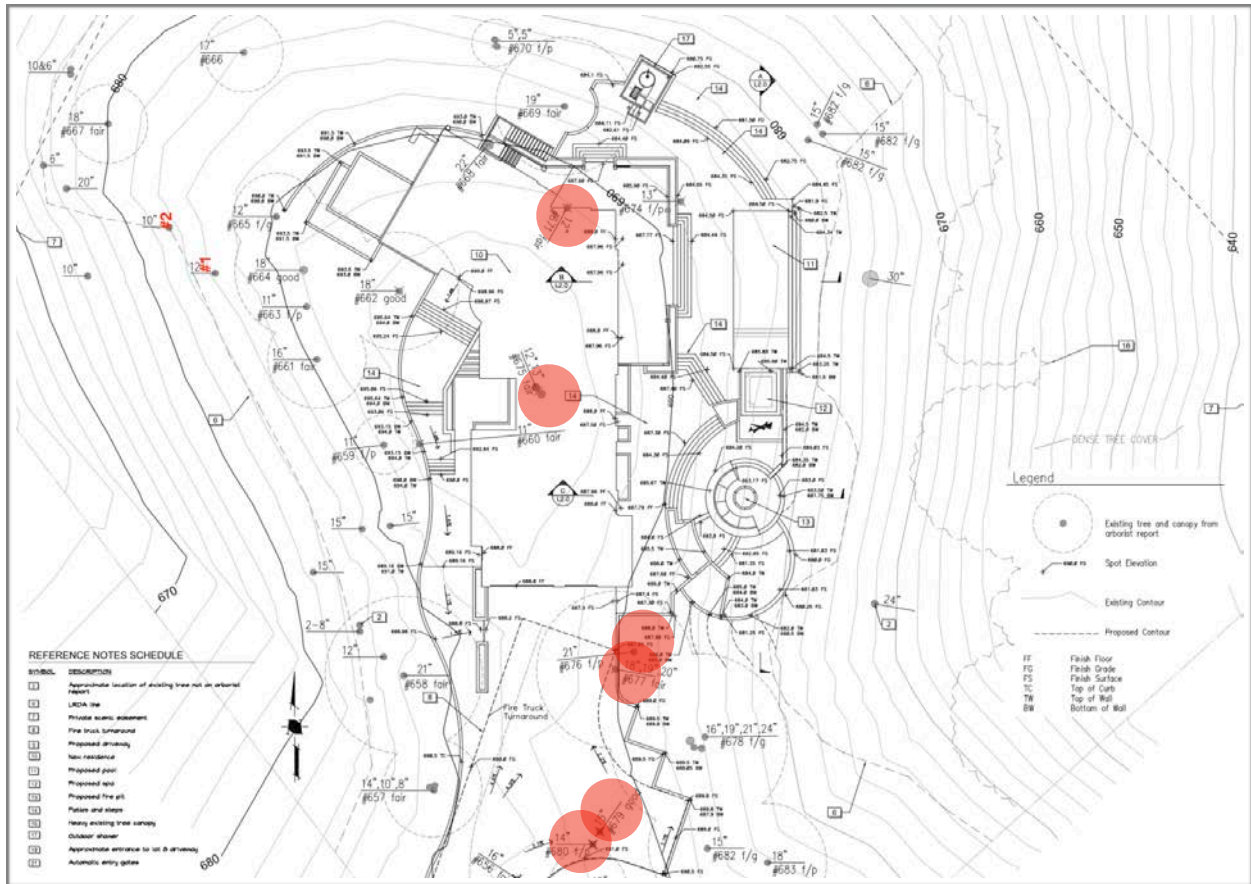
A3: Residence

Sheet taken from L2 (Red circles indicate removals/highly impacted)
