August 15, 2019

Monarch Consulting Arborists LLC
P.O. Box 1010
Felton, CA 95018
831.331.8982

I was asked to locate and inspect the indicated additional trees down slope on 15365 Santella Court (Appendix A). The trees were to be assessed as part of the visibility analysis to help determine their condition. One tree had previously been labeled #244 "blue oak" which is in fact a 36 inch trunk diameter coast live oak (*Quercus agrifolia*).

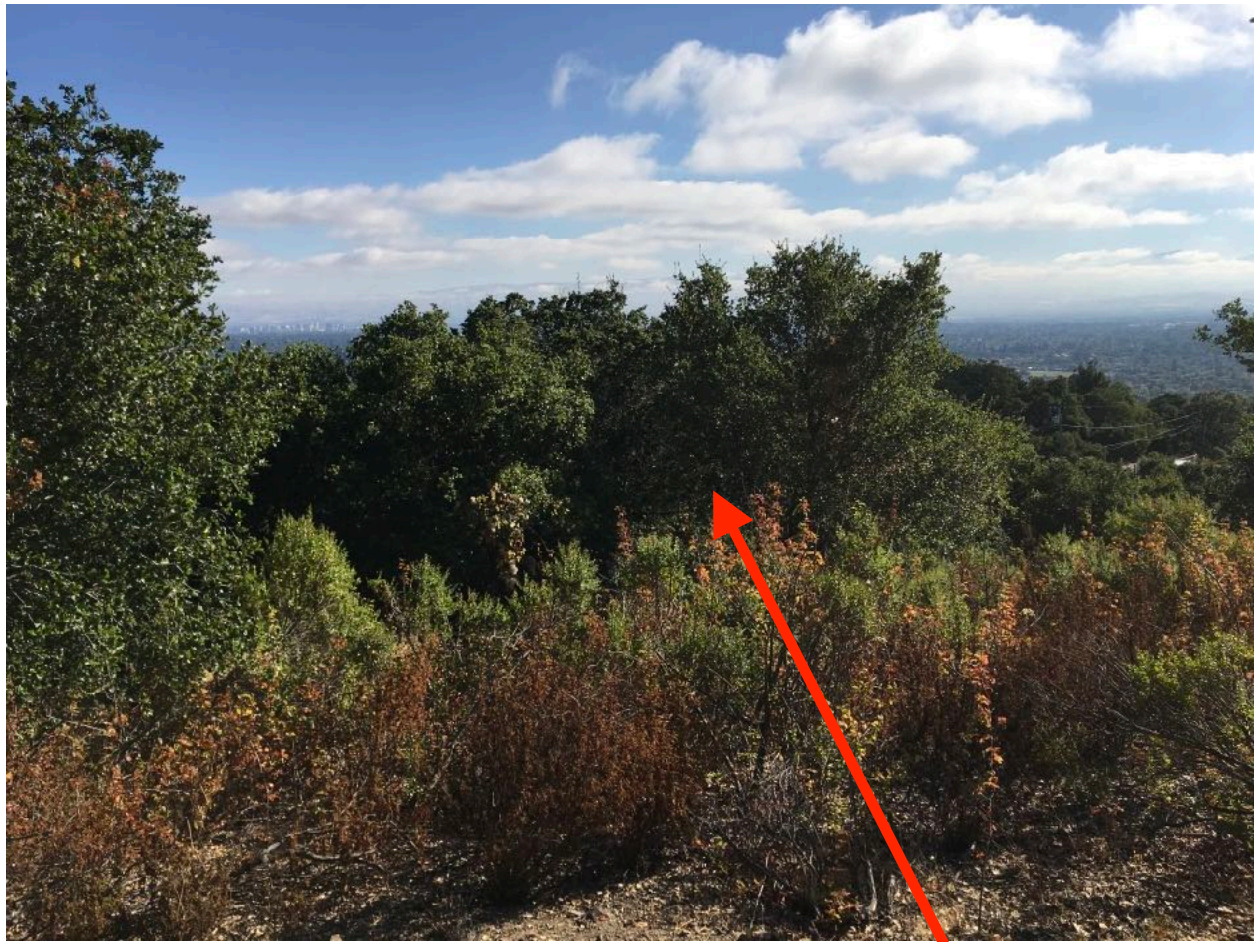
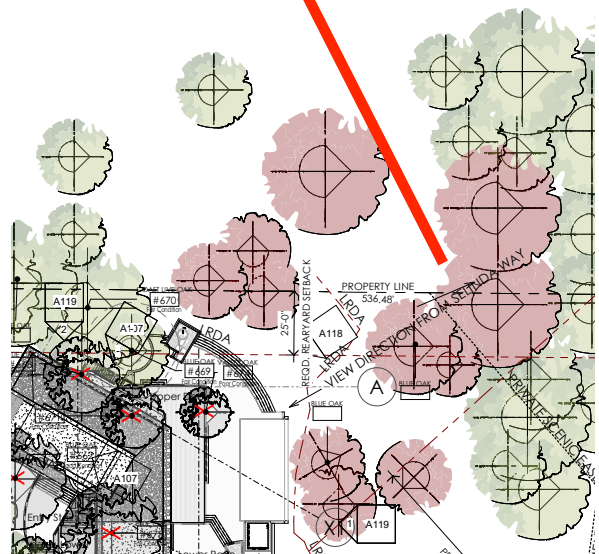
B3: Northeast area

The area where the trees are located to the northeast is a dense stand of coast live oaks (*Quercus agrifolia*). The composition of plants are typical for this area and there are the usual oak woodland species such as poison oak, manzanita (*Arctostaphylos sp.*), and coyote brush (*Baccharis pilularis*). The majority of trees are naturally occurring coast live oaks, most with multiple trunks approximately 8-10 inches in diameter, and are about 25 to 35 feet tall with 25 to 35 foot canopy diameters. This stand of trees along the northeast portion of the site is in good condition with dense crowns and normal foliar color and size (Appendix B). Along the northwest portion there were three trees on the lower slope indicated in the plan which are all blue oak (*Quercus douglasii*) with trunk diameters about 10 to 12 inches and are approximately 30 feet tall with crown diameters of about 30 feet. These trees are in fair to good condition growing amongst the stand indicated as #1 and #2 in my original report.
