Subj: Structural and Condition Photos

Location: 16805 Loma Street

Date: 3/25/2025

## 16805 Loma Street Structural Photos

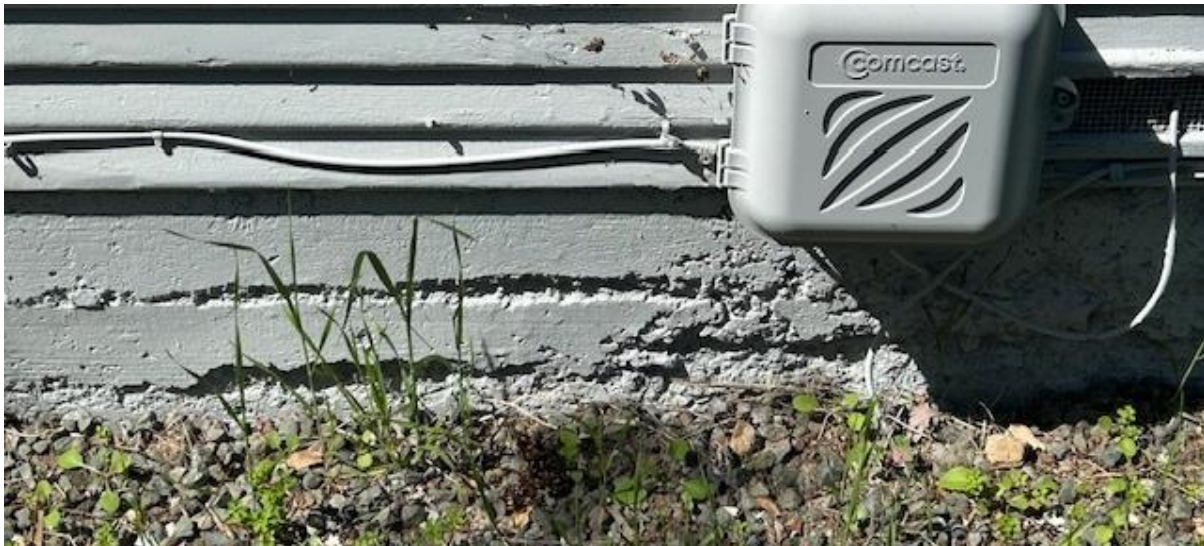
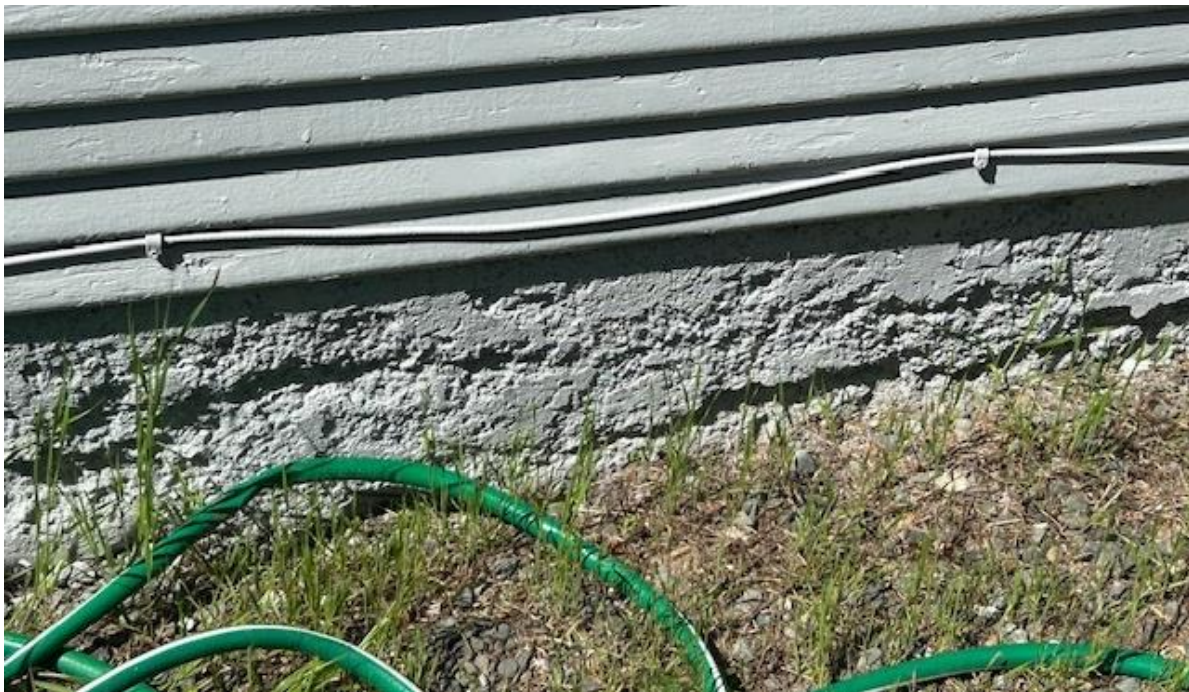
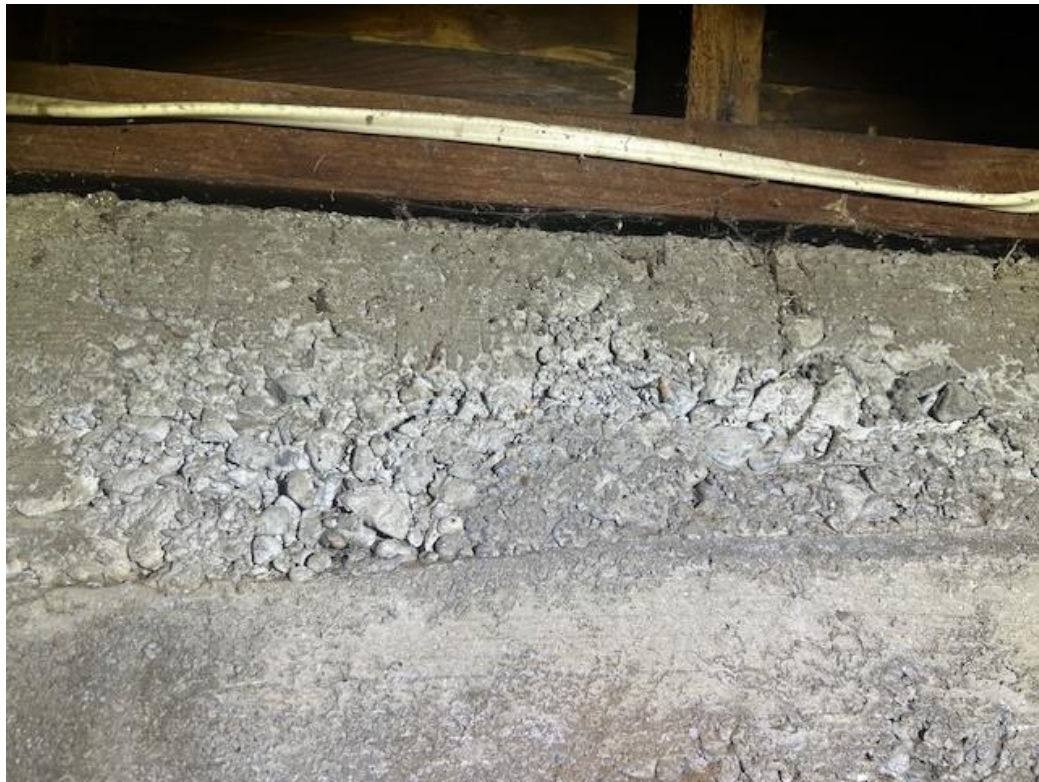
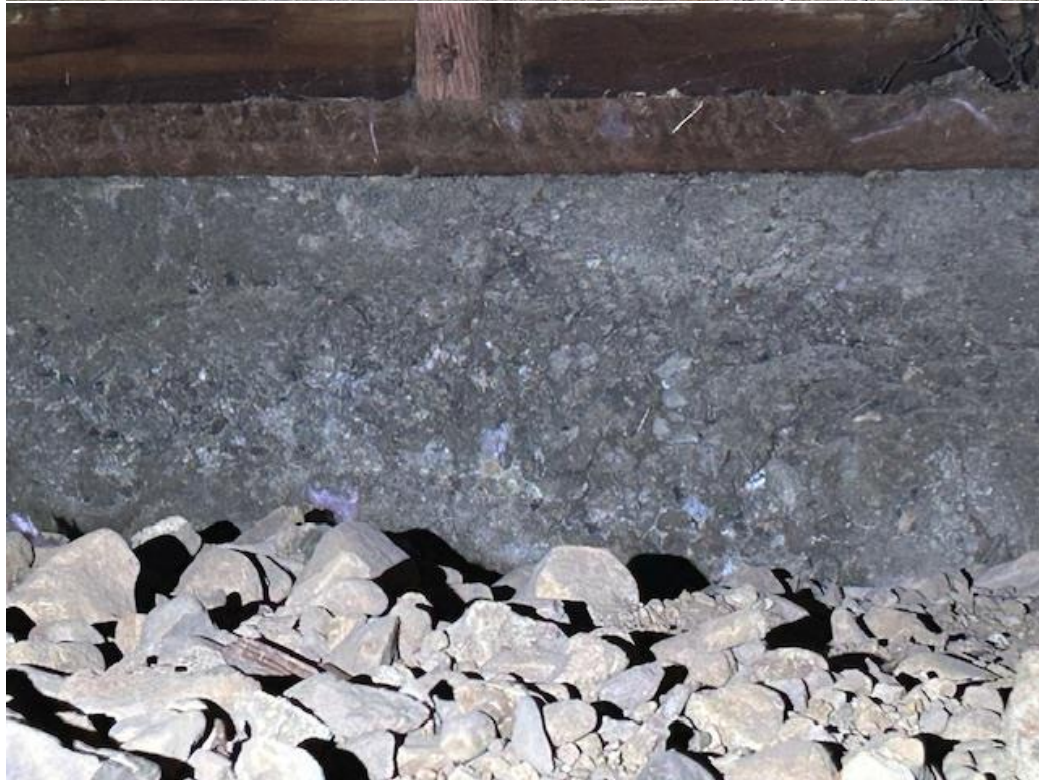
1A. Exterior/Interior Foundation Spalling (painted over recently)

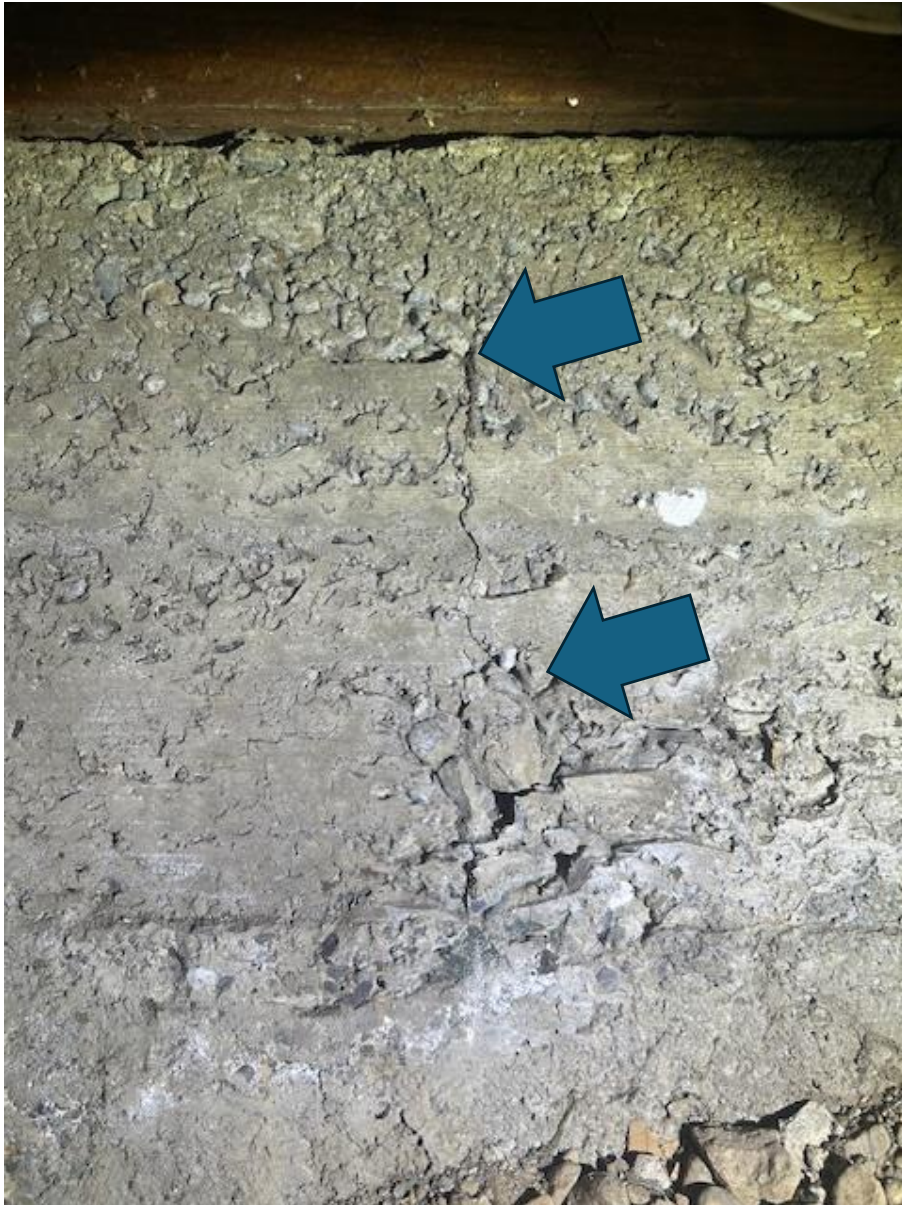
1B. Vertical cracks (front right section)

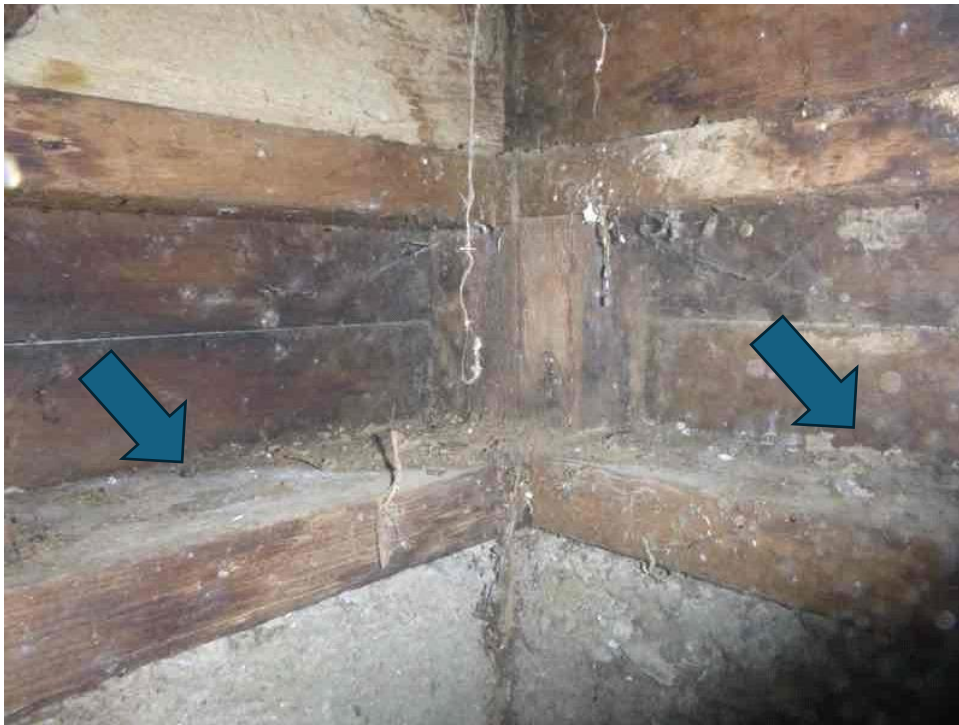
1C. No anchor bolts (Note: this signifies a high probability of no rebar in the foundation walls)

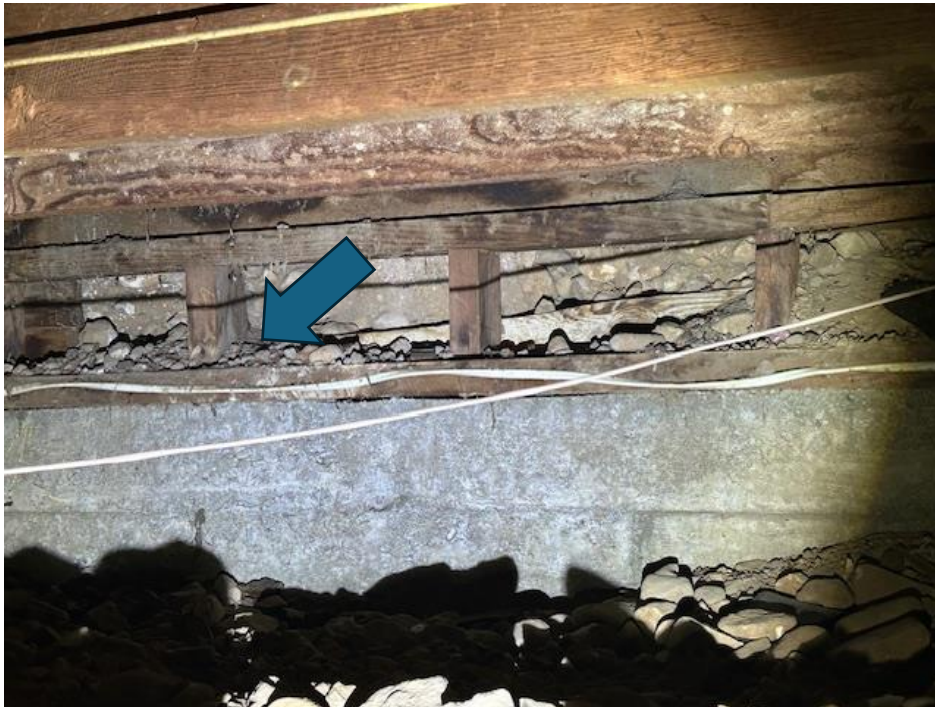
2A. Cripple wall framing on the foundation wall

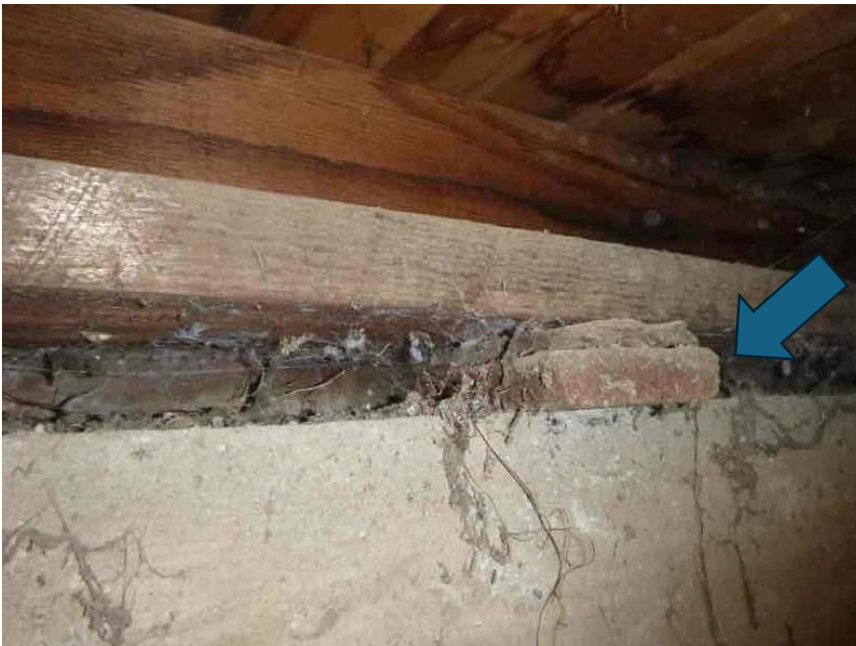
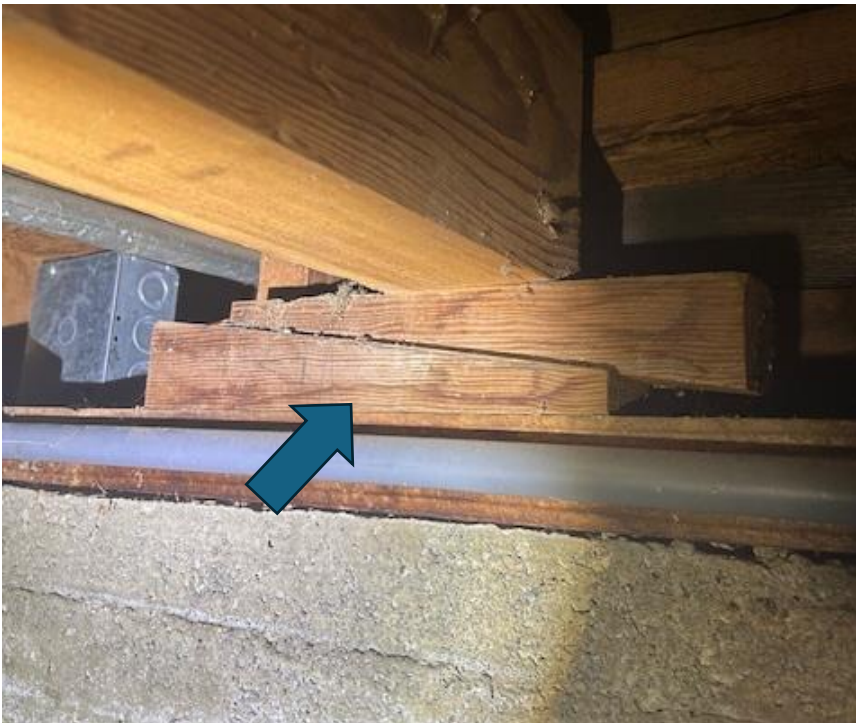
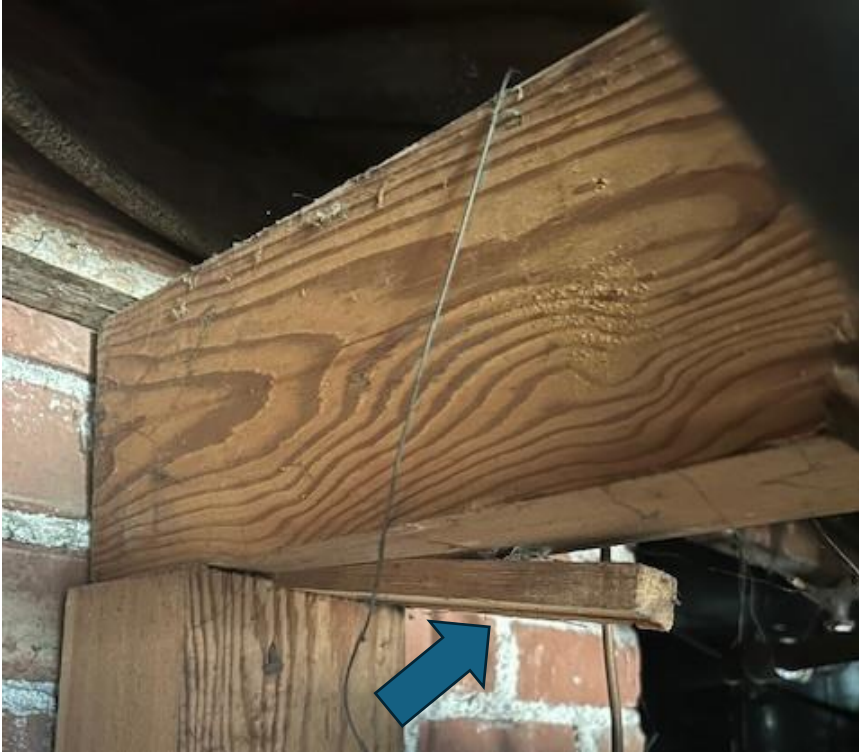
2B. Shimmed floor joists and mud sill

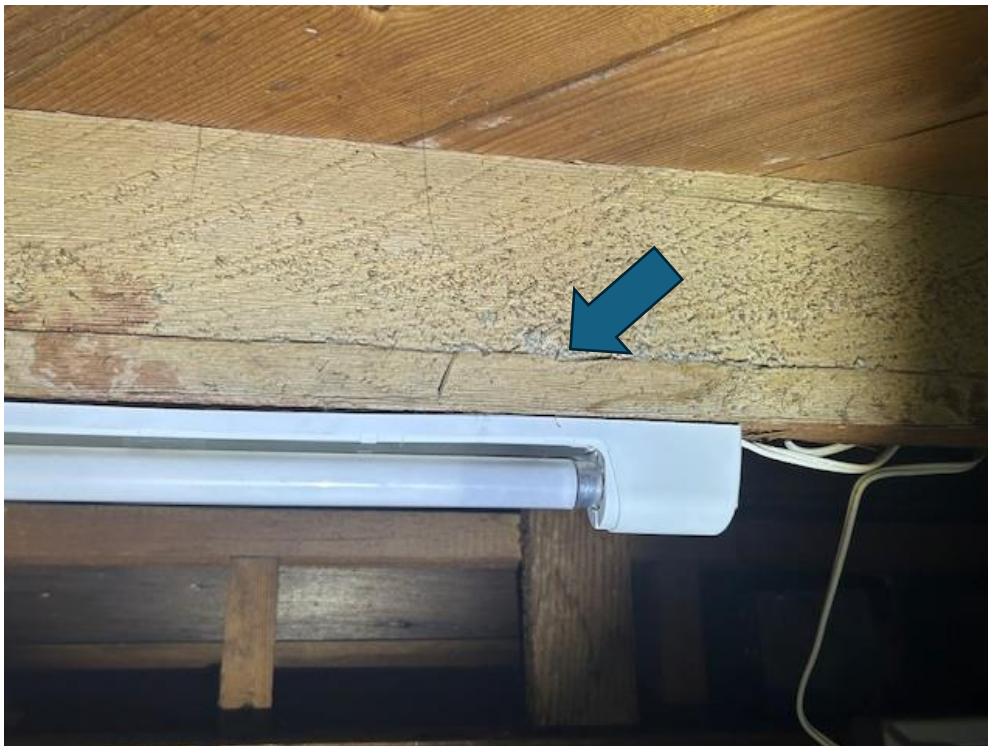
2C. Cracked 2x6 floor joists. Some spans are up to 9 feet.

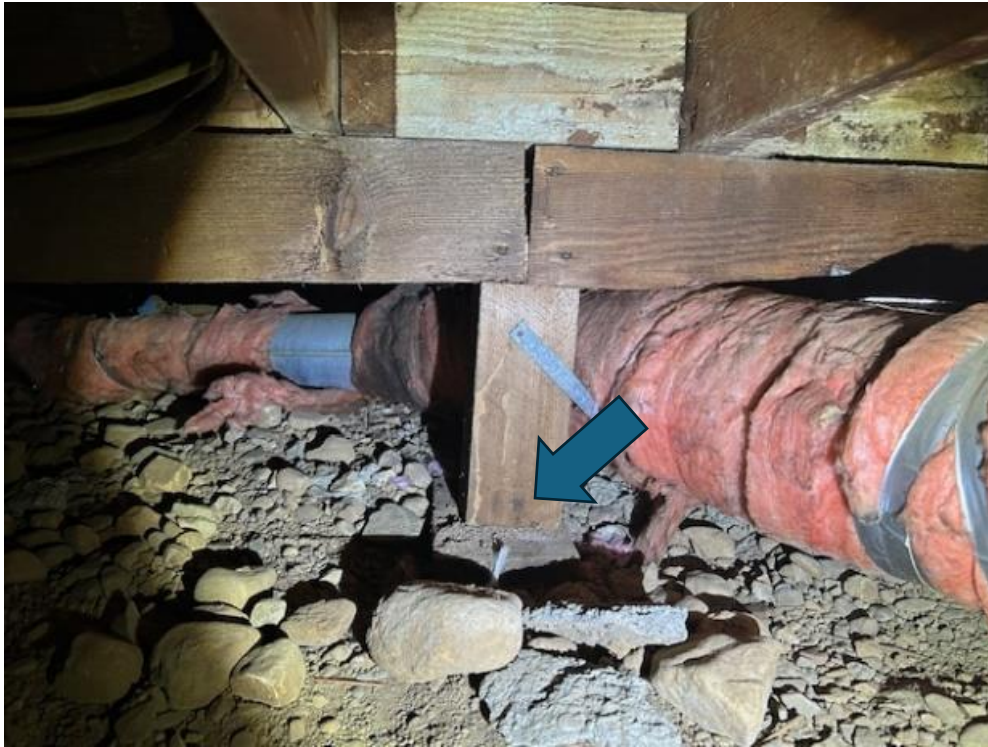
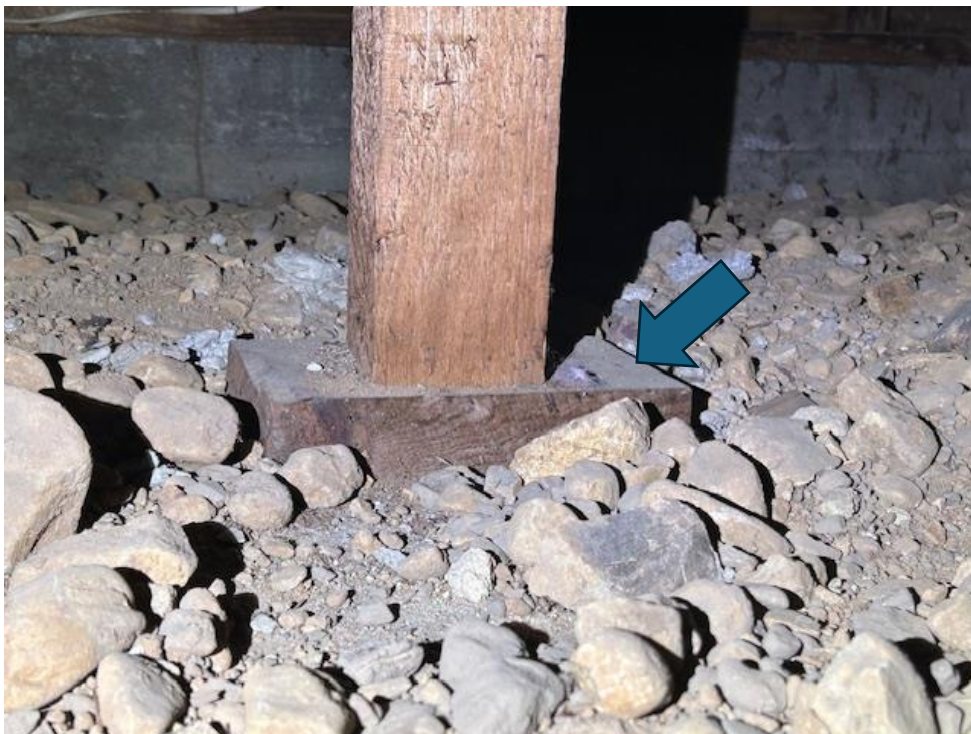
2D. Post framing against dirt.

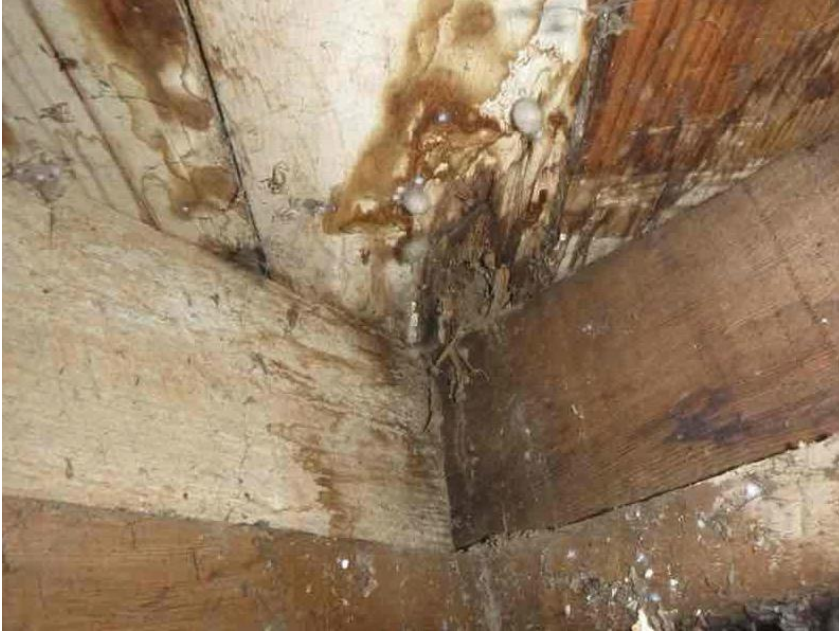
2E. Subfloor damage

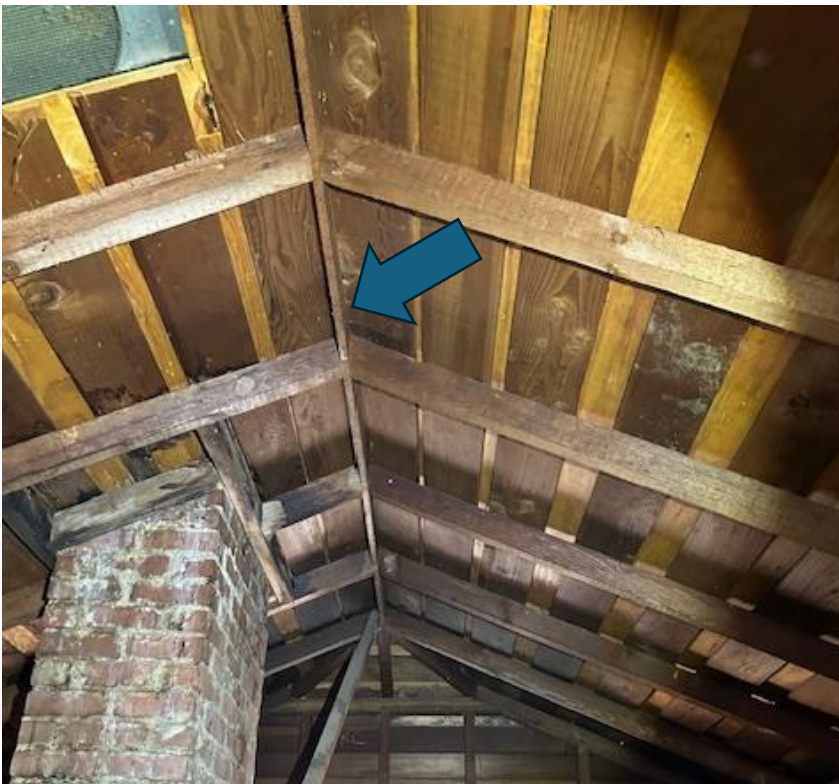
3A. 1x6 ridge beams

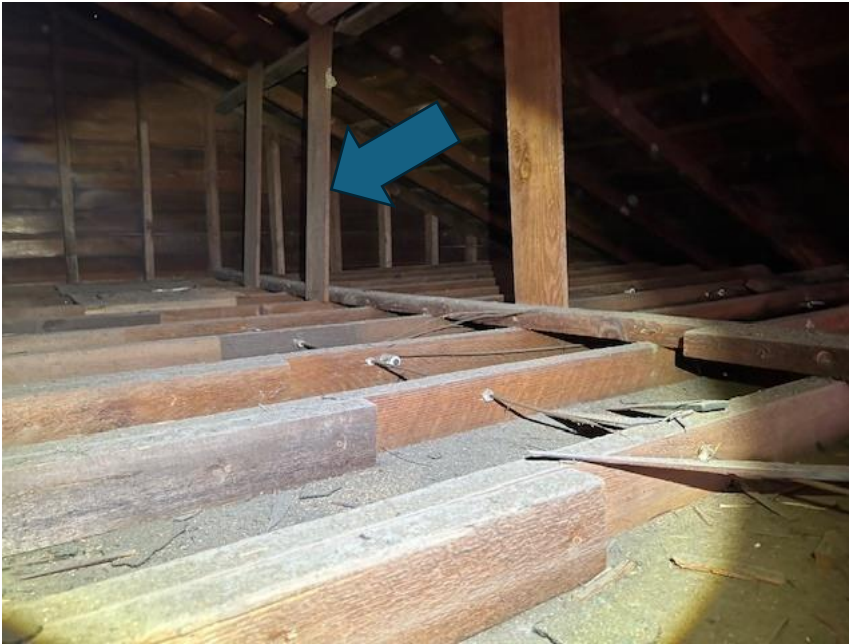
3B. No purlins (just vertical 1x6s)

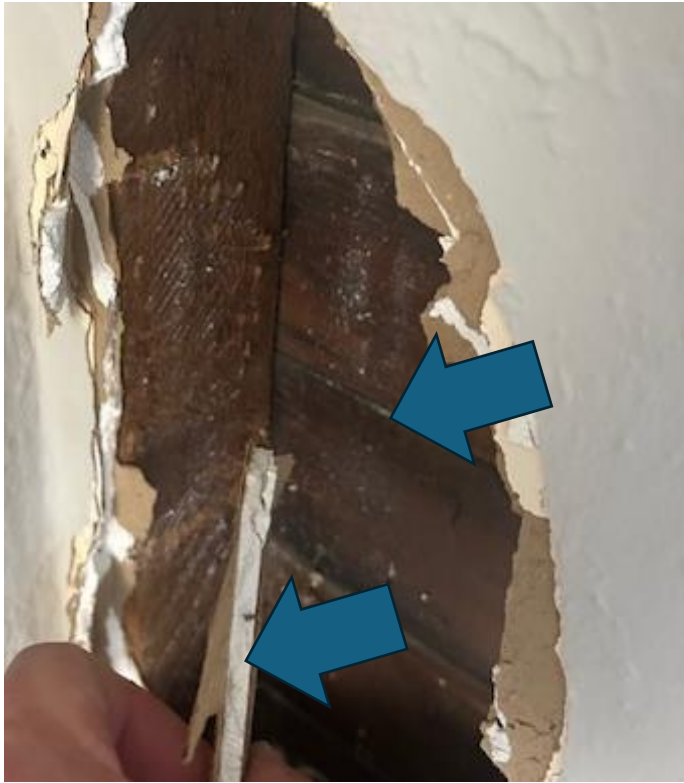
5A-C. No shear walls or exterior plywood sheathing (1X4 siding shown). No insulation and ¼ drywall installed in multiple rooms.

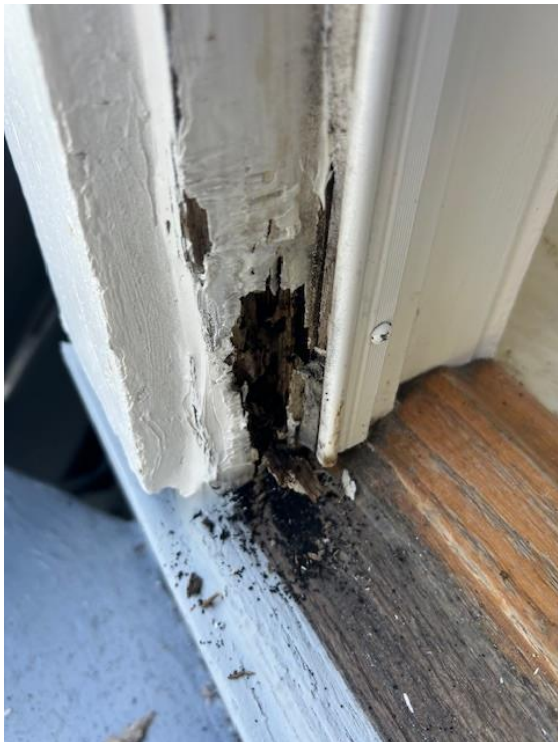
5D. Termite damage (rear door)

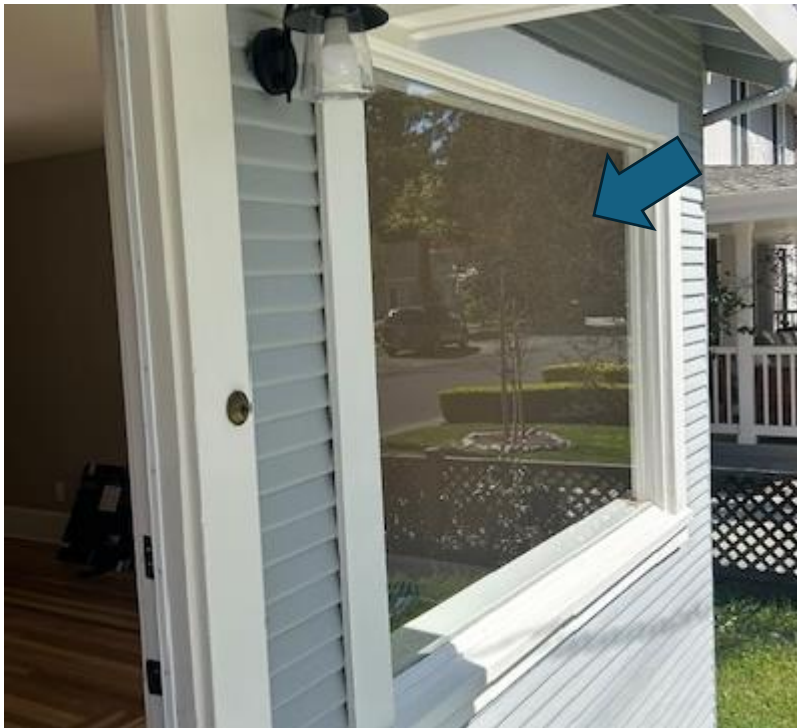
5E. Single pane windows (not original)

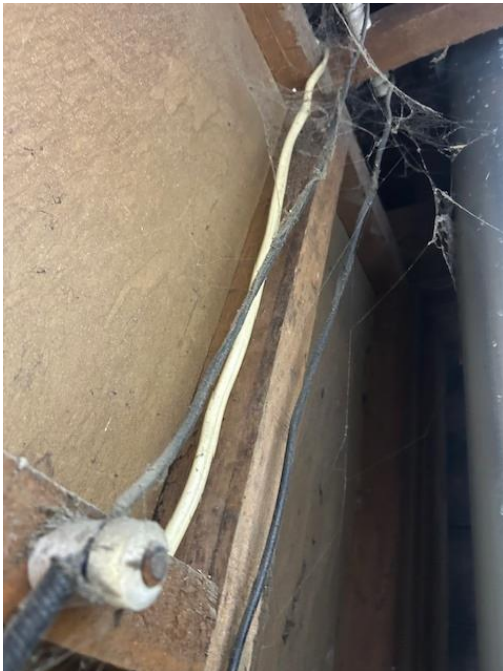
5F. Knob and tube wiring

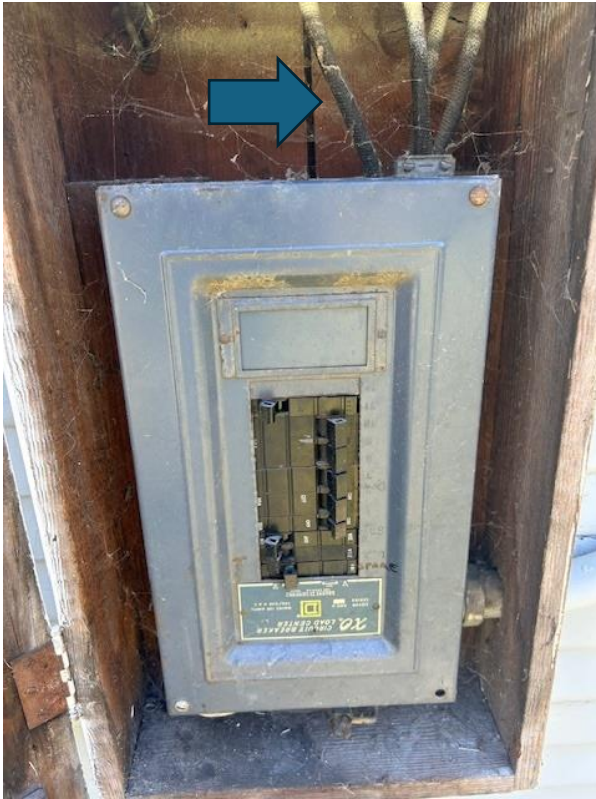
5G. Electrical Panel (unknown amps) with cloth wrapped wiring

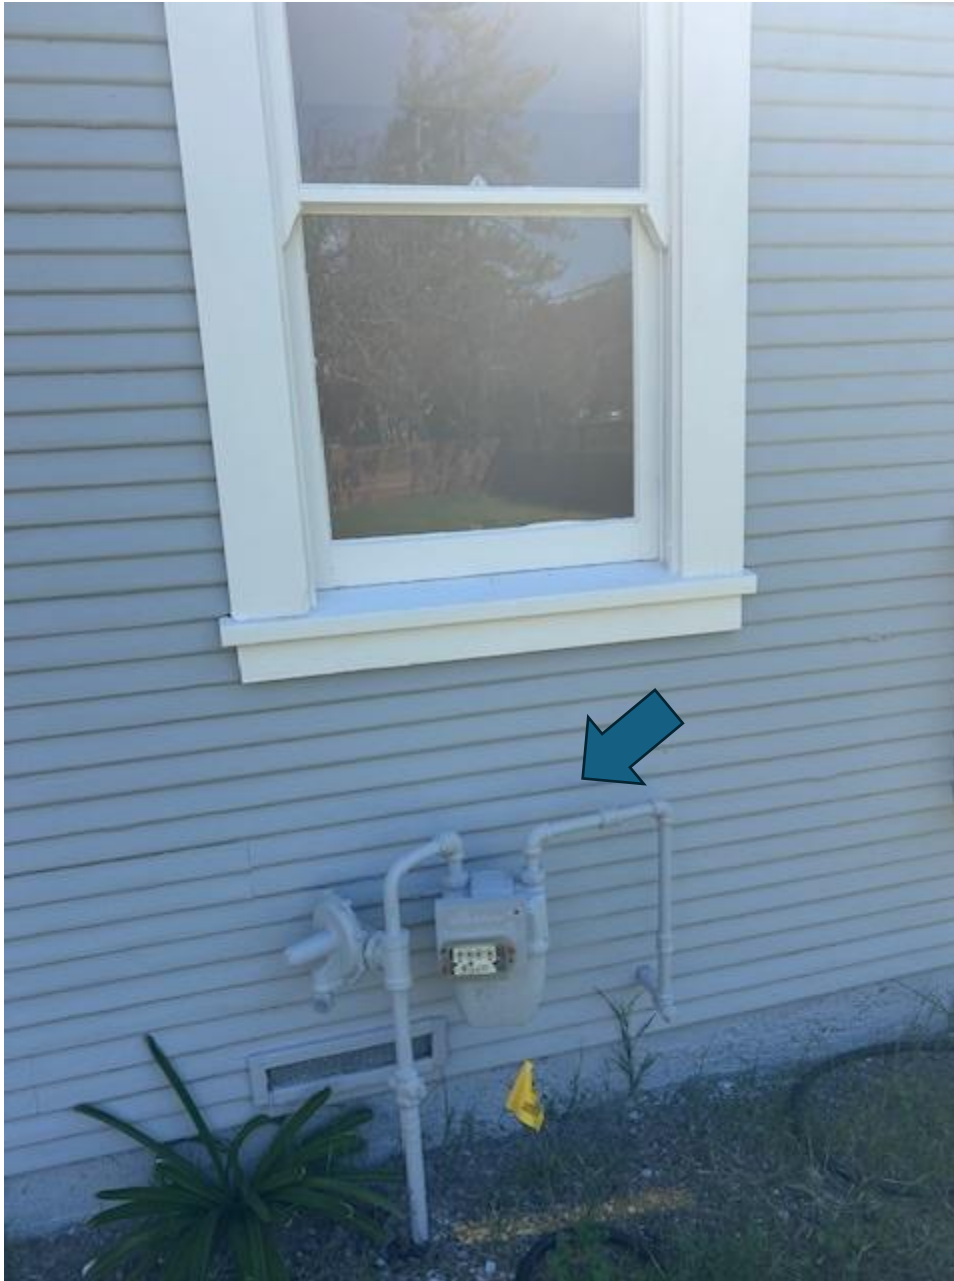
5G. Gas meter location under window (Not allowed)
