November 27, 2023

**Tree Inventory, Assessment,
and
Protection**

**15365 Santella Court
Los Gatos, CA 95032**

**November 29, 2018
Revised
December 9, 2019**

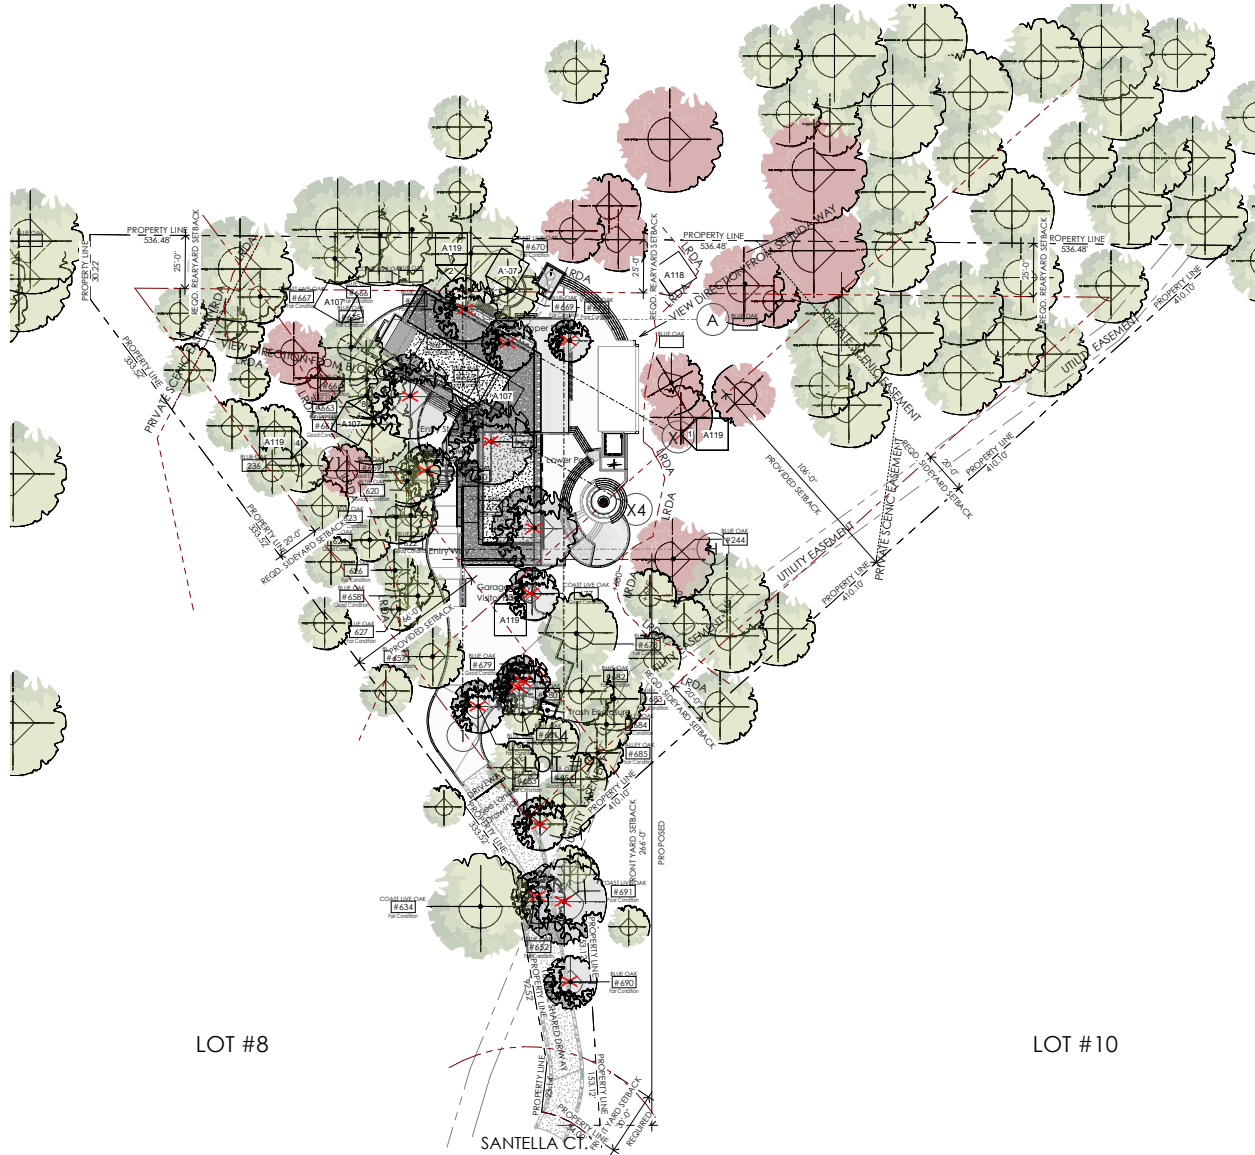
Appendix A: Aerial image provided for assessment

Snapshot not to scale from A120 dated October 19, 2018 provided by Srusti Architecture. The trees in pink are indicated in this report.

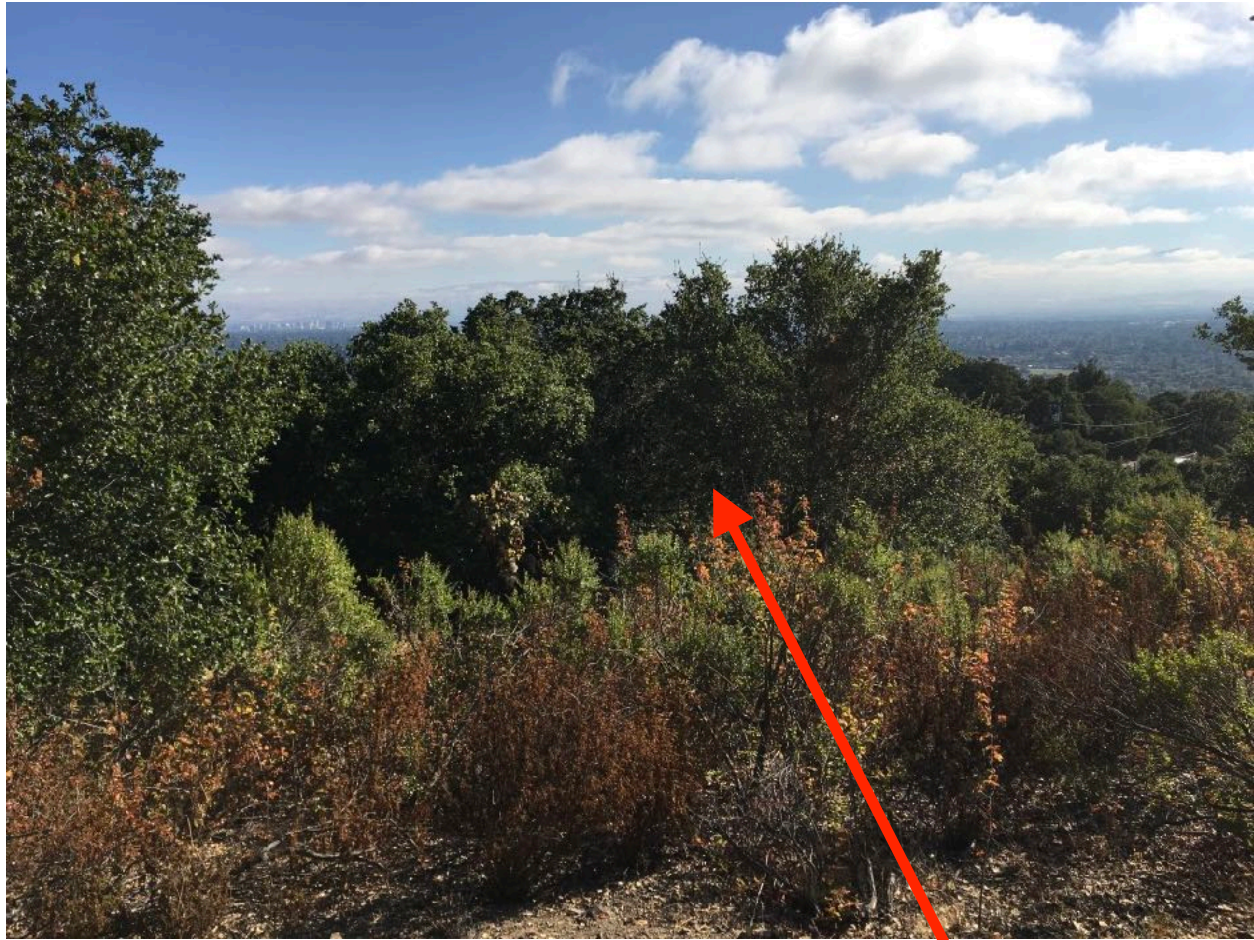
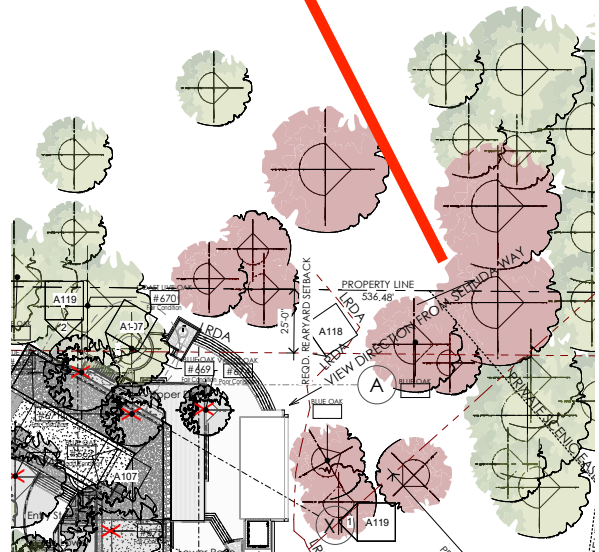
B3: Northeast area

The area where the trees are located to the northeast is a dense stand of coast live oaks (*Quercus agrifolia*). The composition of plants are typical for this area and there are the usual oak woodland species such as poison oak, manzanita (*Arctostaphylos sp.*), and coyote brush (*Baccharis pilularis*). The majority of trees are naturally occurring coast live oaks, most with multiple trunks approximately 8-10 inches in diameter, and are about 25 to 35 feet tall with 25 to 35 foot canopy diameters. This stand of trees along the northeast portion of the site is in good condition with dense crowns and normal foliar color and size (Appendix B). Along the northwest portion there were three trees on the lower slope indicated in the plan which are all blue oak (*Quercus douglasii*) with trunk diameters about 10 to 12 inches and are approximately 30 feet tall with crown diameters of about 30 feet. These trees are in fair to good condition growing amongst the stand indicated as #1 and #2 in my original report.

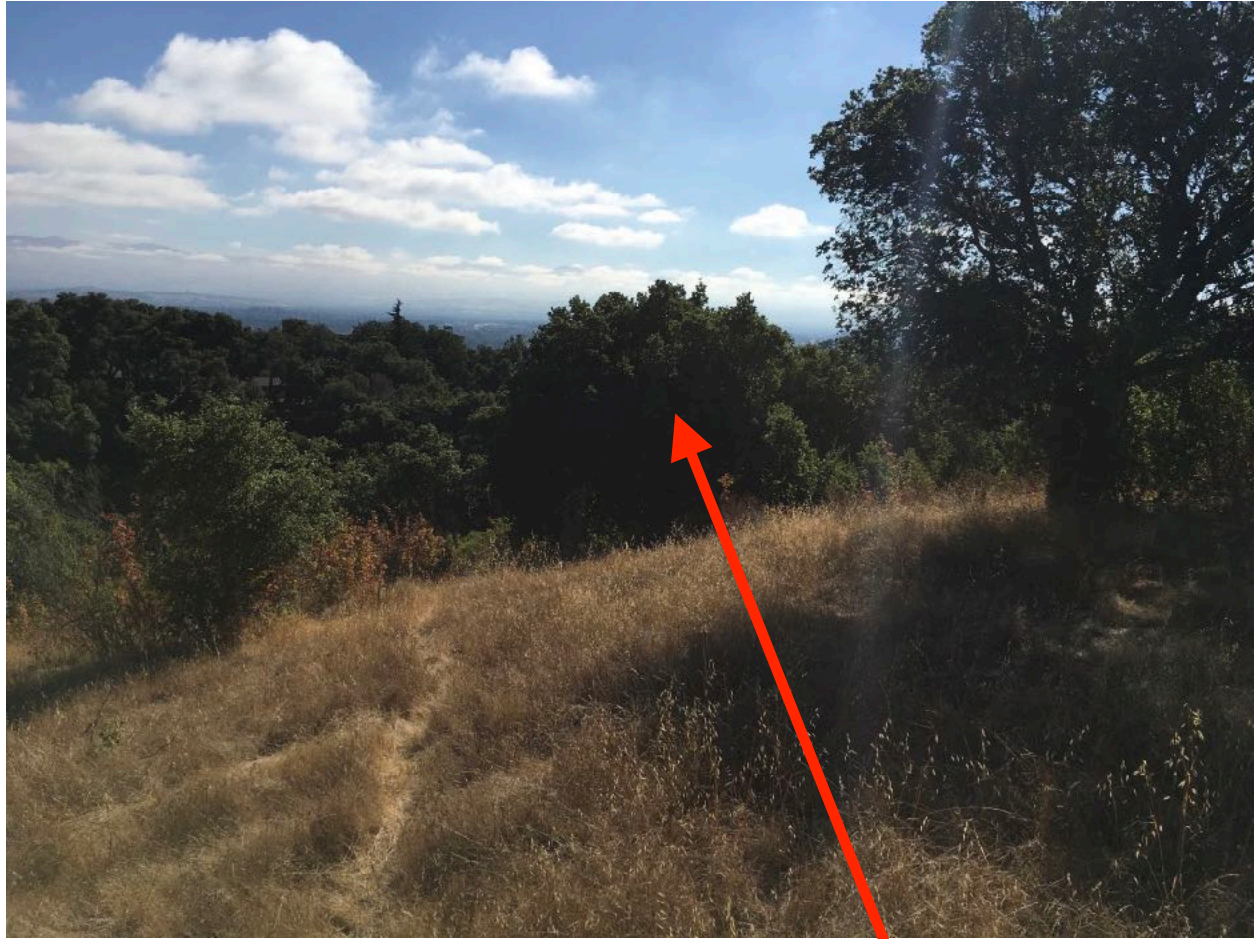
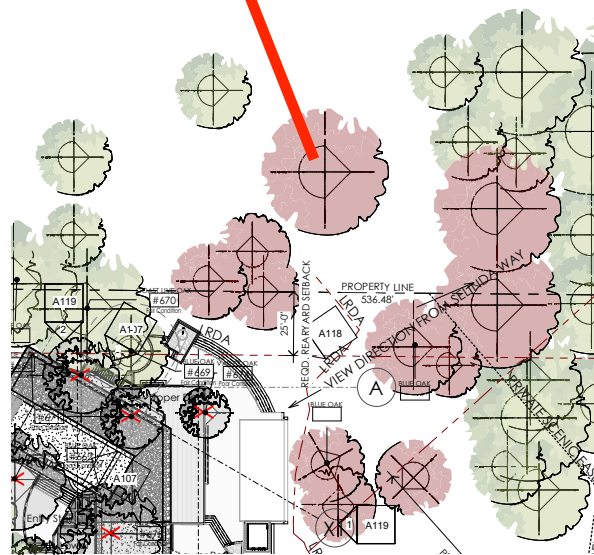
B5: North side down slope

I tried to locate the trees based on the provided map but the area is very dense with poison oak (*Toxicodendron diversilobum*) and is nearly impenetrable without a machete and/or Tyvek suit.

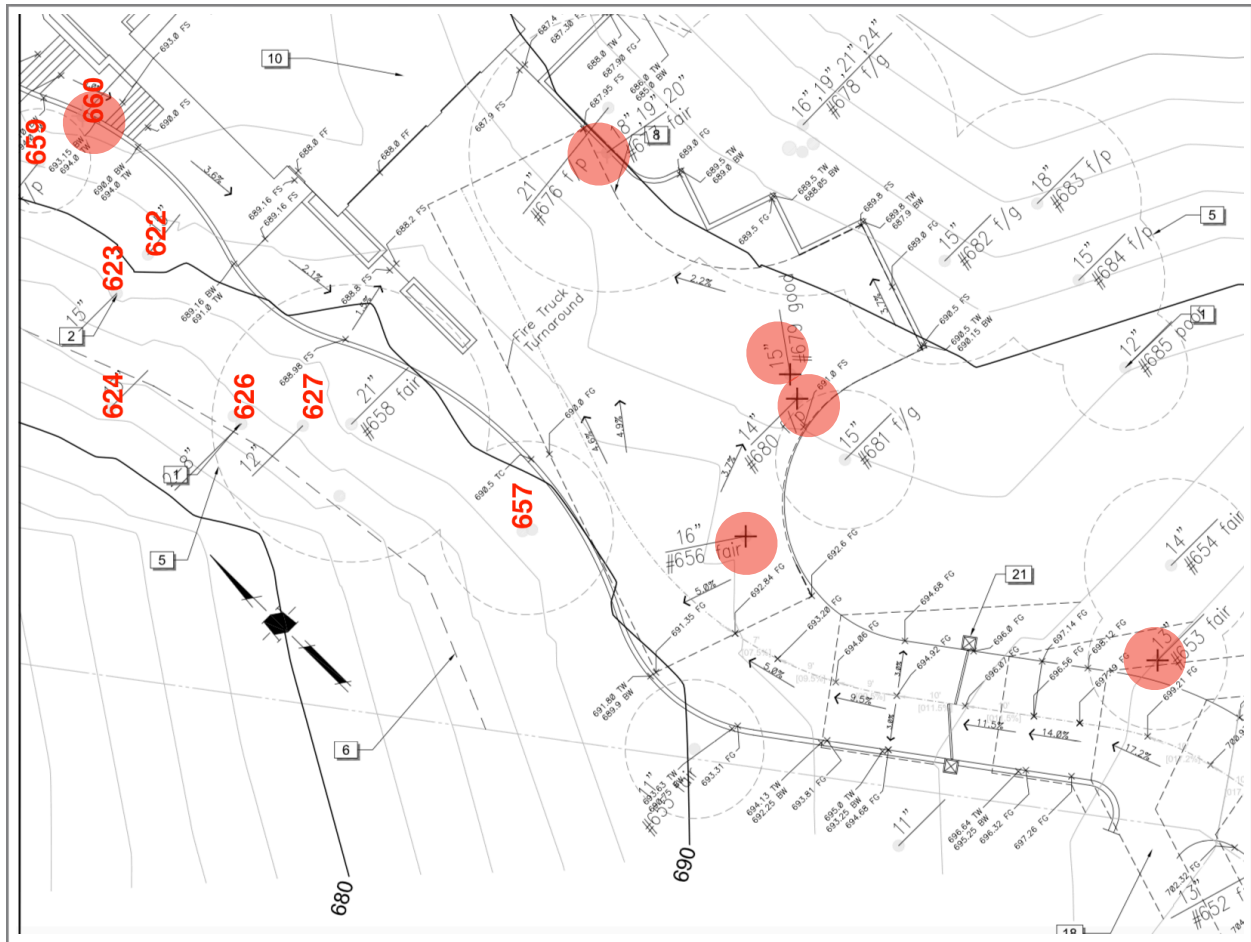
A2: Driveway and Hammerhead

Sheet taken from L1 (Red circles indicate removals/highly impacted)

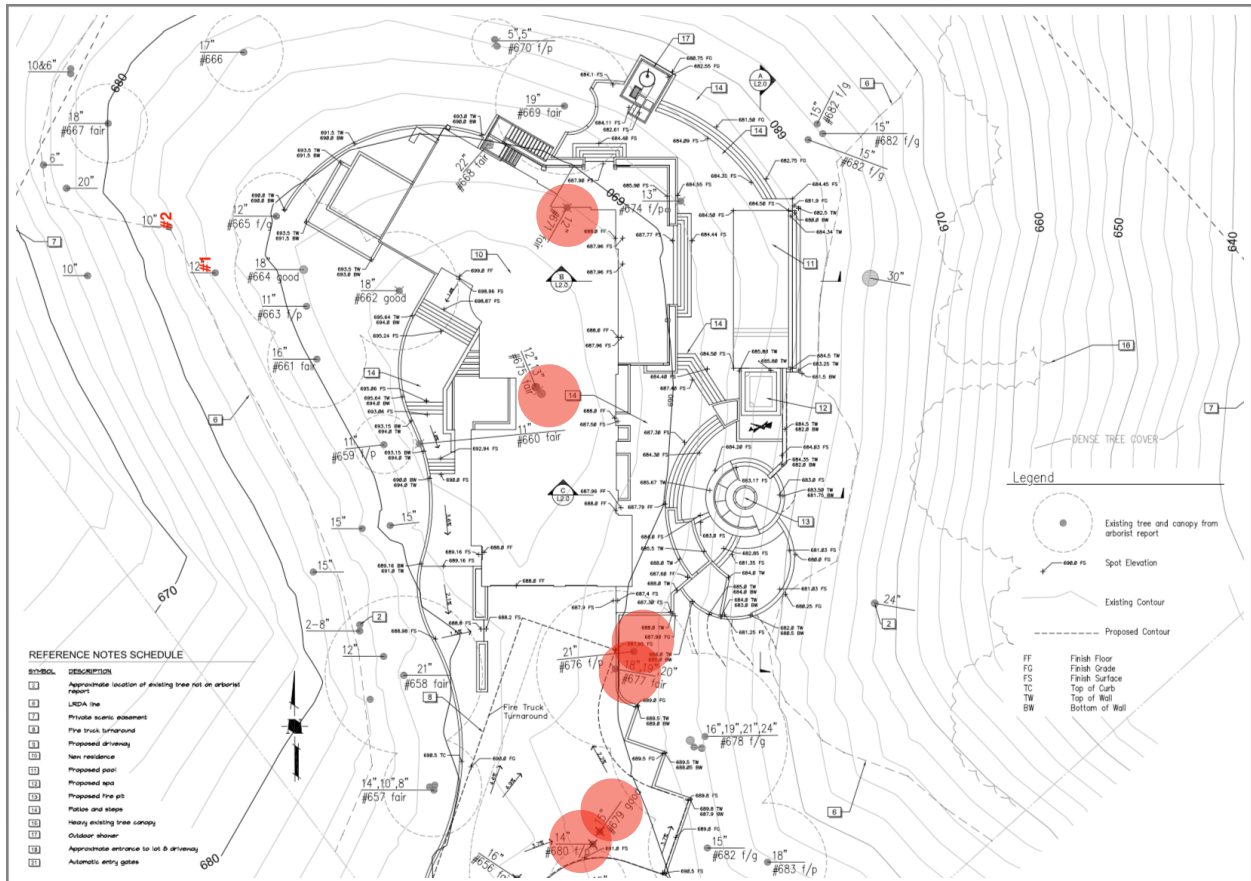
A3: Residence

Sheet taken from L2 (Red circles indicate removals/highly impacted)
