**Tree Inventory, Assessment,  
and  
Protection Report**

**120 Oak Meadow Drive  
Los Gatos, CA 95032**

**Town of Los Gatos**

**December 16, 2022**

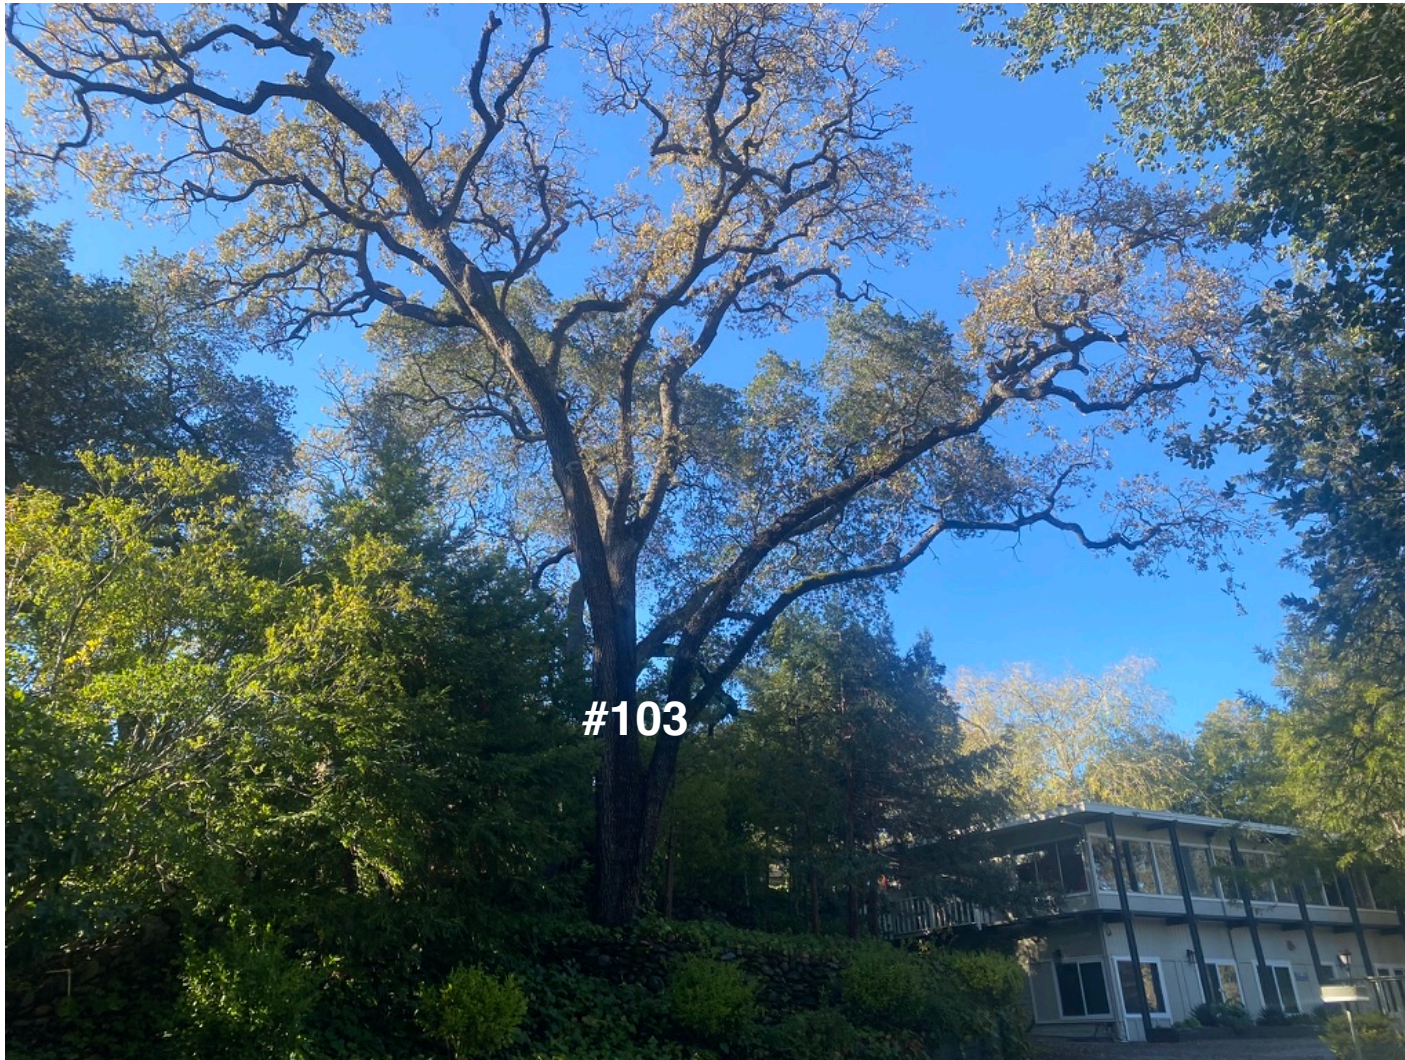
## C2: Valley oak #103

Ten trees will be required to be removed including eight small coast redwoods (Chart 4). Two large protected oaks would require removal although the plans indicate an attempt to retain valley oak #103. Because there is limited root zone opposite the construction around tree #103 I believe this tree will be compromised both from a health and structural perspective. Tree #106 is located in the footprint of the proposed structure and cannot be retained if a project on this parcel is to be constructed.

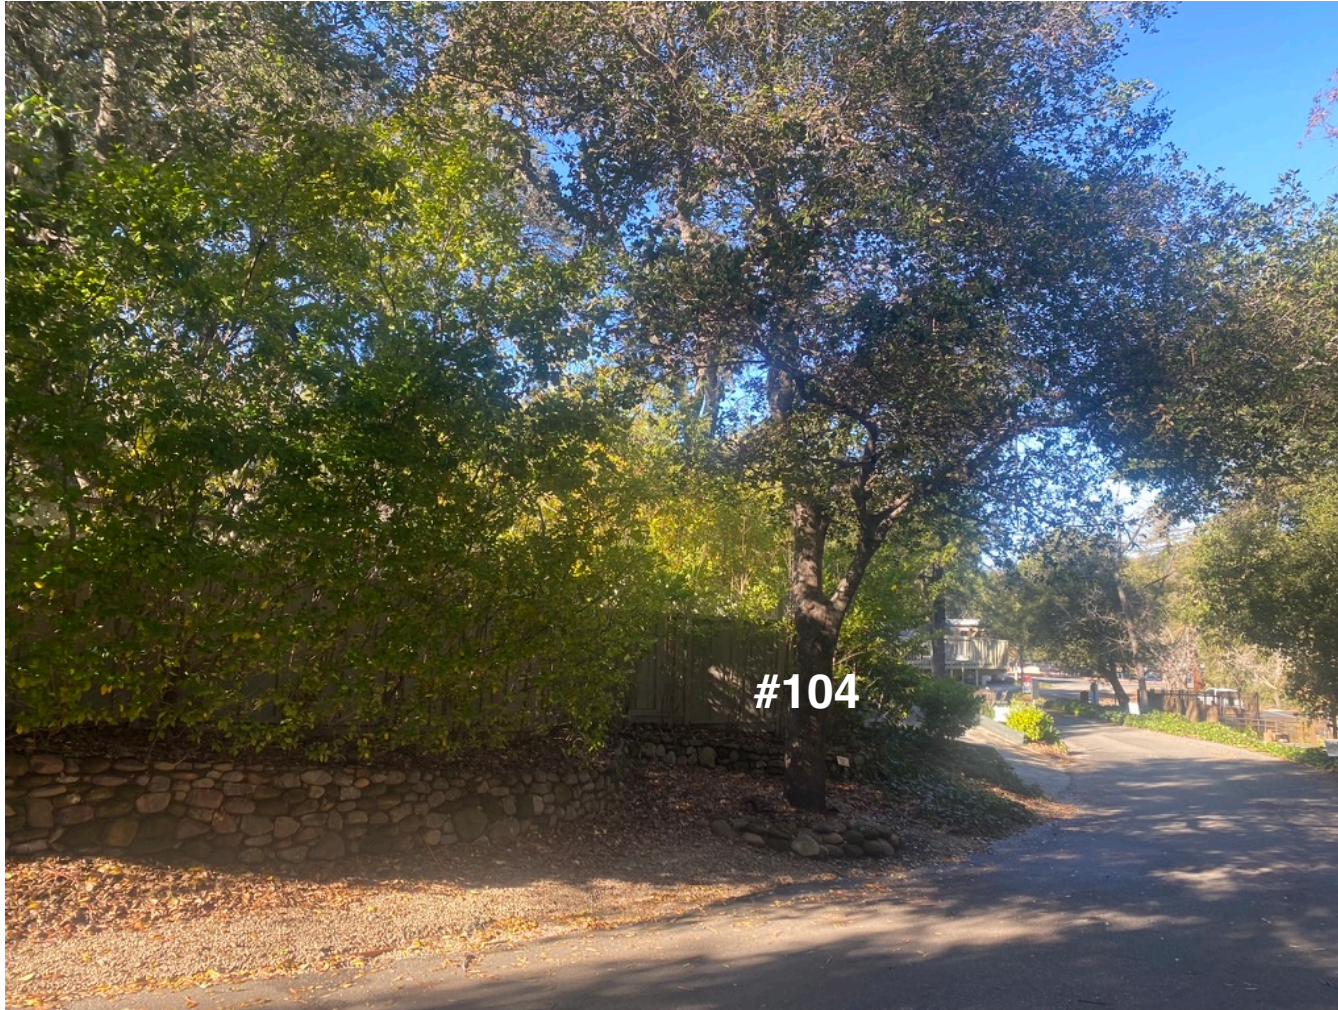
### **C3: Coast live oak #104**

The four trees #101, #102, #104, and #105 moderately impacted could be retained but will require protection. There are both grading and utility impact near these trees and monitoring the construction of the force main, storm drain and dissipator, and the driveway grading and construction. The ideal tree protection zones around these trees will likely need to be reduced to retain them.

2. Install tree protection fence around trees #101, #102, #104 and #105 at the recommended radii where applicable (Table 3, Page 8 or Appendix A). Monitor construction activities around these trees including all grading and utility installations and related trenching.

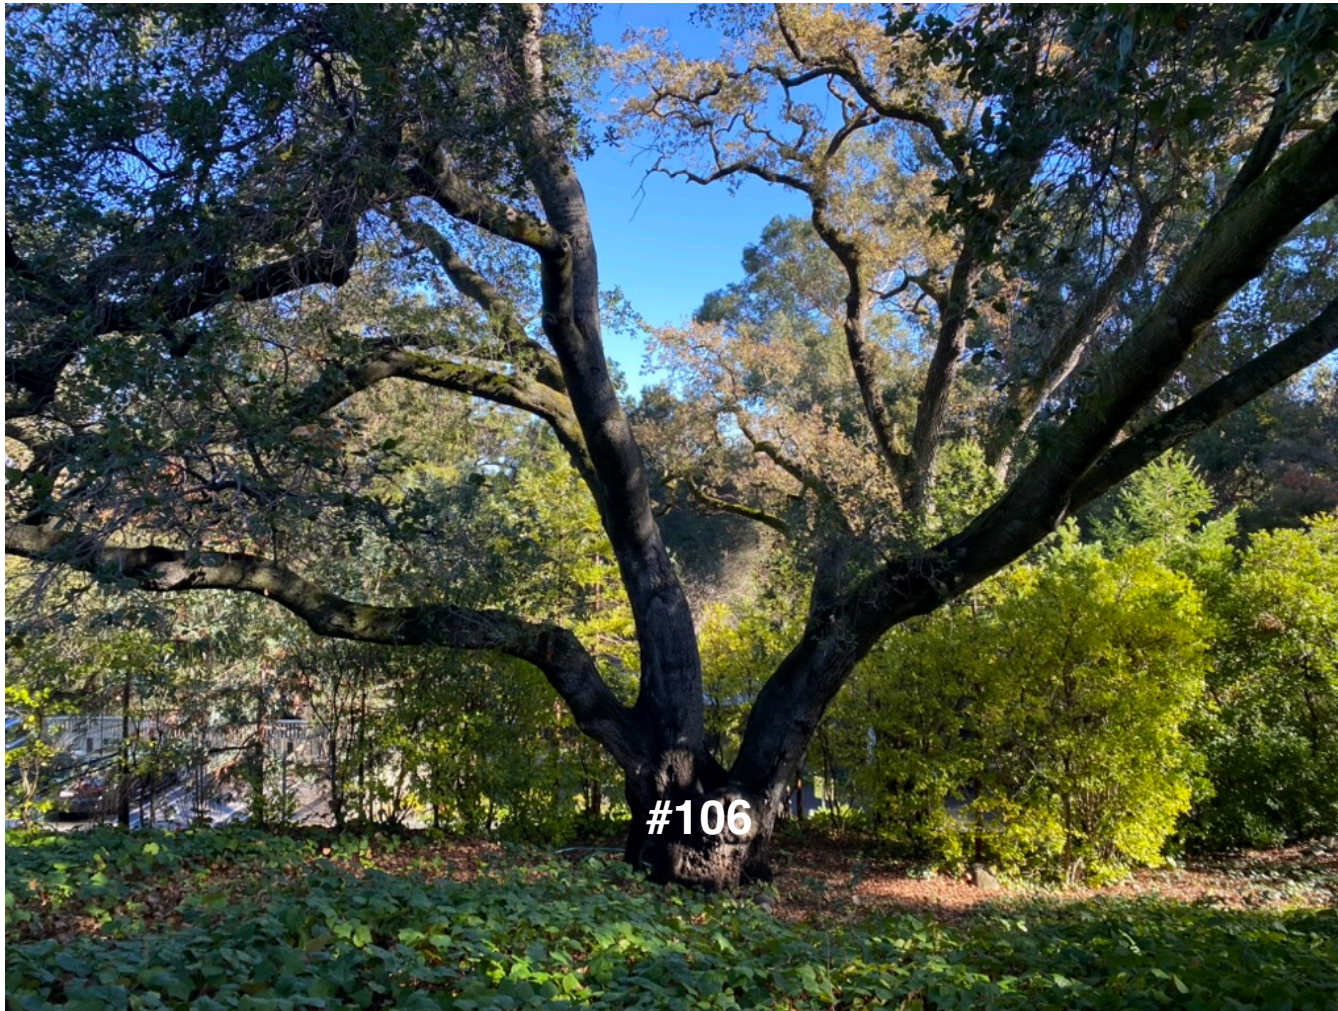
## C4: Coast live oak #106

Eleven trees are in good condition, however eight of those are newly planted small coast redwoods. Three oaks are in fair condition. Saratoga Tree Service provided a report in September condemning coast live oak #106 recommending removal, however the report did not follow the ISA Best Management Practices for Tree Risk Assessment. The tree could still meet the findings for removal but even with the decay I assessed the tree to be in fair shape. This tree may need advanced assessment for decay detection if removal is controversial.

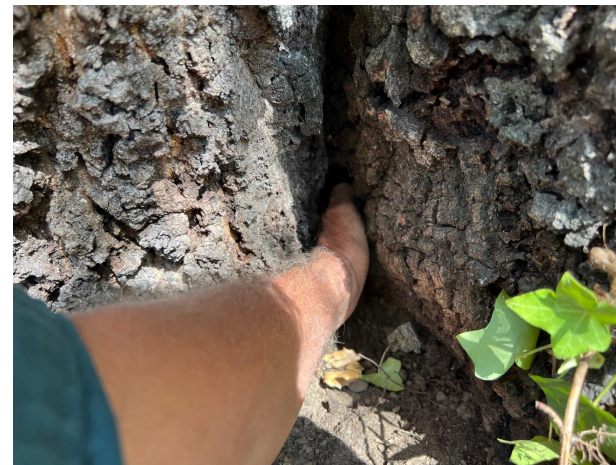
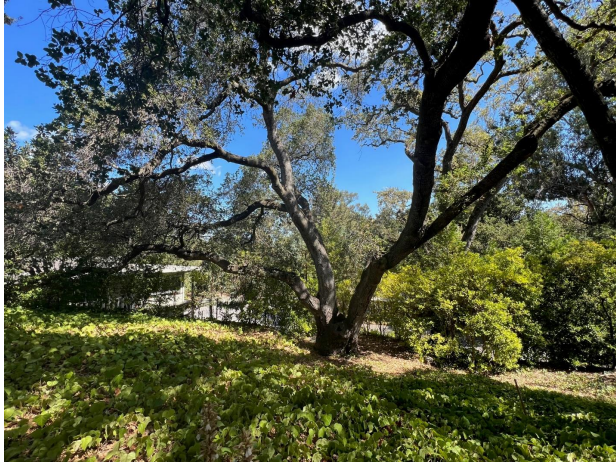
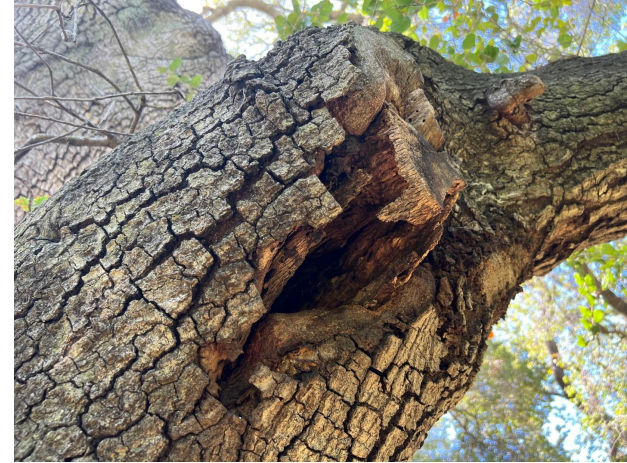
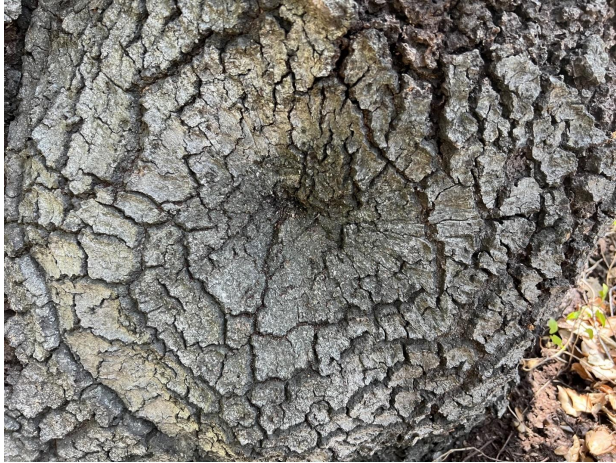
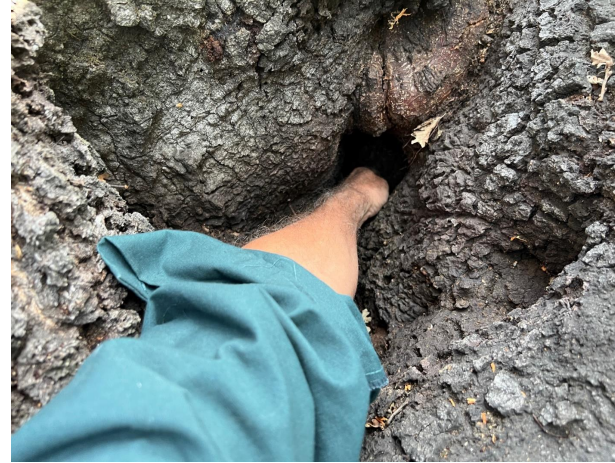
A close inspection of this particular tree shows some serious areas of trunk decay. The main union of these trunks is a catch for debris that has led into further interior decay. An area at the very base of the tree also shows an area of compromise. Surrounding the base of the tree are old wounds that were cut a long time ago. These have new tissue covering the wounds but the internal decay from these old wounds is probable. There is enough visible decay as well as likely hidden decay areas to surmise that this tree is hollow. Because of the union of these large lower trunks in an area of visible decay, this tree has a greater probability of failure.

Further up in the limb structure, there are also areas of visible decay from large, old pruning wounds. These weaknesses will lead to limb failure on the very long, heavy limbs. One of these long limbs is over the neighboring commercial property parking area. A limb failure in this area could lead to possible vehicle damage or injury to pedestrians. The very large limb that leads toward the home on this property would destroy another oak tree when it fails. It would not likely cause damage to the home.

Because of all the recognized decay in this tree, it is likely that a failure will occur. There is not a good pruning option to make this tree safe as this is a very wide spreading structure. Because of these areas of decay, and the likely damage to adjacent trees and possible neighbor's property, I am recommending removal.
