REVISED GEOTECHNICAL AND ALTERNATIVES REPORT
SHANNON ROAD EMBANKMENT STABILIZATION PROJECT

CE&G DOCUMENT: 200300.001

7 DECEMBER 2020

Town of Los Gatos
41 Miles Avenue
Los Gatos, California 95030

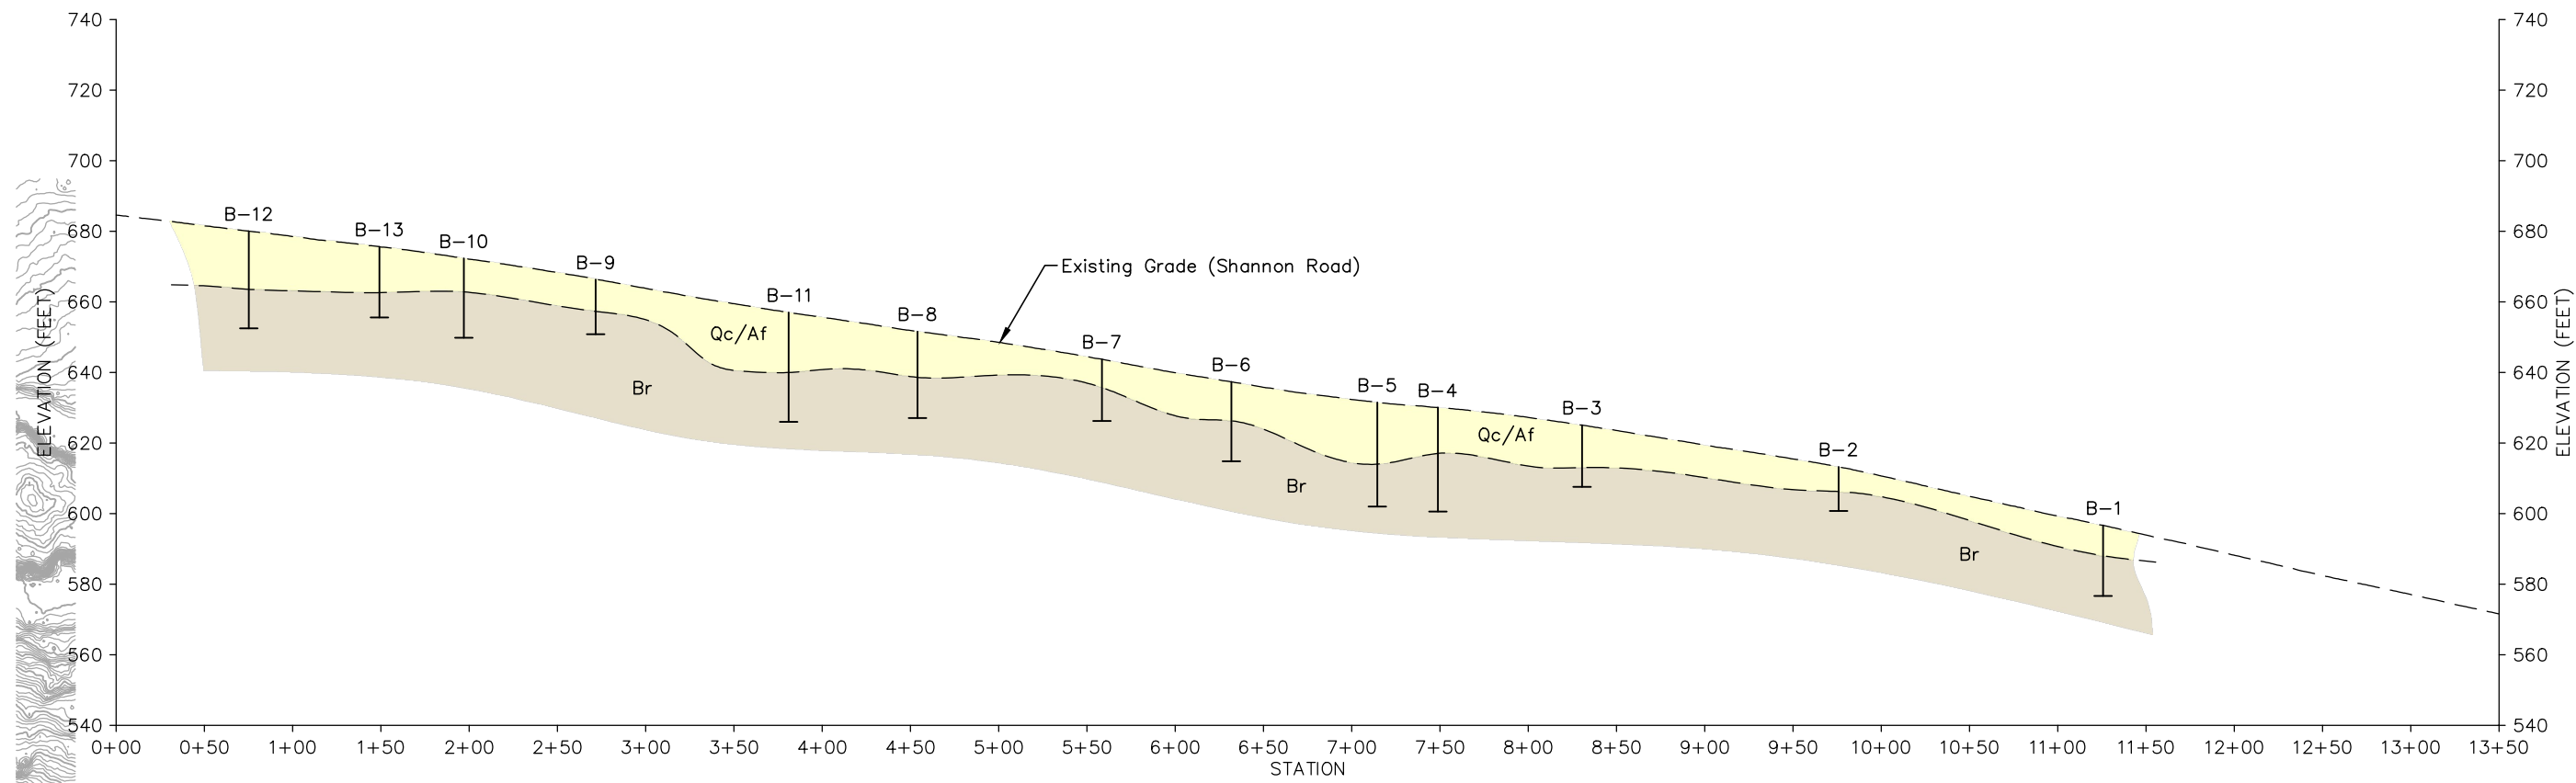
SHANNON ROAD EMBANKMENT STABILIZATION PROJECT SHANNON ROAD LOS GATOS, CALIFORNIA SECTION A-A'		
200300	DECEMBER 2020	FIGURE 6A

The settlement and lateral movement have been most evident in the outboard, eastbound lane, and in the two intervals traversing topographic swales mapped as having experienced landsliding in the past. The longitudinal profile (Figure 6A) illustrates how the thickness of fill and colluvium are greatest within these two intervals. Asphalt thicknesses up to approximately 2.3 feet observed in our borings indicate this process has been ongoing for some time.

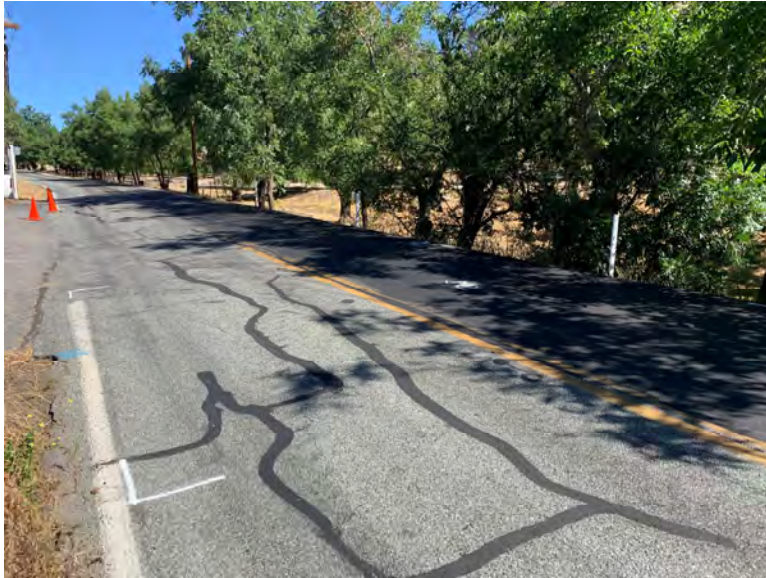
Road Condition at Boring B-1 (June 22, 2020)

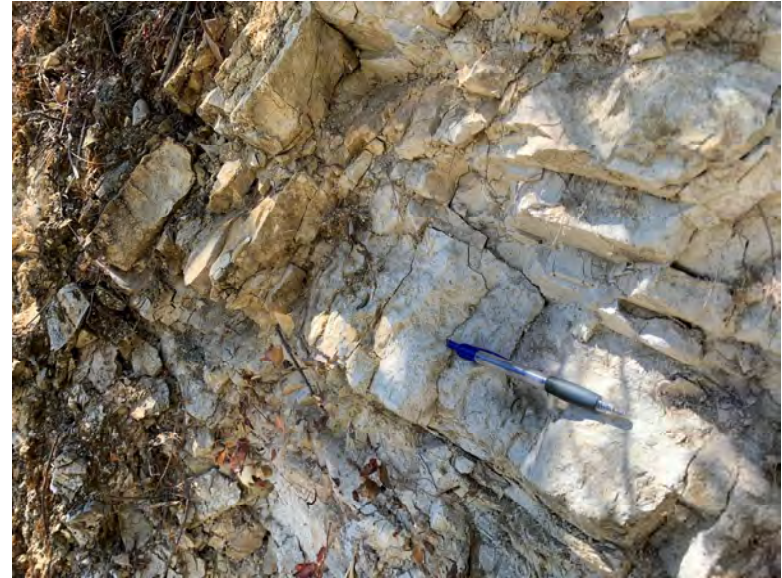
Exposed Bedrock Near Boring B-2 (June 25, 2020)

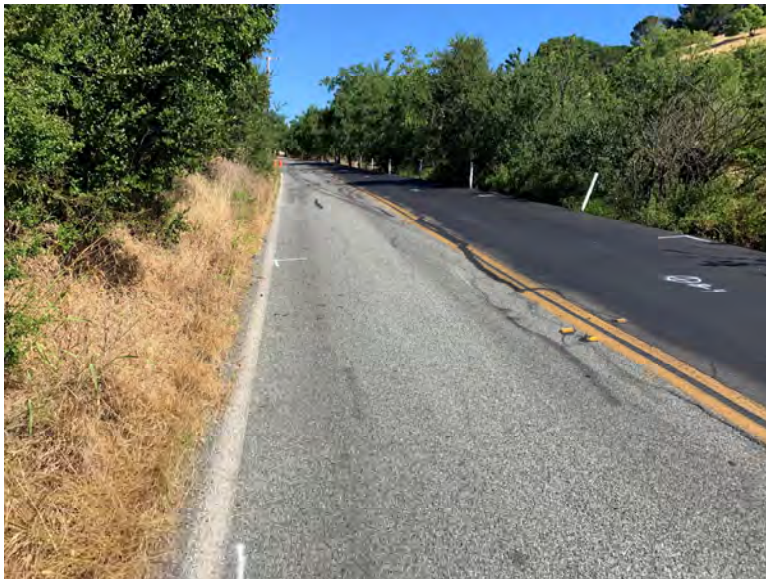
Road Condition at Boring B-4 (June 22, 2020)

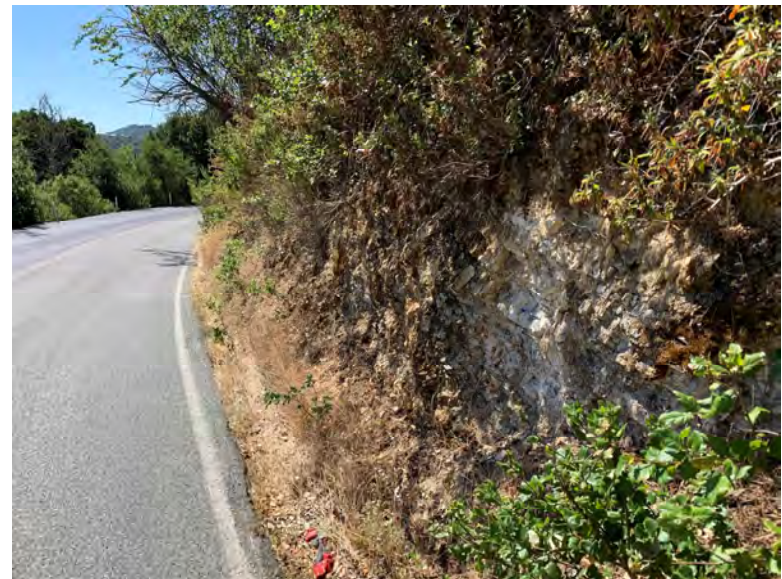
Exposed Bedrock Near Boring B-2 (June 25, 2020)

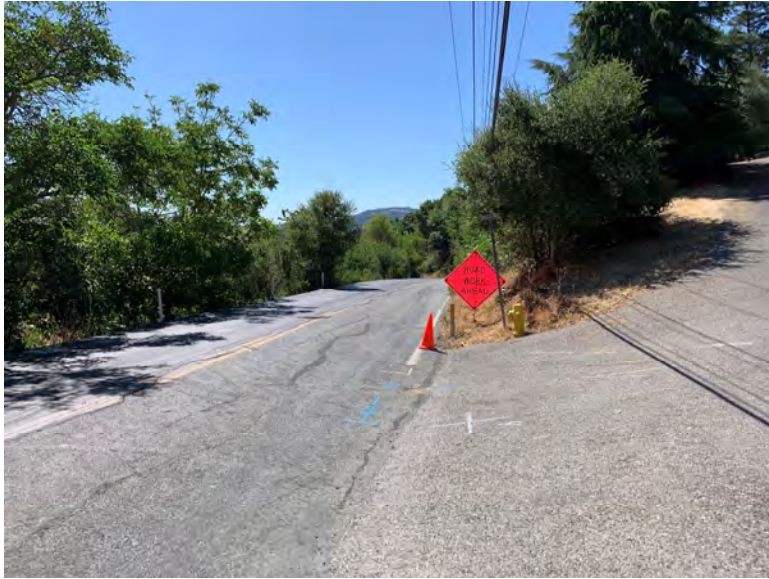
Road Condition at Boring B-12 (June 25, 2020)

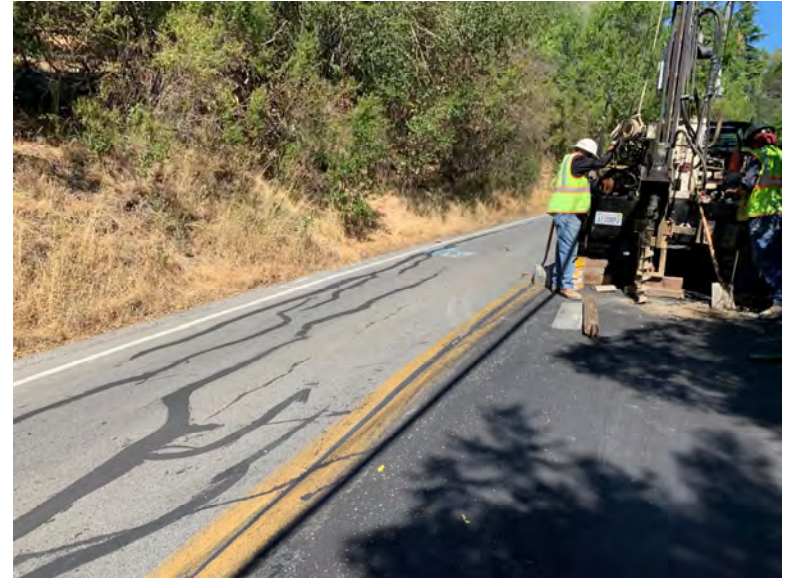
Road Condition During Drilling at Boring B-11
(July 1, 2020)
