TREE REPORT
For
La Rinconada Golf & Country Club
MAINTENANCE YARD UPGRADE PROJECT
14595 Clearview Dr. Los Gatos 95032

Lisa Edwards & Straun Edwards
Trees 360 Degrees
Certified Arborist #WE-5055A / #WE-5612A
Ph. (408) 455-5911/408-898-0625

January 29th, 2026
(Revised February 28th, 2026)

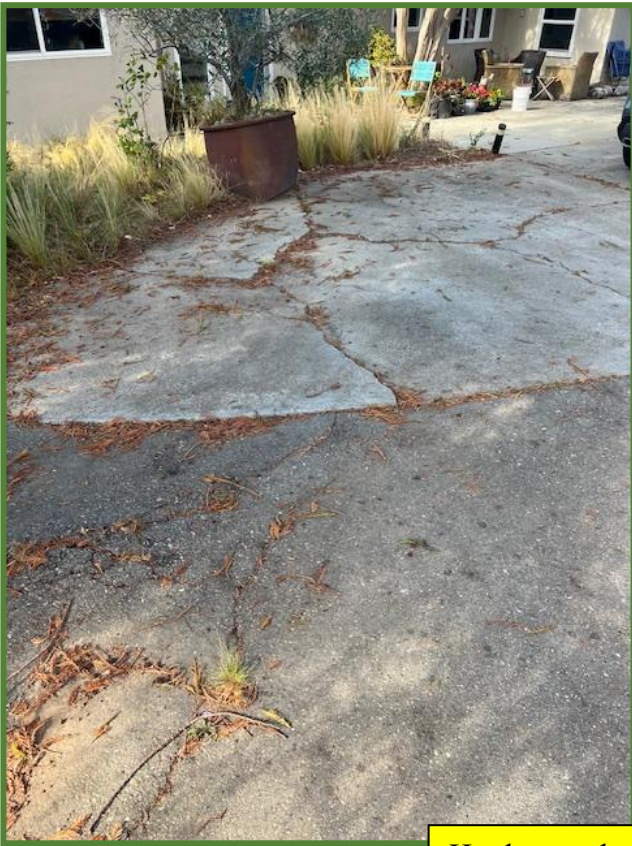
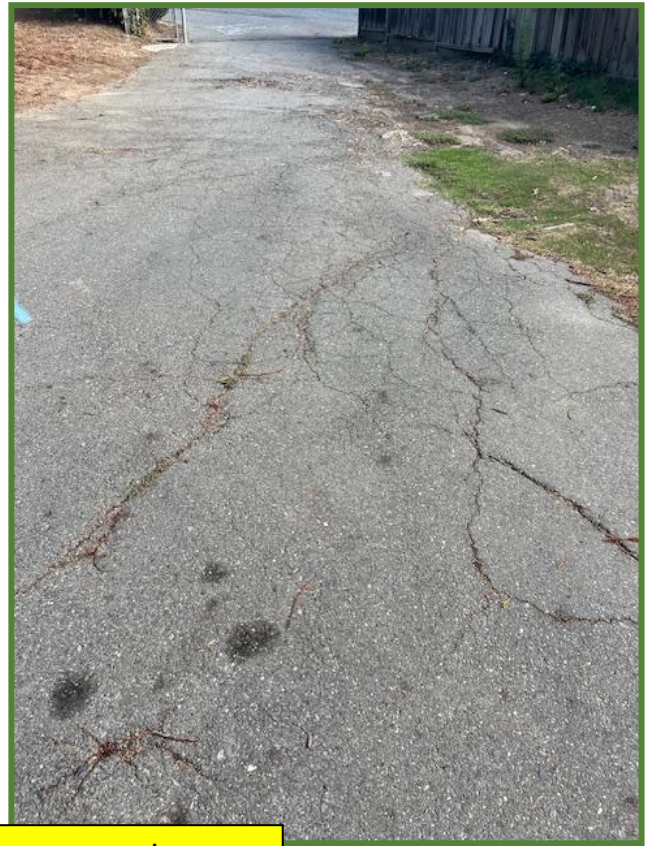
Hardscape damage due to extensive surface roots from Trees No. 947 & 948

948	36.00	na	na	<i>Sequoia sempervirens</i>	coast redwood	75/20	40/75/50	40%-Poor	Protected	High	Remove	1, 4, 10	(3x) 24in. boxed	\$13,714.16	Trees no. 947-948 are located in the front yard of the residential property 17445 Zena Ave., adjacent to the yard facility. They have extensive surface roots that have caused damage to the existing driveway. Tree No. 948 has a thinner canopy top than compared to the lower portion of the tree. Trees No. 947 & 948 are recommended for removal based on their location and the proposed development around them.
949	43.00	na	na	<i>Sequoia sempervirens</i>	coast redwood	55/20	90/90/90	90%-Excellent	Protected	Moderate	Retain	na	na	\$44,023.41	Tree No. 949 is located in the far NW corner of the backyard of residence. This tree is situated in the corner and adjacent to the fence between the service yard and golf course. It stands together with Tree No. 507 and will be retained.

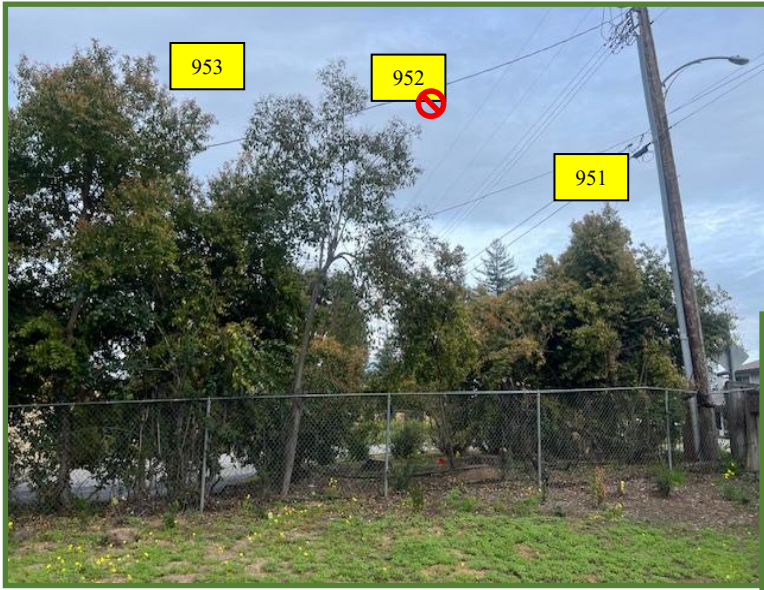
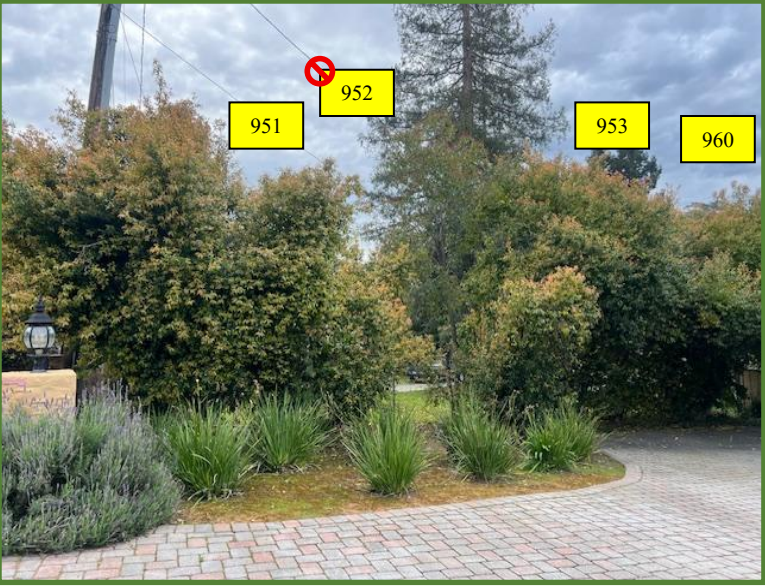
View from west side of hedged Xylosmas on 17423 Zena Ave. front yard.

View from east side of hedged Xylosmas on 17423 Zena Ave. front yard.

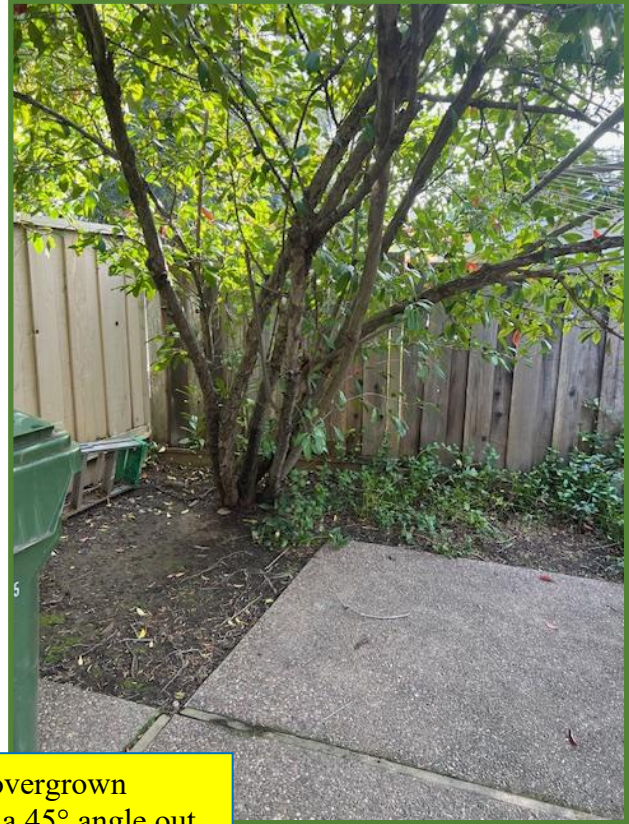
Tree No. 966 is a mature, overgrown Photinia shrub growing on a 45° angle out from other trees.

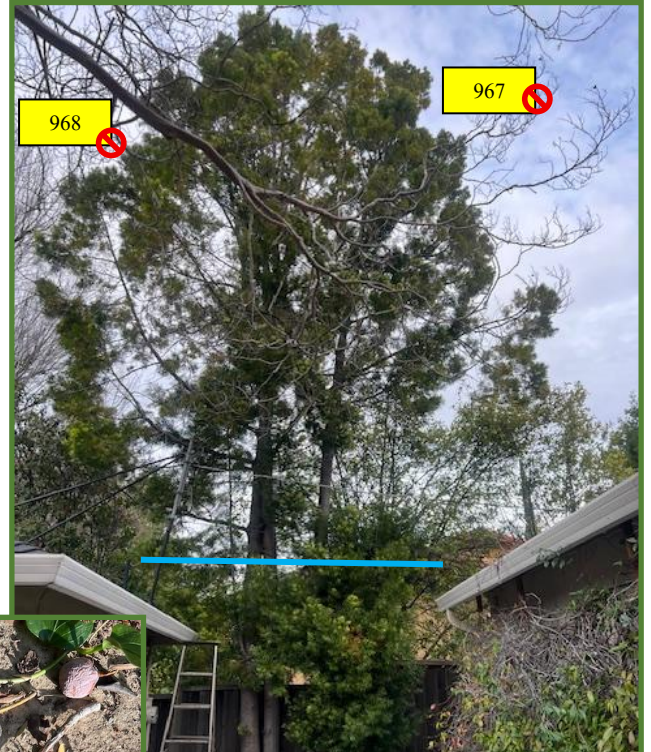
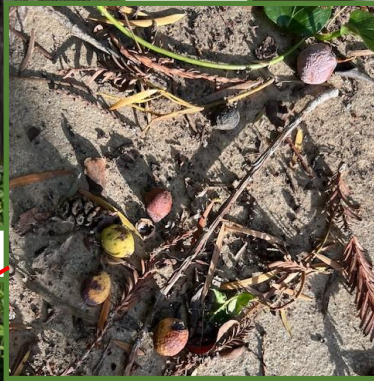
Fruit drop from female Tree No. 968

Highly recommend removal of these two large trees adjacent to the fence – growing in confined space with no room for future growth.
OR
Top to reduce canopies back to a manageable hedge height between 10-15ft (see blue line in photo)
