**Tree Inventory, Assessment,
and
Protection Report**

**45 Reservoir Road
Los Gatos, CA 95032**

Town of Los Gatos

December 4, 2022

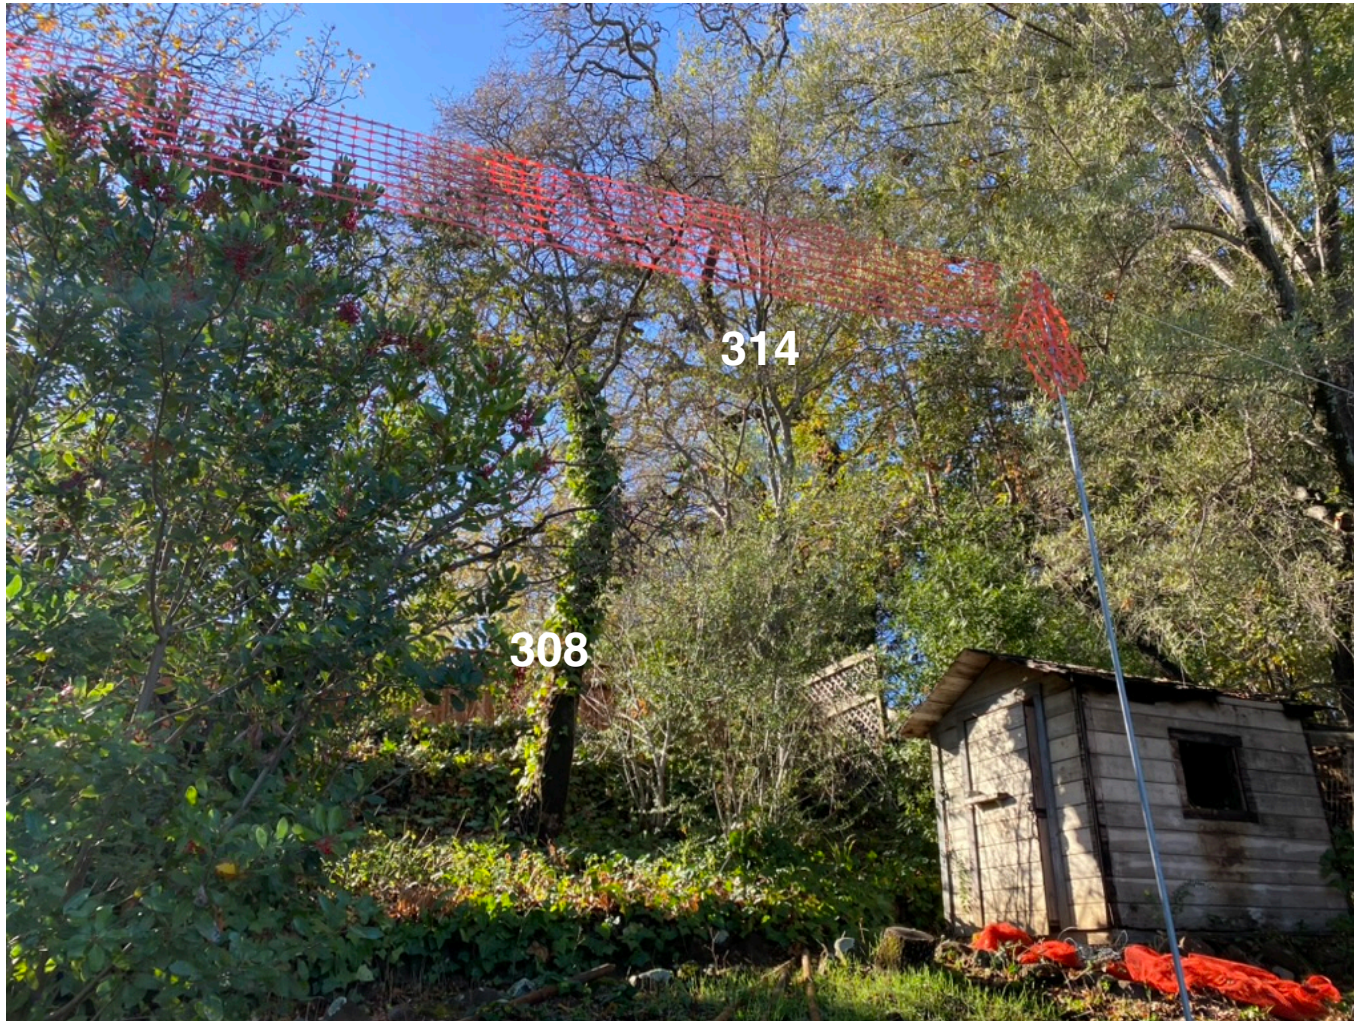
C5: #308 and #314

Twelve trees are in good condition, three fair, four poor and one coast live oak (#308) is in very poor shape (Chart 2). The lot and the trees have not been maintained or maintained very well. Several trees #304, #311, and #312 are either topped or poorly maintained to avoid overhead high voltage lines.

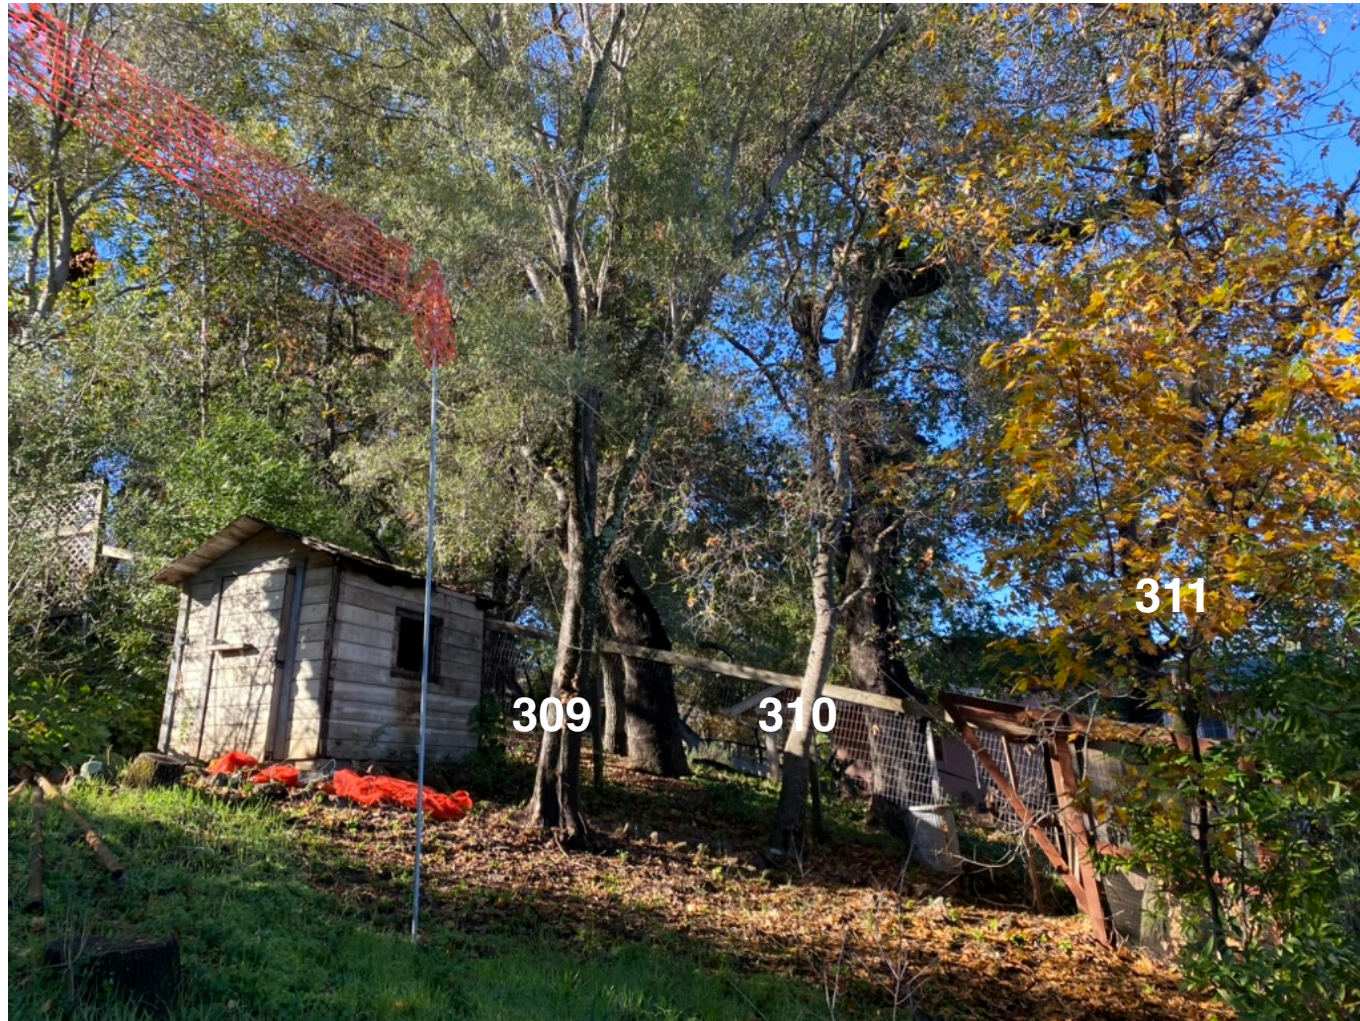
C6: #309, #310 and #311

coast live oak (<i>Quercus agrifolia</i>)	310	10	20	Poor/30%	High	Protected	\$1,190.00	7
black oak (<i>Quercus kelloggii</i>)	311	10	10	Poor/30%	High	Protected	\$2,020.00	7
