ARCHITECTURAL/CULTURAL SURVEY  
LOS GATOS RESEARCH

File address 117 Edelen

*Assessment Report*  
117 Edelen Avenue

Subject: Structural Evaluation of Property Listed Above

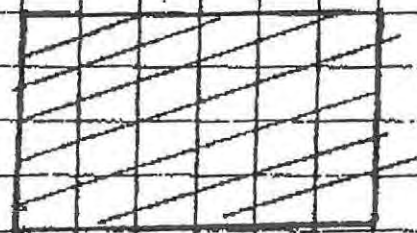
From investigation of the structure, the original house consisted of the front porch, living room and two middle bedrooms (see attached sketch plan). The original house form was altered probably prior to the 1930s with additions of: front bedroom, back kitchen and rear pantry, bathroom, and rear porch. The early alterations utilize compatible building materials and are within the period of significance of the building, although they are not well constructed or detailed. For instance: foundations are settling at varied rates; seams are visible in the siding material; visual separation and gaps occur at roof lines; and interior finishes indicate locations of additions.

PROBABLY THE  
ORIGINAL HOUSE
