**Assessment of Twenty-Four (24) Protected-Size Trees  
at and adjacent to  
16010 Winterbrook  
Los Gatos, California**

Prepared for:  
Ryan Safty, Associate Planner  
Town of Los Gatos Community Development Department  
110 E. Main Street  
Los Gatos, CA 95030

Field Visit:  
Walter Levison, Contract Town Arborist (CTA)  
7/7/2020

Report by CTA  
7/20/2020  
Revised 8/12/2021

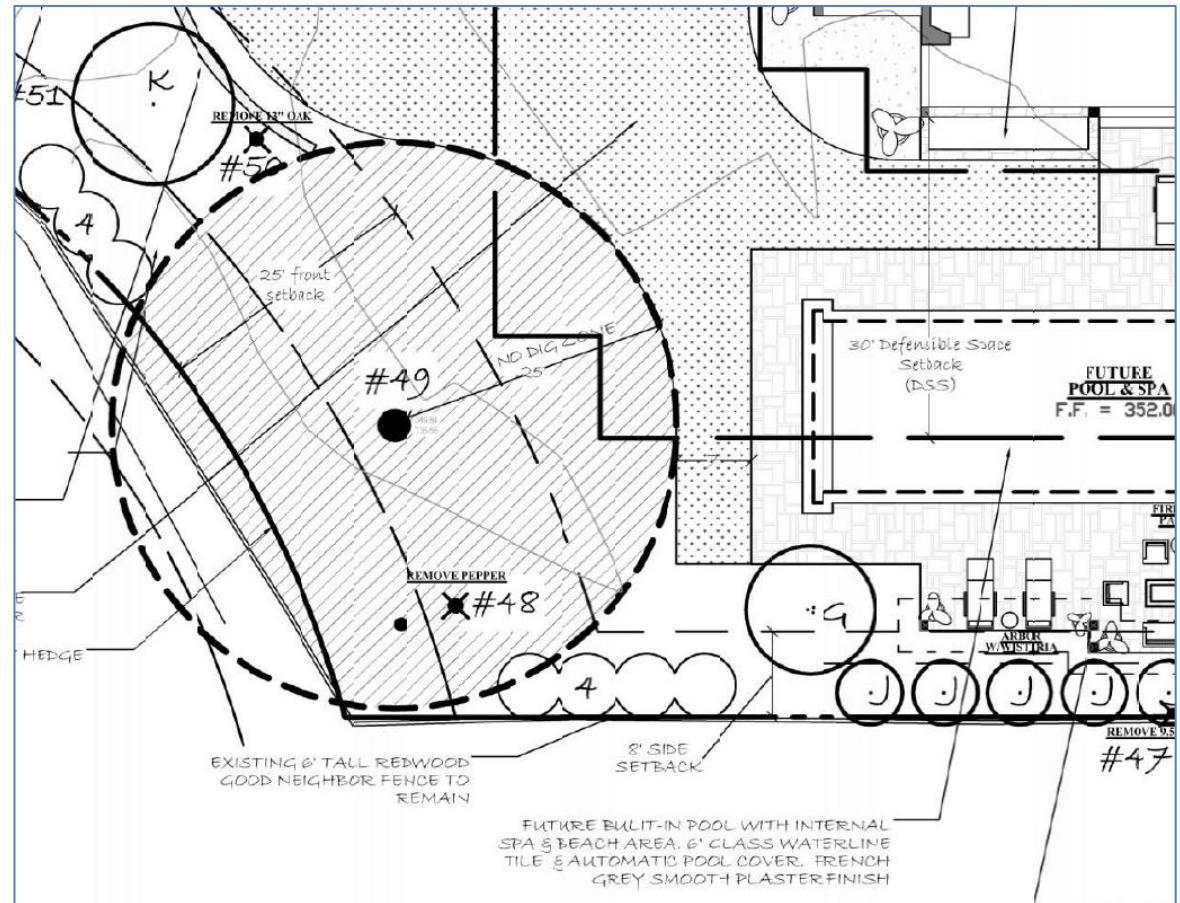
Note however that the most current grading plan sheet 4 of 6 dated 4/16/2021 still shows the wall location at 16 feet from trunk edge of oak #49, which appears to be an error or oversight.

Staff will need to verify with the applicant as to which of the two plan sheets shows the correct proposed retaining wall location in relation to oak #49.

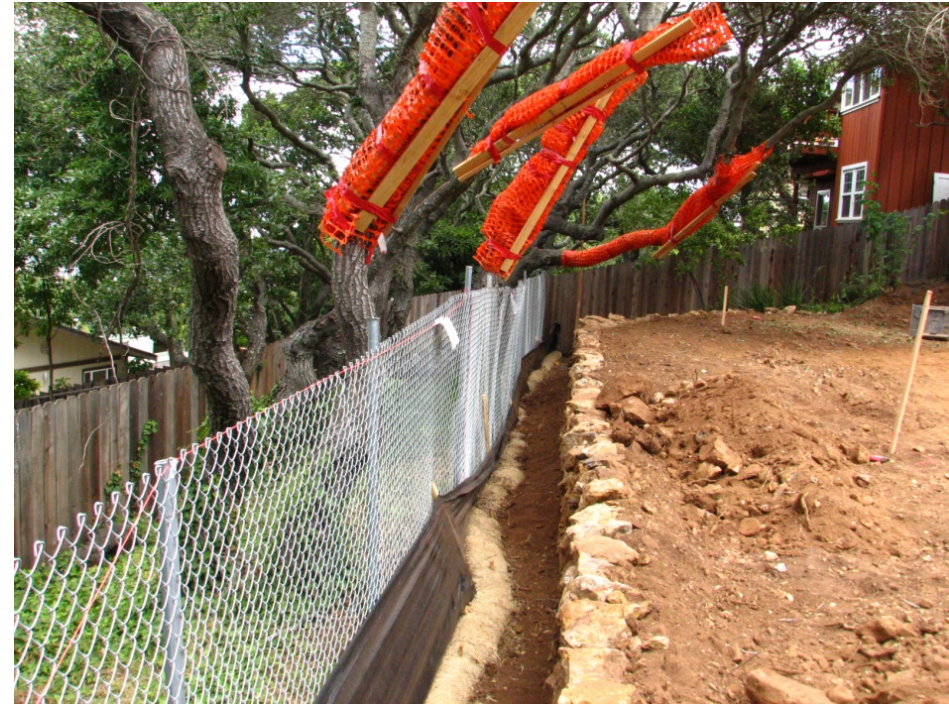
See image at right, where the applicant actually buttressed the base of silt fencing using a straw wattle that was pinned down into the ground using wooden dowels. Use of straw wattles in addition to the silt fence is the best method found to date, as it ensures that the base of silt fence is always tight on grade, to prevent migration of any phytotoxic materials, garbage, waste, soil, etc. into the trees' root protection zones downhill from the chain link alignment.

**For the sections of fence that run along the south end of the site near to trees #31, 32, 34, 35, 36, 37, use silt fencing with the bottom edge tucked down into the soil, or engineer's filter fabric zip tied to the fencing, as an additional barrier specifically designed to stop movement of slumping soil and wastes from dropping downhill into the root protection zones of these trees.**

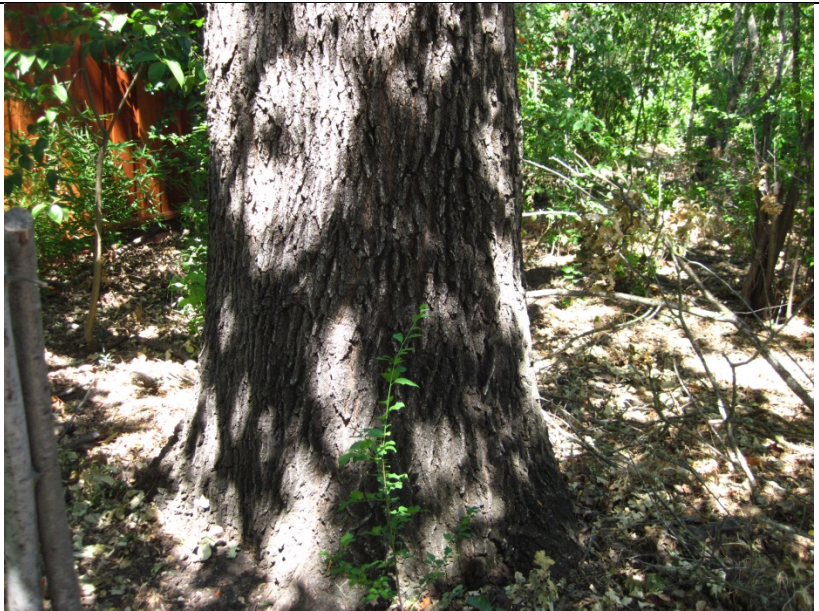
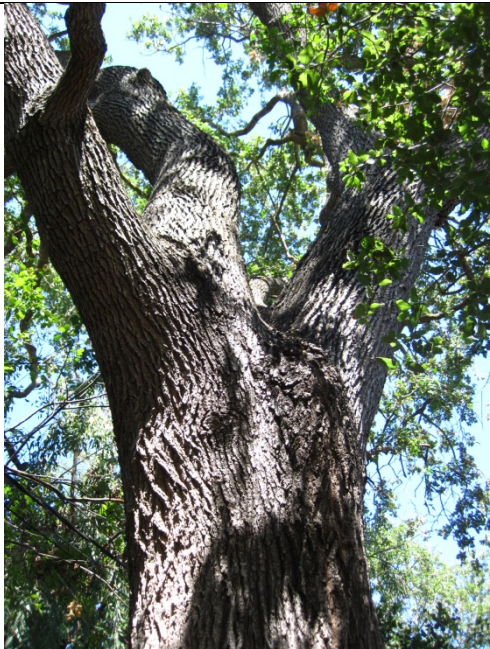
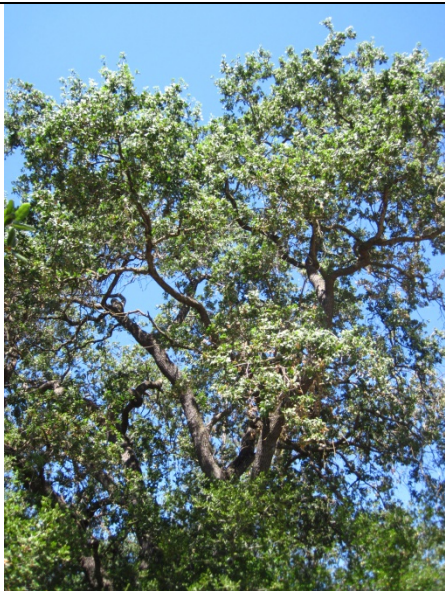
| <p>49</p> | | <p>49</p> | |

The presence of a possible bark inclusion "discontinuity" zone at the fork (roughly 12 feet to 15 feet elevation) is cause for concern. The fork may be a point of elevated risk of splitout, which would cause the tree to fail and endanger a "target zone" at least 50 feet in radius in all directions around the tree. Therefore, the proposed swimming pool (future permit application) and other higher use-type elements such as chairs, lounges, benches, etc. should be situated at least 50 feet or greater offset radius from the trunk edge, for safety purposes.<sup>2</sup>

The CTA recommends that Town Staff verify with the applicant's project team whether the wall will be built at 25 feet from trunk edge of oak #49 as shown on the landscape plan sheet, or at 16 feet from trunk edge as shown on the grading plan sheet.

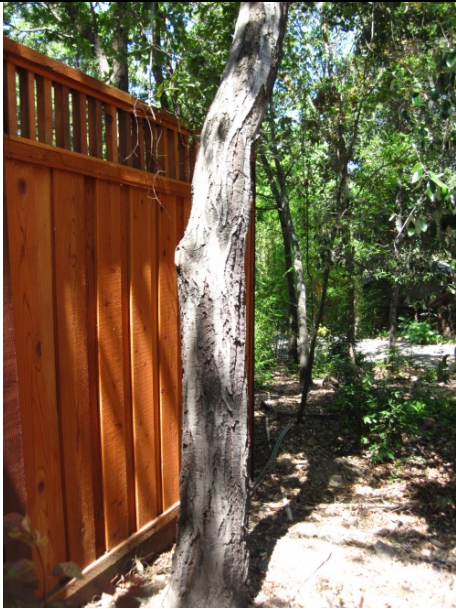
| 53 | | | --- | (Intentionally blank) |

These two pipe trench routes are in conflict with the Critical Root Zones of trees #41, 53, and 57, and are suggested to be relocated or built using trenchless directional bore technology to avoid causing severe root loss to the trees, the most important of which are trees #41 and #53.

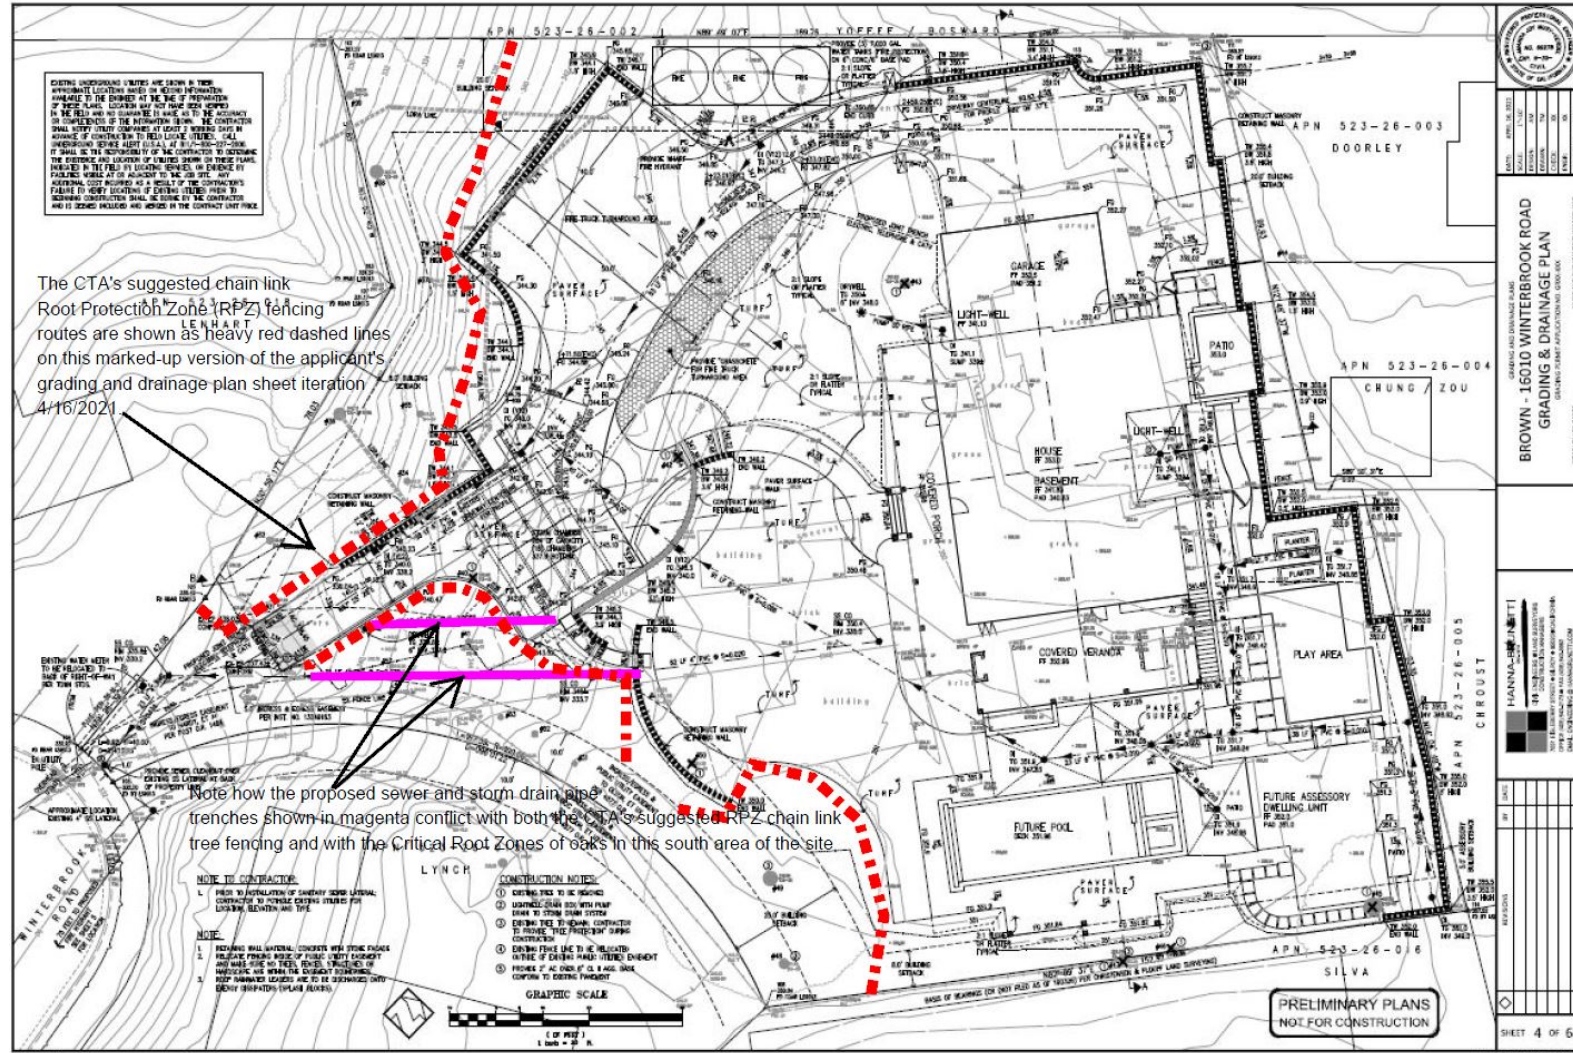
- a. Red dashed lines indicate suggested optimal chain link fencing tree root protection zones or root protection zones (TPZ or RPZ). The routes can be adjusted in the field during the initial pre-con meeting between the builder and the project arborist chosen by the applicant.
- b. Magenta highlight lines indicate the current alignments for the sewer and storm drain trenches, as proposed by the applicant.

- **STORM DRAIN:** The proposed storm drain routing as shown on the 4/16/2021 version of the grading and drainage plan is still considered unacceptable in terms of lateral offset distance between the trunk edges of tree #41. It is suggested that the applicant's project team consider relocating the storm drain to 10 feet offset from trunk edge, or use of horizontal directional bore "trenchless" technology to install the storm drain in order to avoid severe damage to this tree's root system. Otherwise, the tree will be considered a removal in terms of new construction-related impacts, and canopy replacement in-lieu fee payment will apply per Town Code.

- **SANITARY SEWER:** The proposed sewer pipe trench route as currently shown on the 4/16/2021 version of the grading and drainage plan will cause severe root loss to oaks #41 and #57. It is suggested that the project applicant push the pipe trench to at least 10 feet offset from trunk edge of oak #41, and 6 feet offset from trunk edge of oak #57, or use trenchless directional bore technology to avoid trenching altogether. Otherwise, these two native oak trees will be considered a removal in terms of new construction-related impacts, and canopy replacement in-lieu fee payment will apply per Town Code.
