May 5, 2021

Monarch Consulting Arborists

Summary

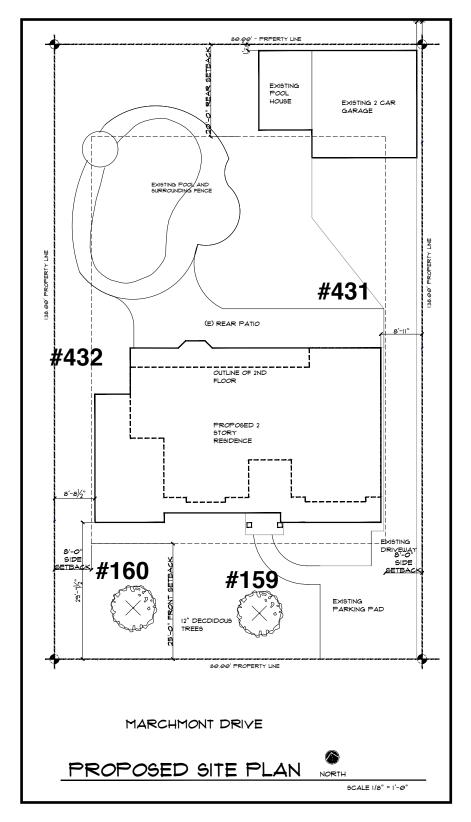
IMAGE 2: TREE LOCATIONS AND PROPOSED SITE PLAN

Proposed site plan and four tree locations adjacent to house (Image 2).

The crape myrtle and Japanese maples are young small trees in good condition while the walnut is a remnant orchard tree in poor shape. The remaining trees in back around the pool are all in good condition.

None of the trees are expected to be impacted by this proposed project. The project does not encroach into the root zones, which results in a rating of low. The two maples may require some clearance pruning but would only be impacted aesthetically.

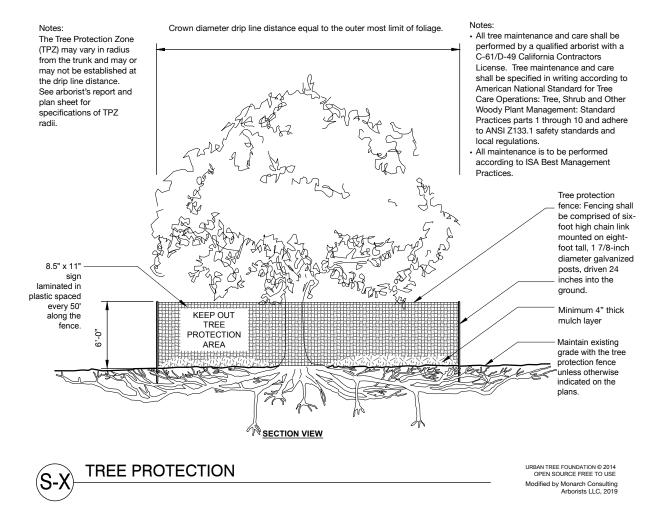
For this project the tree protection fence should be placed around the crape myrtle and walnut at a radius of 10 feet enclosed as a group.

- 2. Place tree protection fence around the crape myrtle and walnut to be retained in front of the site. Fence should be at a radius of ten feet and enclose both trees. Place temporary irrigation within the tree protection zone or maintain the current watering scheme.
