**Tree Inventory, Assessment,  
and  
Protection Report**

**140 Prospect Avenue, Los Gatos  
Los Gatos, CA 95032**

**Town of Los Gatos**

**October 13, 2021**

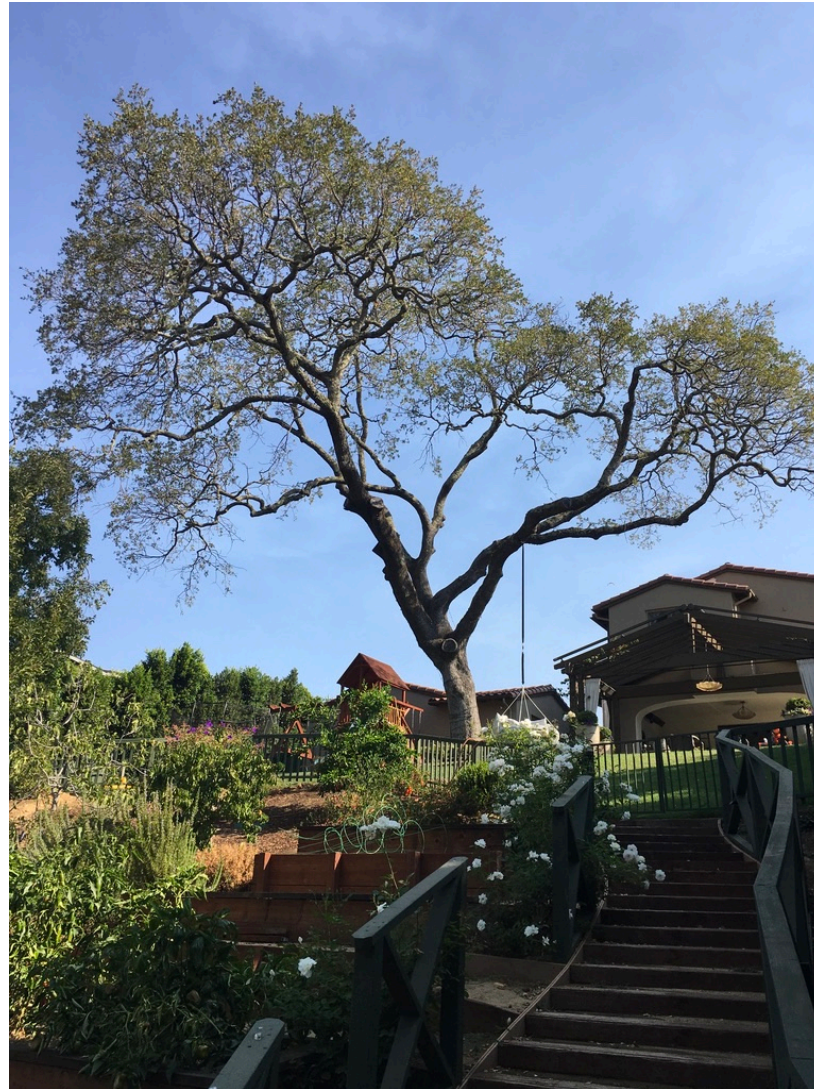
### C1: Blue oak #261

Seven trees could highly impacted by the proposed plans including two Large Protected blue oaks #261 and #254. Tree #254 is in irreversible decline and may in fact be dead. Oaks #261 and #275 would be affected by the expanded garage while #257 and #254 are either adjacent to grading or within the footprint. I considered #275 and #252A to be moderate-highly impacted. The four coast live oaks in front #746, #747, #748, and #749 would all require removal or transplanting while #749 is a failed planting with a shifted root ball and leaning trunk. It may be possible to work around #261 and #254 or use alternative construction techniques to minimize impacts but as displayed these trees would be destroyed. The trees in front were all somewhat recently planted large specimens and

3. Consider revising the plans to retain tree #261 and work around it or use alternative construction methods to help preserve the root area. Consider relocating trees #746, #747, and #748.

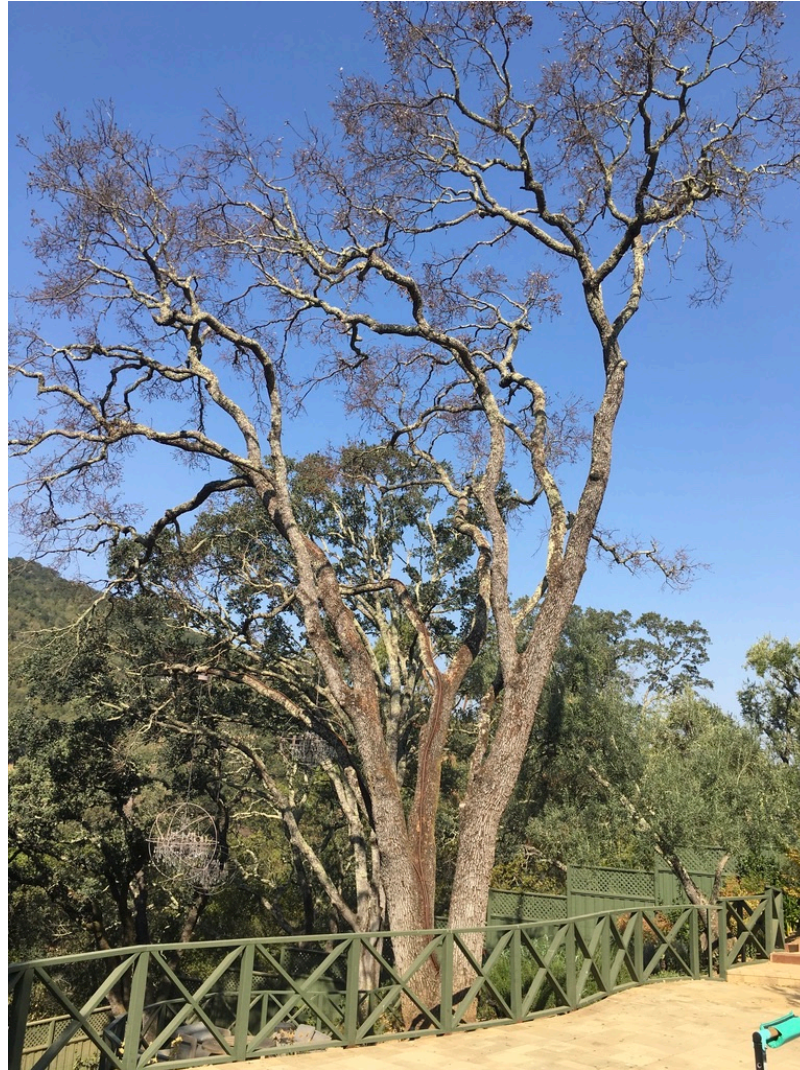
**C2: Blue oak #254**

Three trees are in good condition and they are the newly planted coast live oaks in front with the exception of #749. Seven trees are in fair shape, one poor (#749), and one very poor (#254). Large Protected blue oak #254 is void of foliage and in irreversible decline. Black oak #275 and blue oak #252B have large columns of decay and the black oak leans.
