"Hands On Tree Care"

2/11/2019

Re: Arborist Report for Proposed Development Project at 16 Chestnut Ave. in Los Gatos

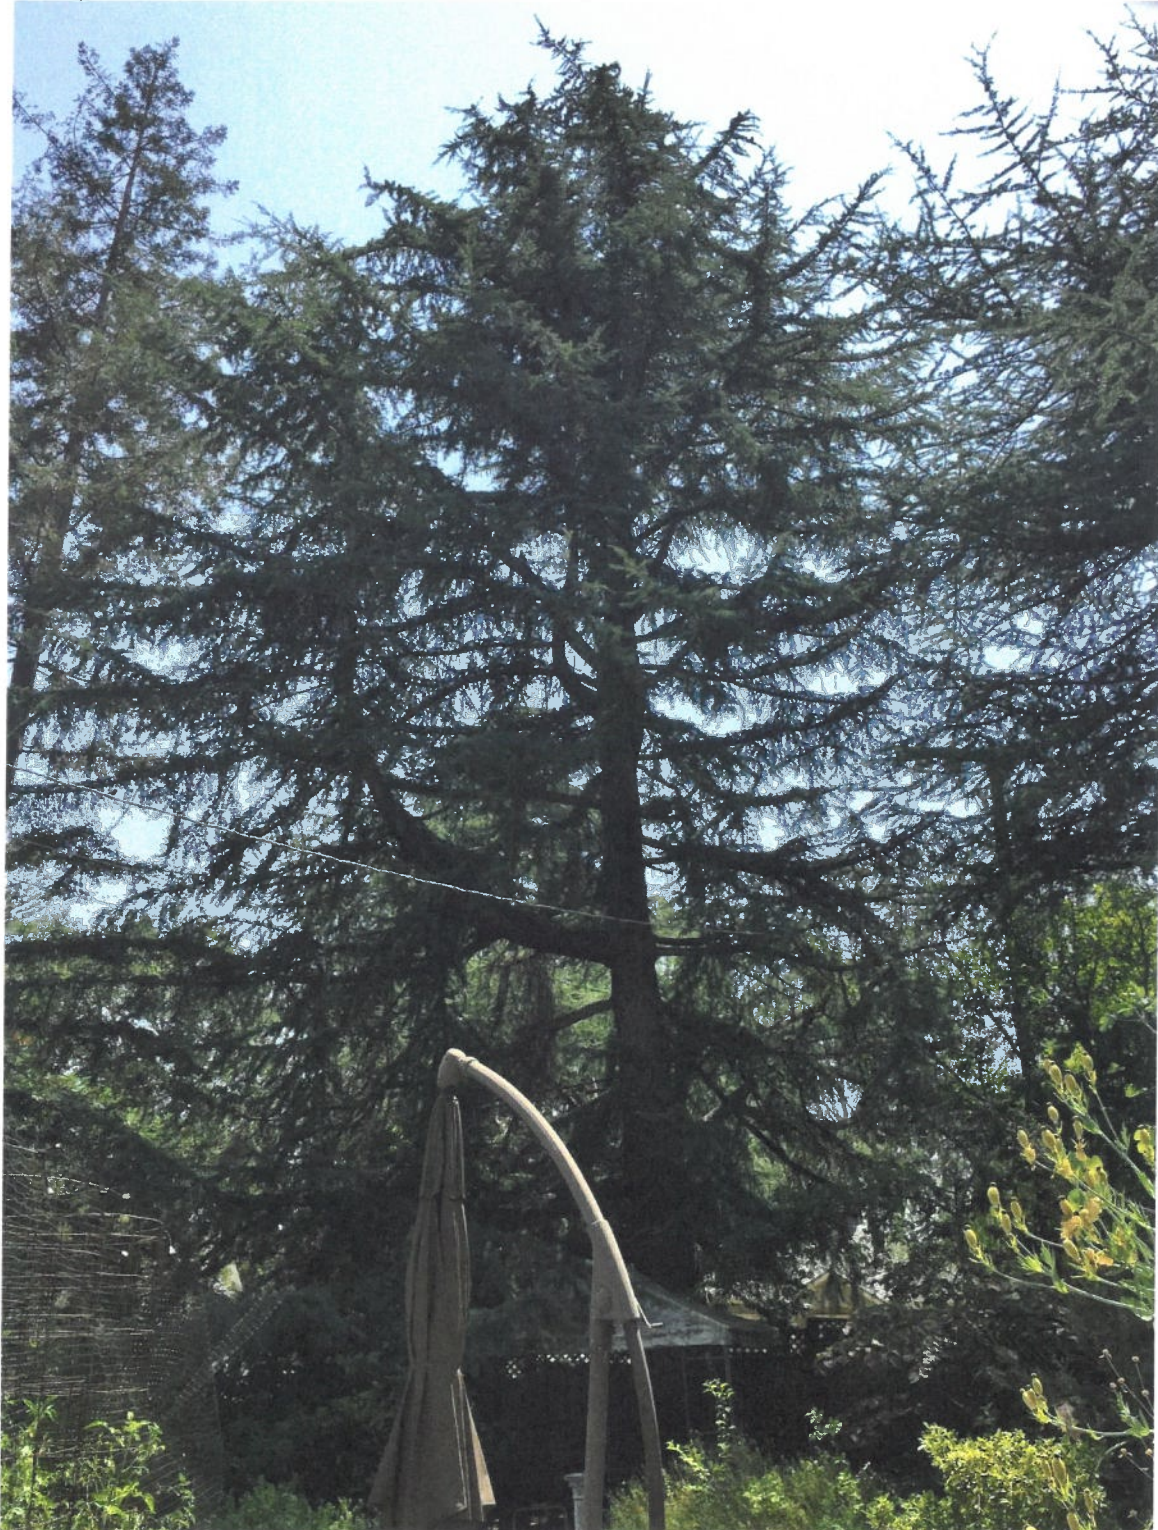
Image 1: deodar cedar #1

A new backyard fence will be installed within the tree protection zones of trees #1 and 11. I have assumed this will likely occur fairly late in the construction process, after the house is finished.

Trees #1 and 11 will likely undergo minor impacts from fence installation. It should be practical to exclude construction personnel and equipment as needed for the duration of house construction.

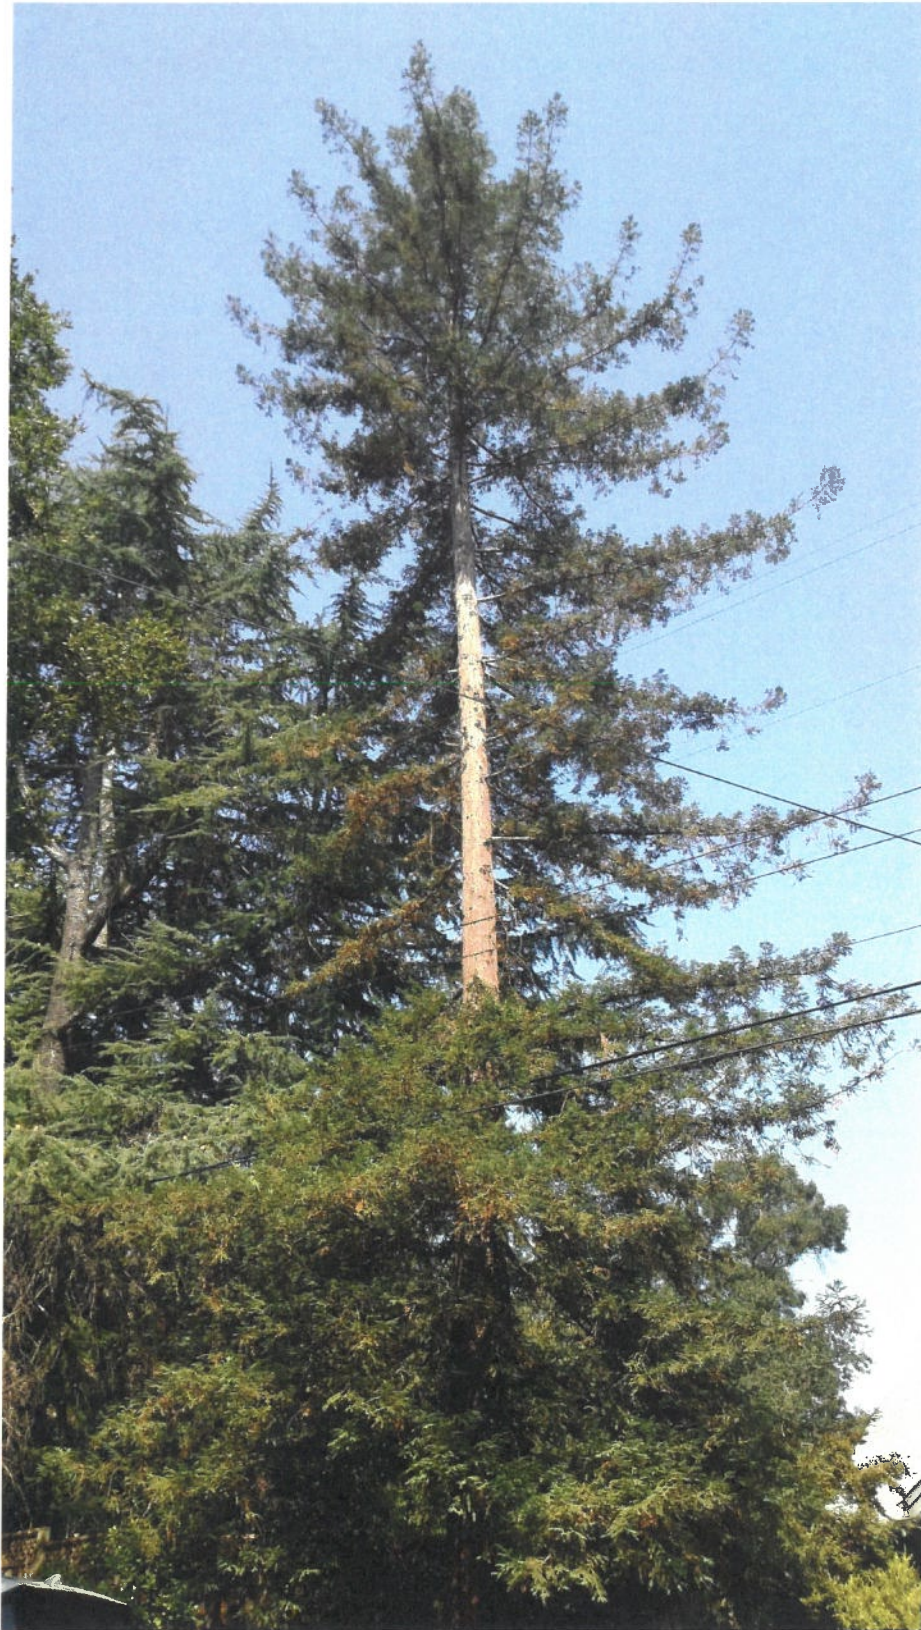
Image2: coast redwood #2

A decomposed granite path between Chestnut Ave. and the front door will be installed within the tree protection zones of trees, #2 and 6.

Tree #2 will likely undergo minor impacts from installation of the decomposed granite walkway. It should be practical to exclude construction personnel and equipment as needed for the duration of house construction.

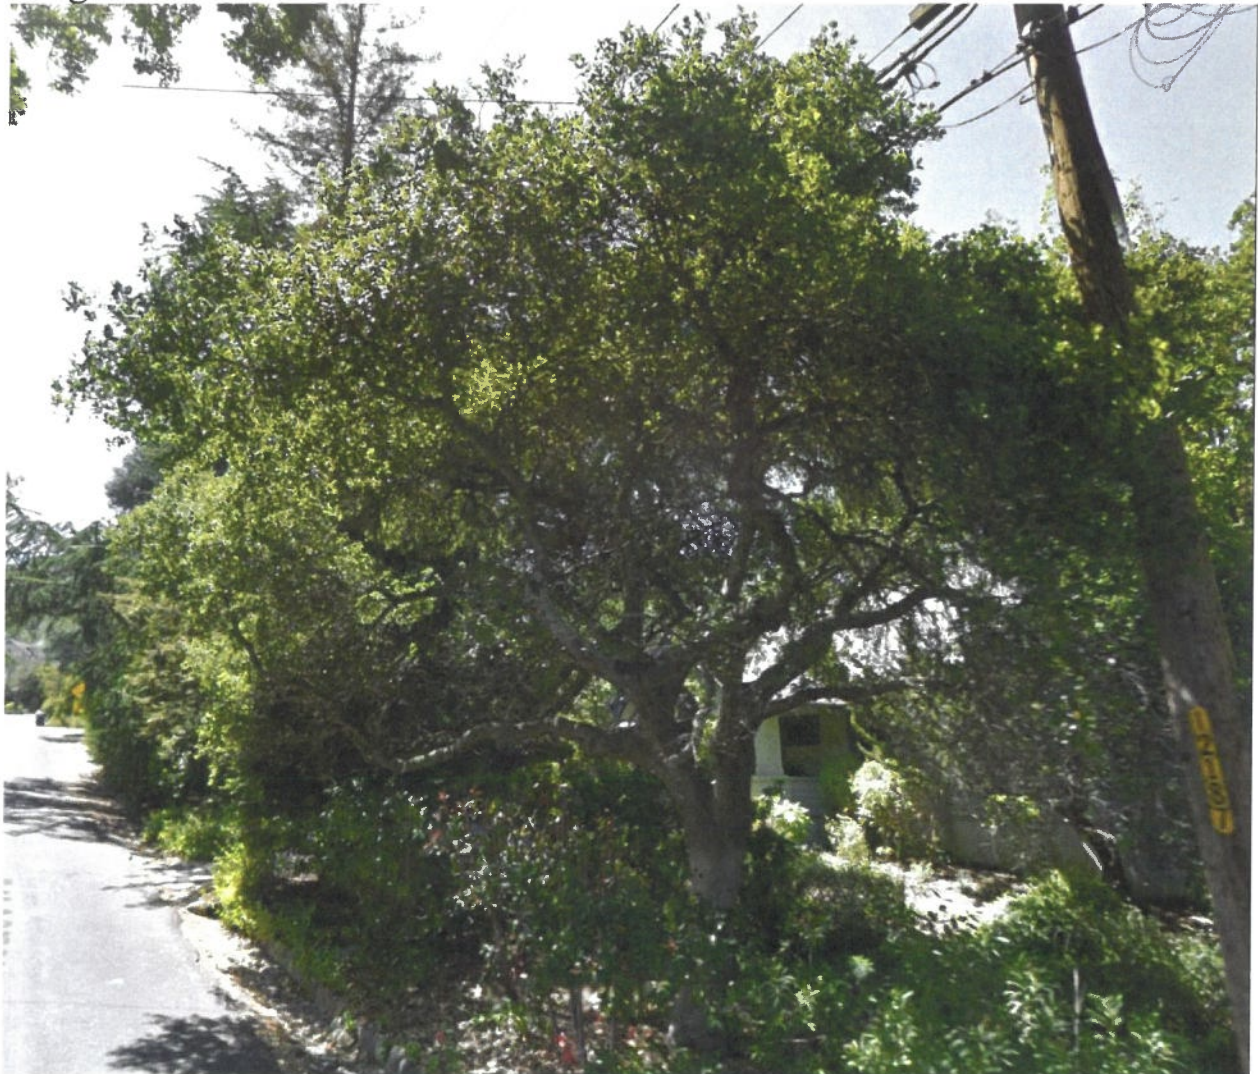
Image 3: coast live oak #3

Water utility trenching will occur within the tree protection zone of tree #3.

Tree #3 will likely undergo minor impacts from water line installation if care is taken to preserve roots as detailed below.

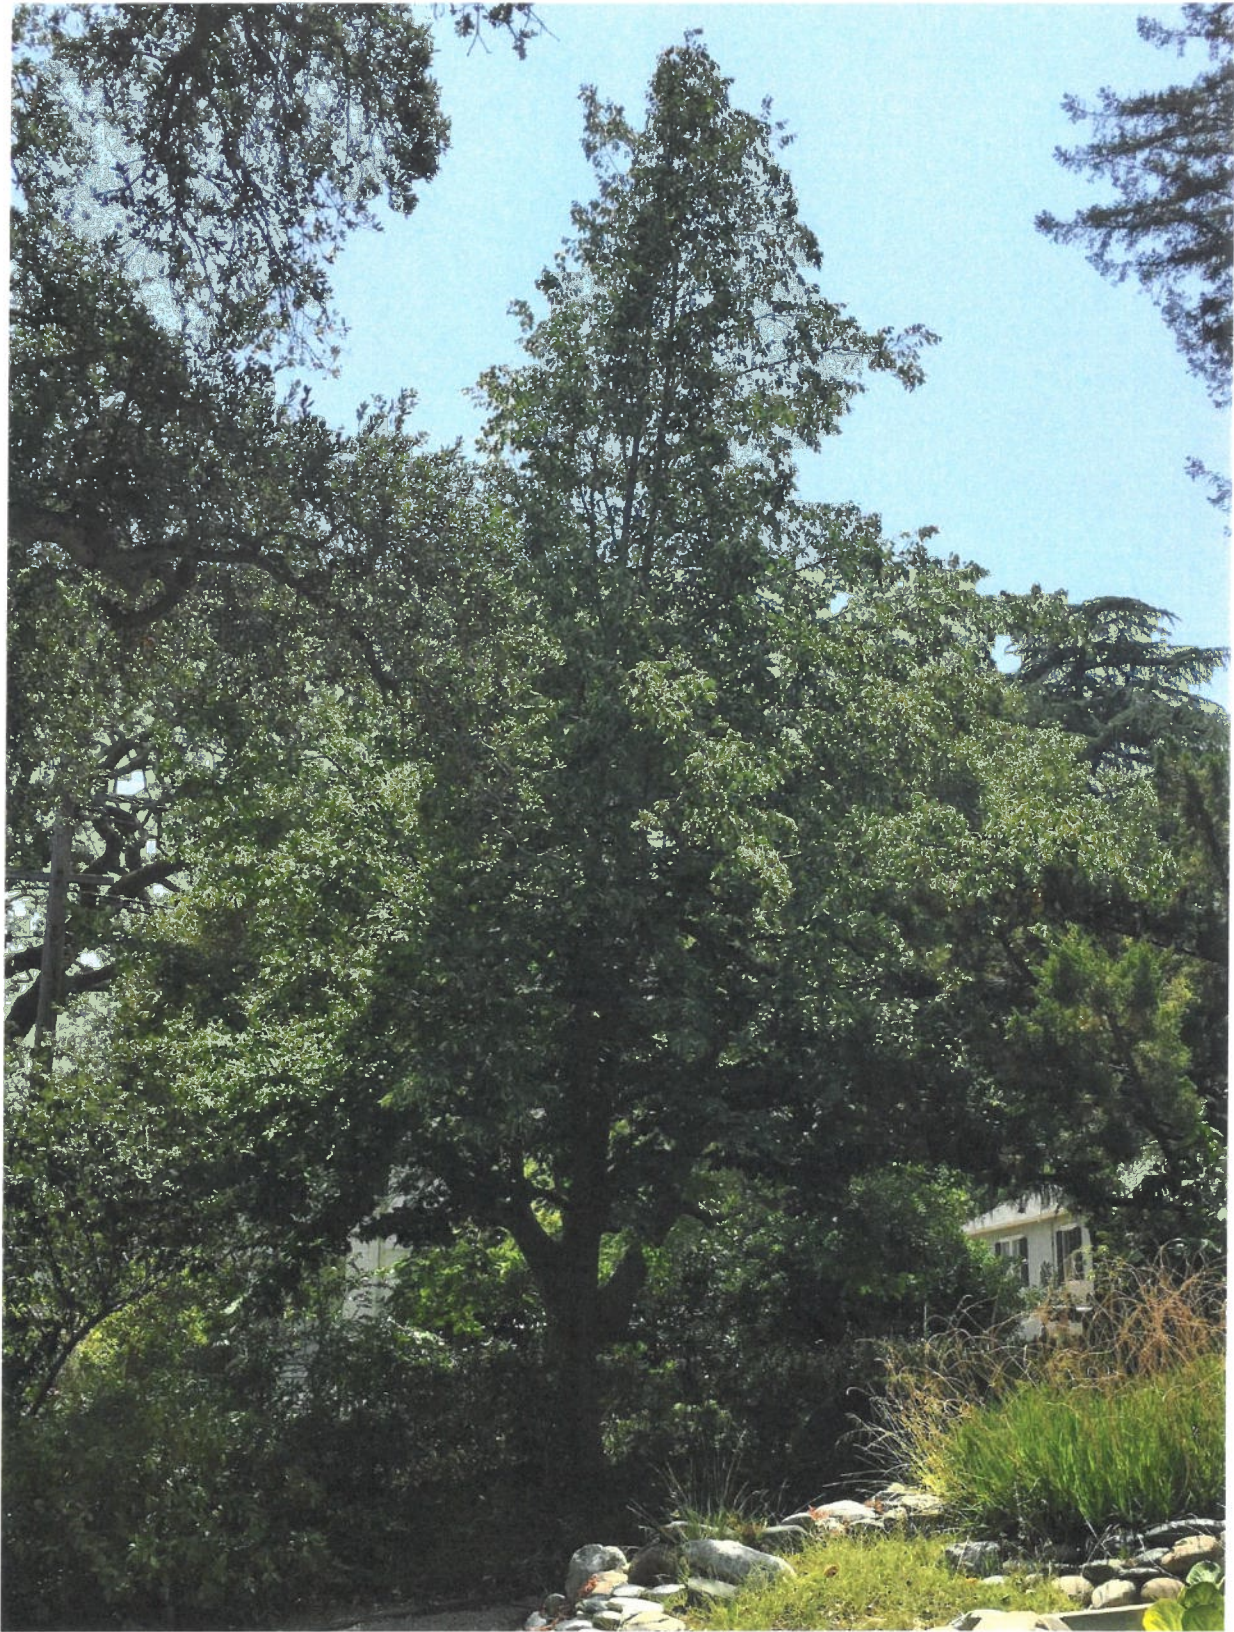
Image 4: Linden #4

Trees #4 and 5 are unlikely to undergo impacts from the project as proposed if proper tree protection measures are implemented.

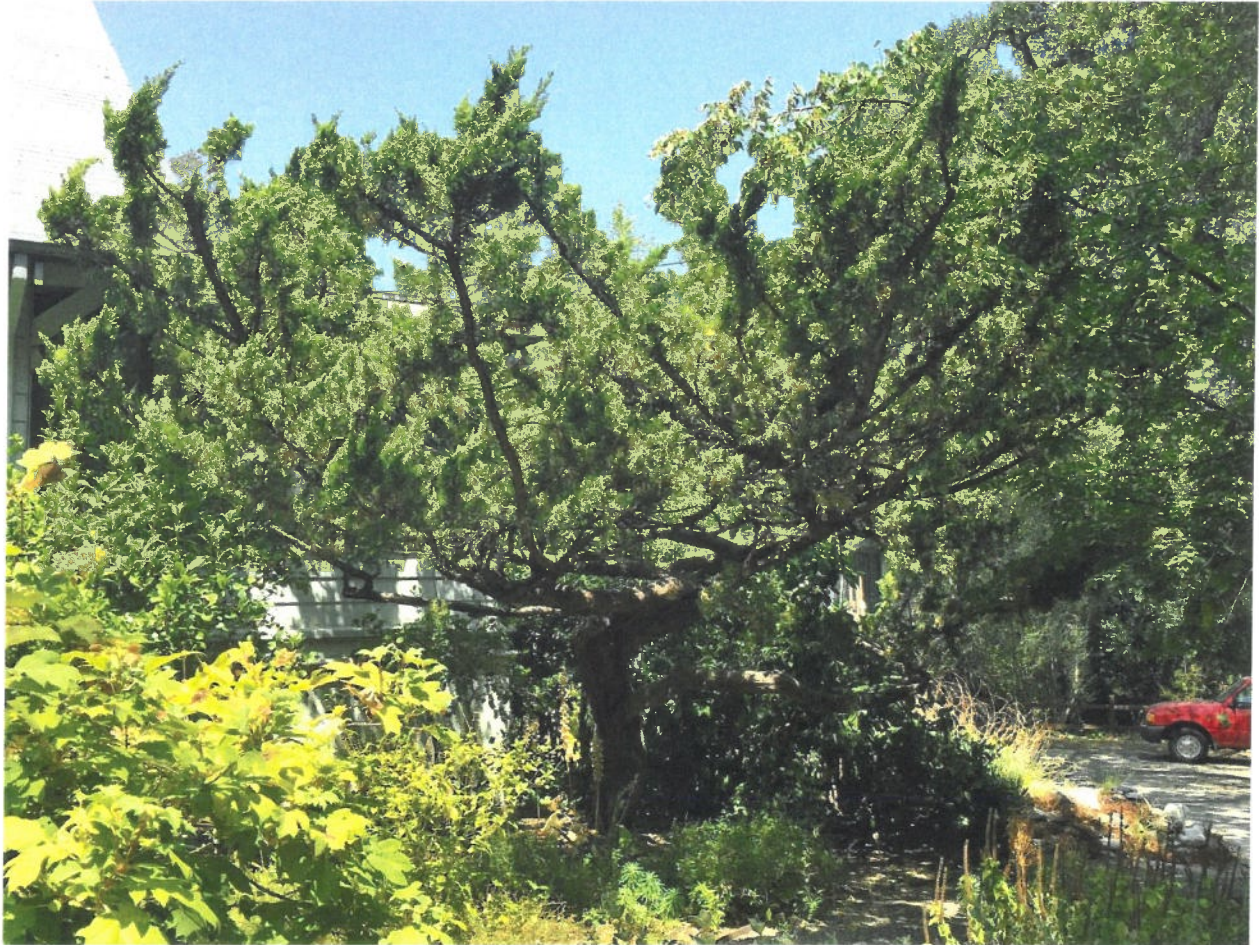
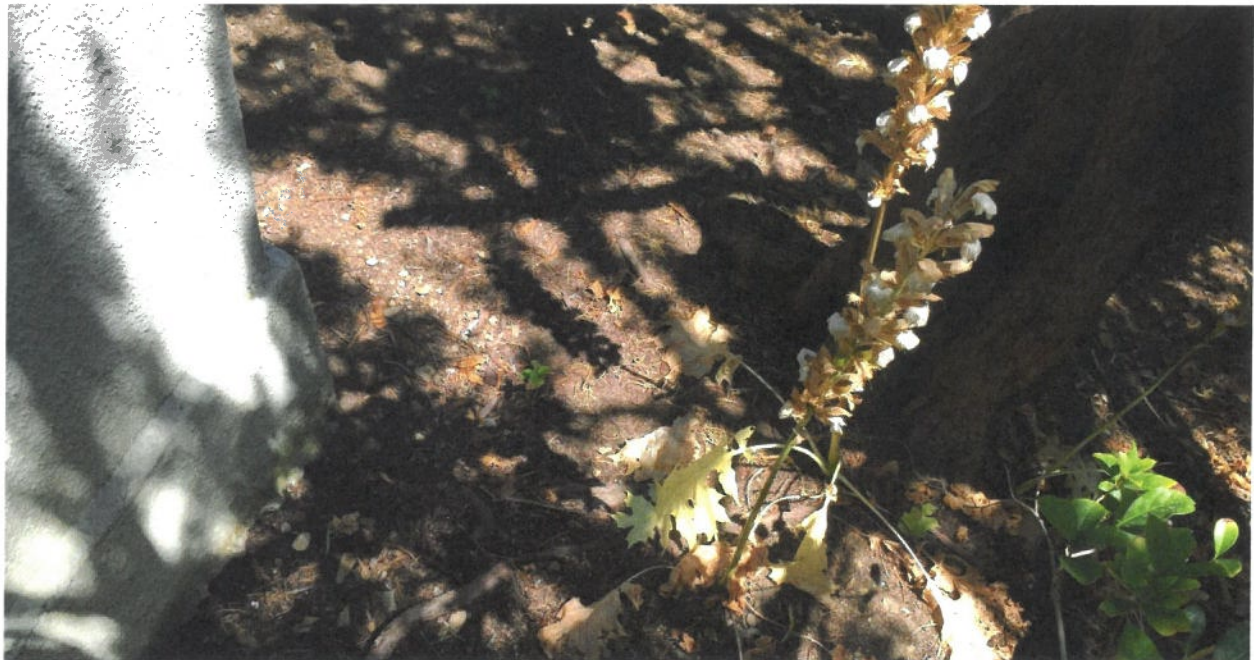
Image 5: Chinese juniper #4A

Tree #4A lies approximately 2 feet from the corner of the existing house to be demolished (**Image 5**).

Tree #4A must be removed in order for the project to proceed as proposed, as it conflicts directly with demolition of the existing corner of the house.

1. Remove trees #4A and 7 prior to commencing construction.
2. All tree removal and limb pruning must be performed by trained tree work personnel under the direction of an ISA-Certified Arborist.
3. Apply a growth regulator to tree #6.
4. Remove visible girdling roots from tree #6.
5. Install tree protection fencing for all other trees, conforming to the following specifications put forth in the Los Gatos Town Code, Section 29.10.1005:²
 - a. Fencing shall consist of six (6) foot high chain link fencing, mounted on two-inch diameter galvanized iron posts, shall be driven into the ground to a depth of at least two (2) feet at no more than 10-foot spacing. For paving area that will not be demolished and when stipulated in a tree preservation plan, posts may be supported by a concrete base.

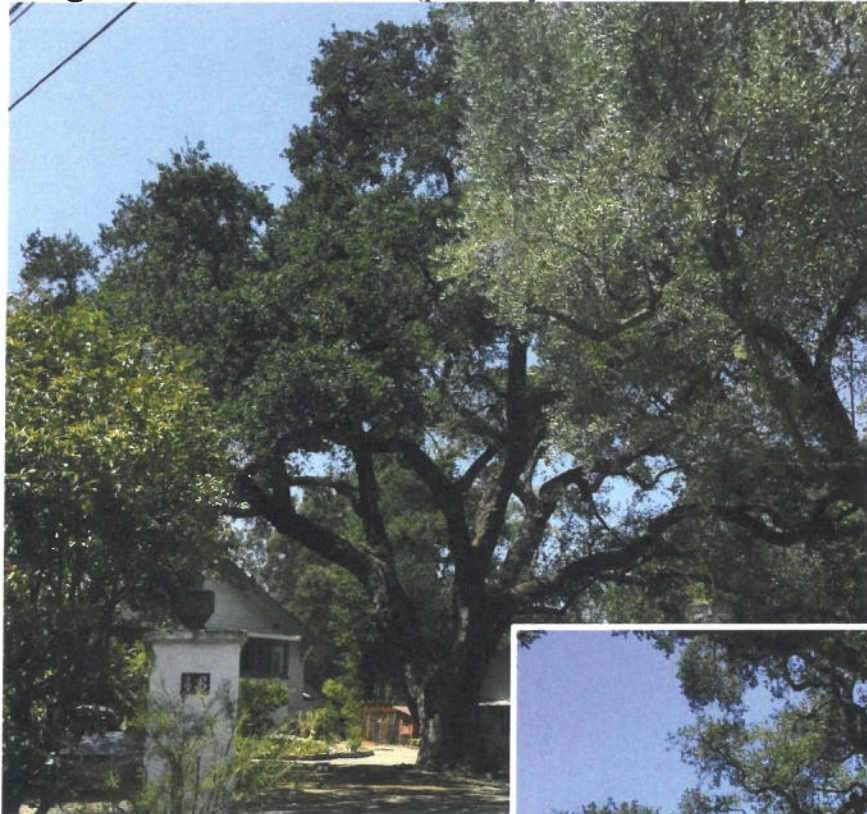
Image 7: coast live oak #6 (partially obstructed by olive #5 in foreground)

Tree #6 is a large and apparently quite old coast live oak. This tree's health appears poor, evidenced by a relatively thin canopy and slow reaction growth around large wounds (**Image 7**). Several girdling roots are present at the base of the trunk.

Tree #6 will likely undergo moderate impacts from installation of the driveway and decomposed granite walkway. This tree appears likely to decline in health irrespective of construction activities. It would benefit from removal of its girdling roots, and remediation of its root zone.

- 12. After construction is complete:
 - a. Install six 15-gallon trees to replace trees #4A and 7.
 - b. Perform root zone remediation in all unpaved areas within the CRZ of tree #6:

- i. Decompact the soil with an air spade,
 - ii. Incorporate compost into the soil with the air spade, and

iii. Spread wood chips over the top of the decompacted soil to a depth of 3-6 inches.

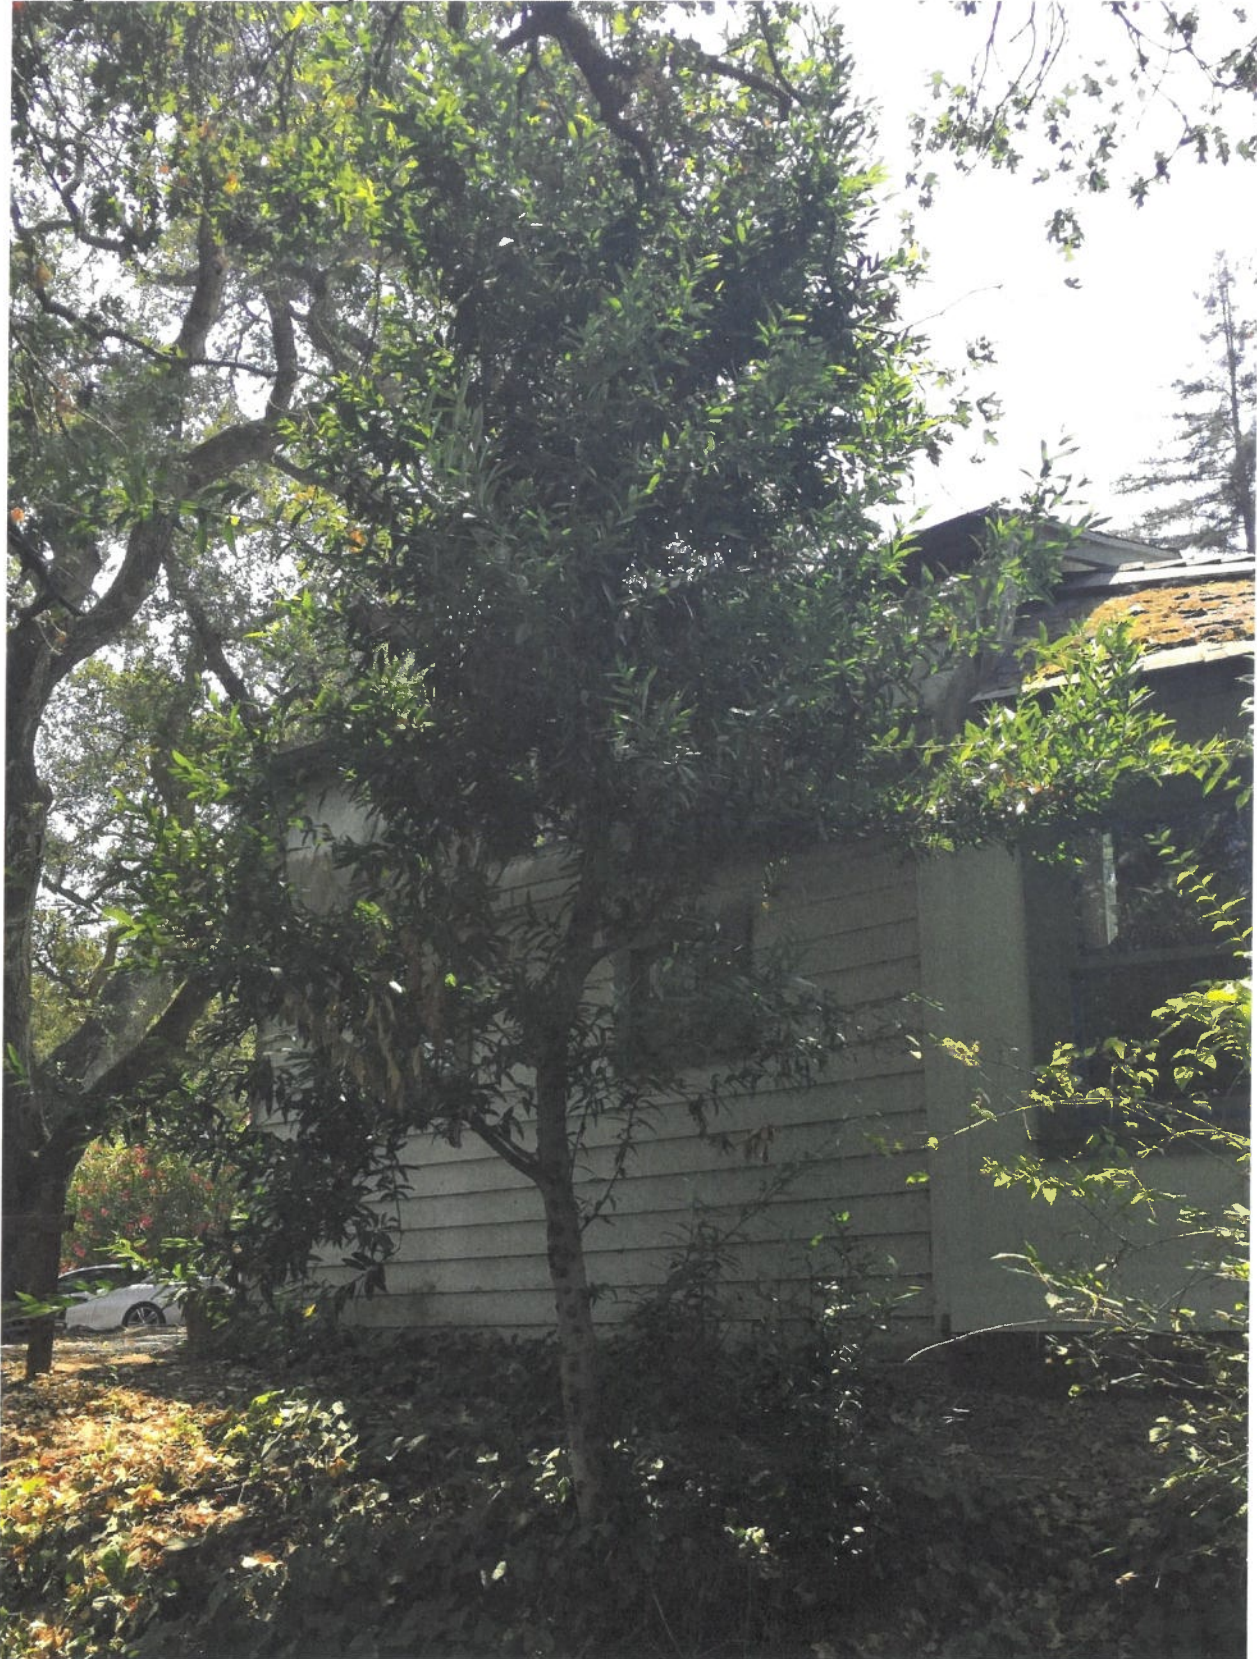
Image 8: California bay #6A

Trees #6A-9 are separated from the project area by existing features: a substantial grade change, a concrete retaining wall, and a chicken coop (**Images 8-10**).

Trees #6A-9 are unlikely to undergo impacts from the project as proposed, as they are separated from the work area by existing site features.

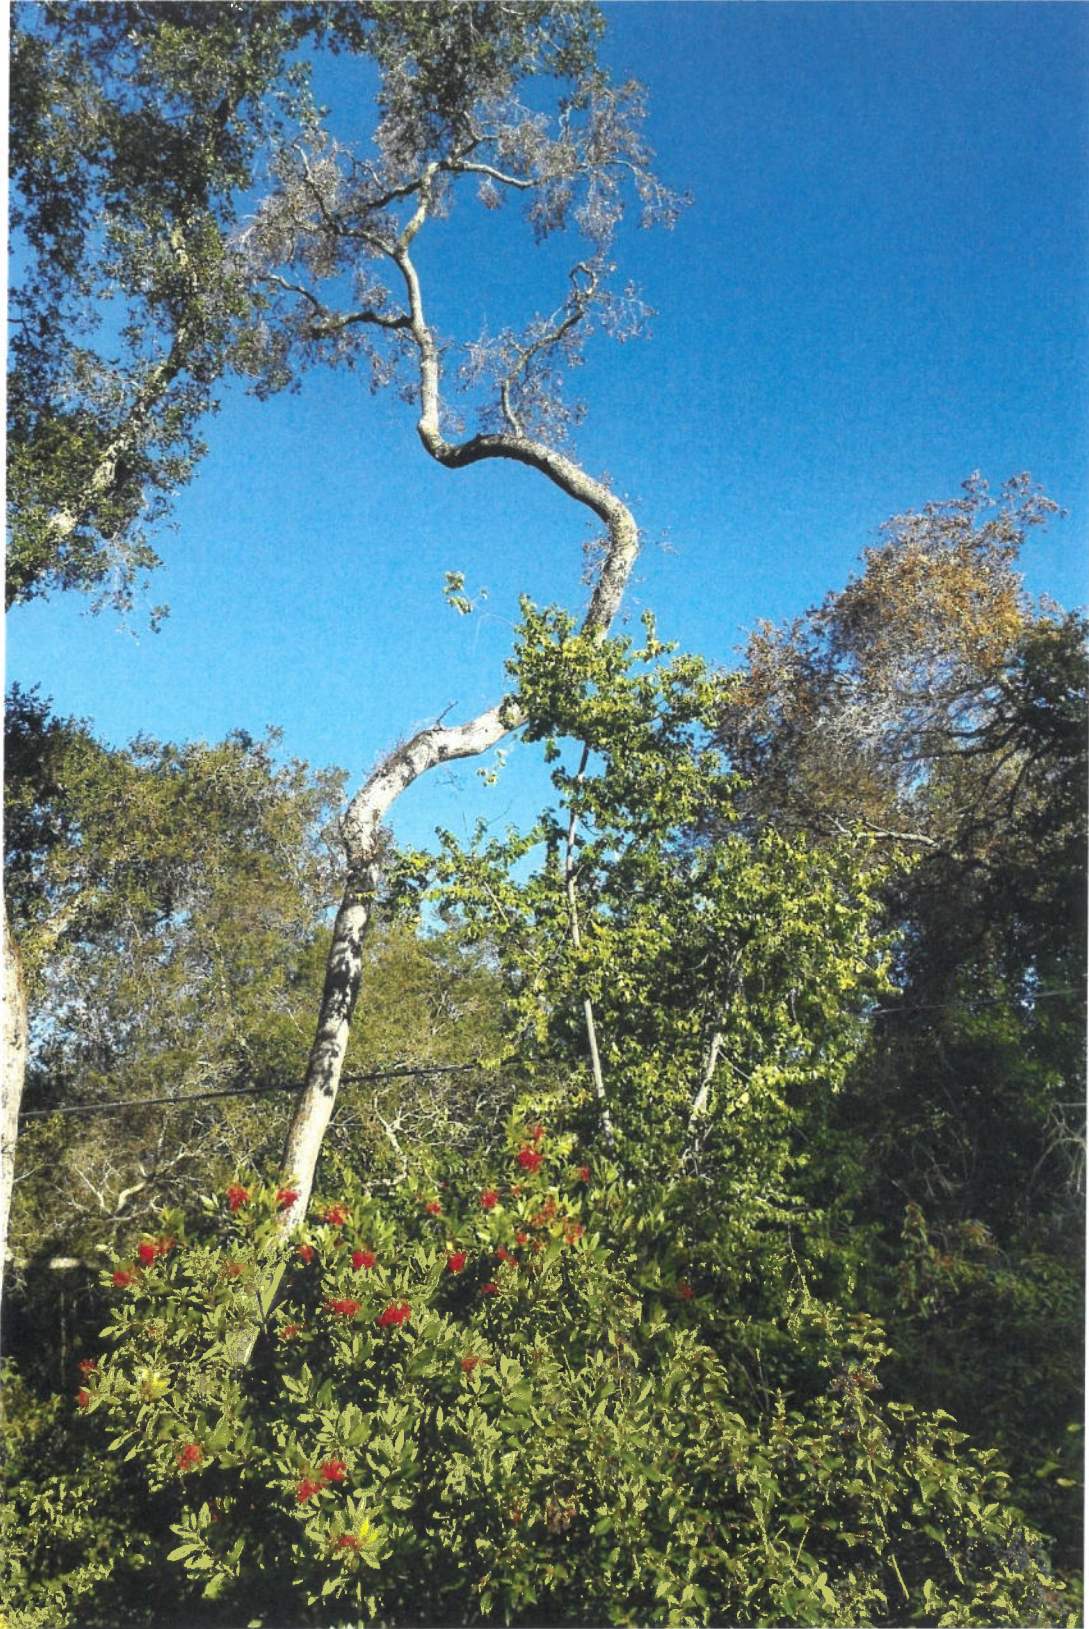
Image 10: coast live oak #7 (photo taken in 2019)

Tree #7 is dead, though it was alive at my 2018 site visit (**Image 10**).

Tree #7 should be removed irrespective of construction activities, as it is dead.

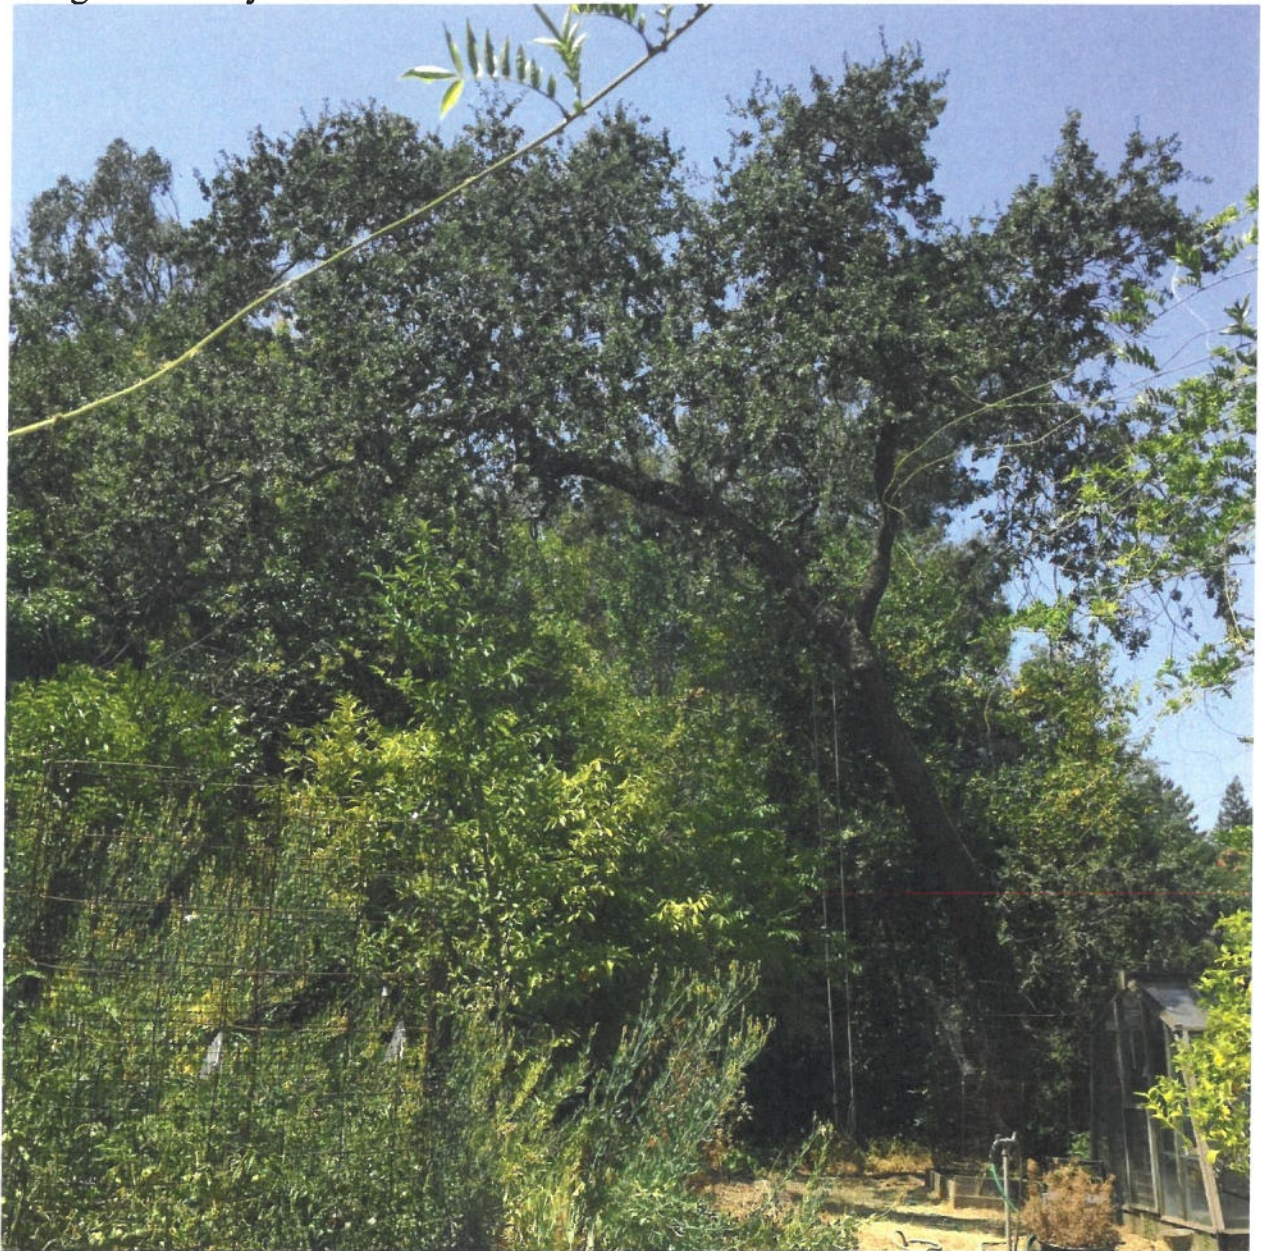
Image 11: valley oak #10

The new backyard patio lies slightly within the tree protection zone of tree #10. This tree's canopy is highly asymmetrical (**Image 11**) and will overhang a substantial portion of the patio and barbecue area.

Tree #10 will likely undergo minor impacts from backyard patio installation.
